NATIONAL TRANSPORTATION SAFETY BOARD

HAZARDOUS MATERIALS ACCIDENT REPORT

OVERFLOW OF GASOLINE AND FIRE
AT A SERVICE STATION-CONVENIENCE STORE
BILOXI, MISSISSIPPI
AUGUST 9, 1998

NTSB/HZM-99/02
PB99-917007
Notation 7120A
Adopted: September 21, 1999

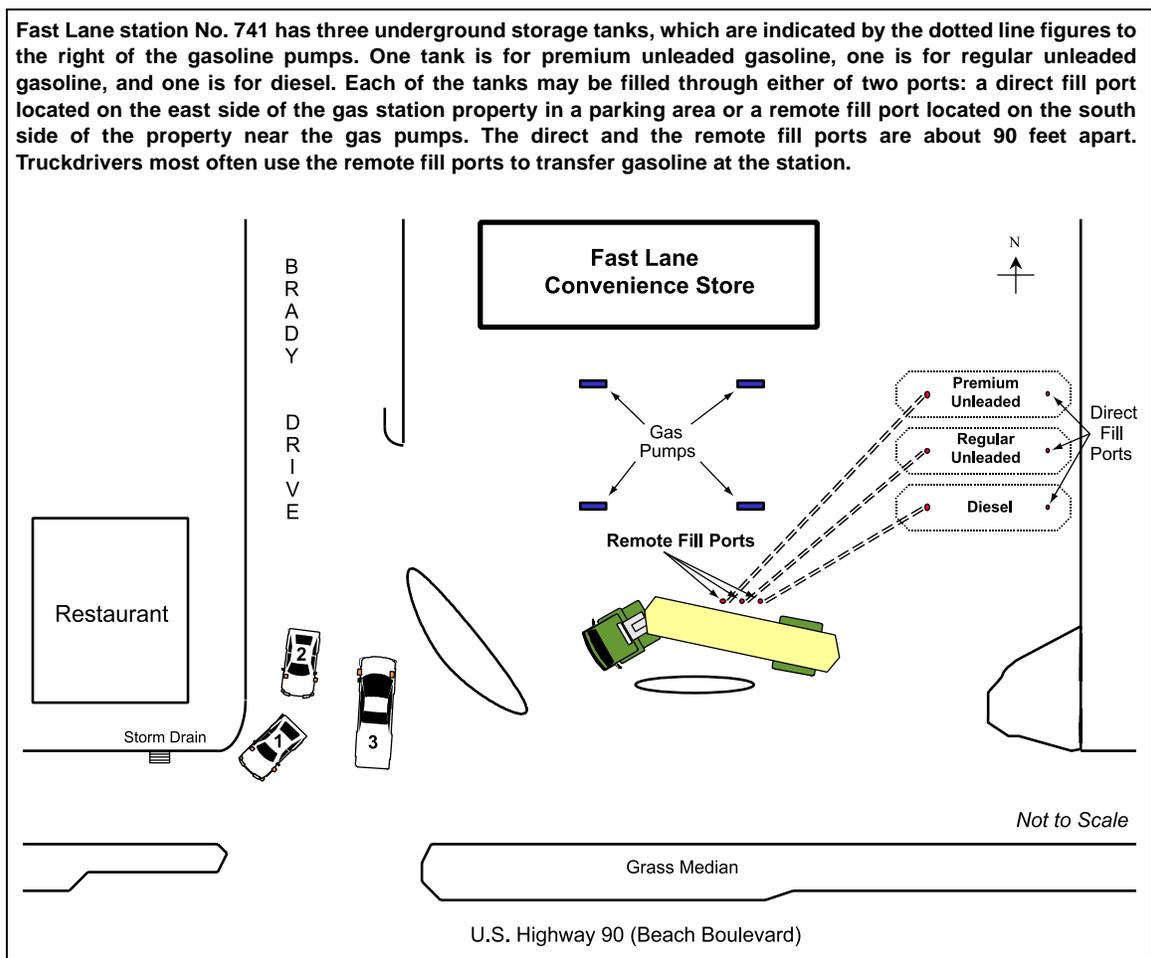
Figure 1. Layout of accident site. The vehicles numbered 1, 2, and 3 are, respectively, a 1995 four-door Hyundai sedan, a 1997 four-door Mazda sedan, and a 1999 Ford pick-up truck.

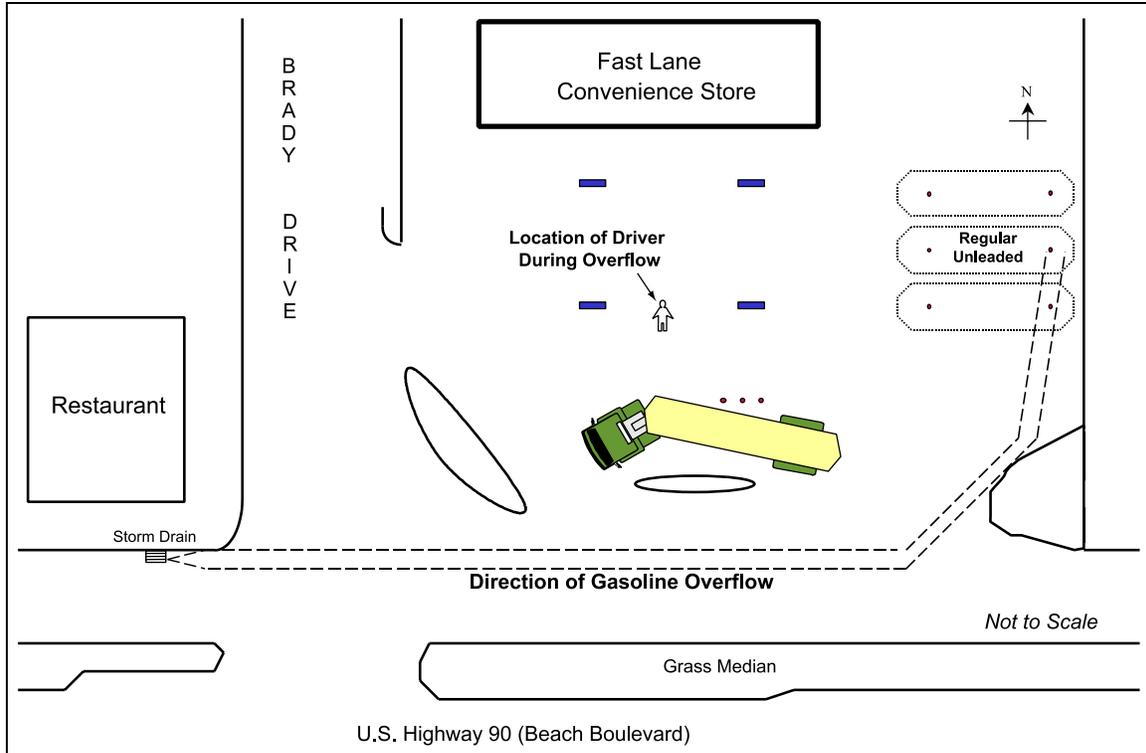
**Figure 2.** Dotted lines from the regular unleaded underground storage tank to the storm drain represent the flow of the gasoline overflow.

About 550 gallons⁹ of regular unleaded gasoline overflowed the underground storage tank. The excess gasoline flowed south from the open fill port through the gas station parking lot, then west along the north side of US 90 across the Brady Drive intersection, where it entered a storm drain under the highway. The drain emptied into an open concrete culvert, which ran southward toward the Gulf of Mexico.

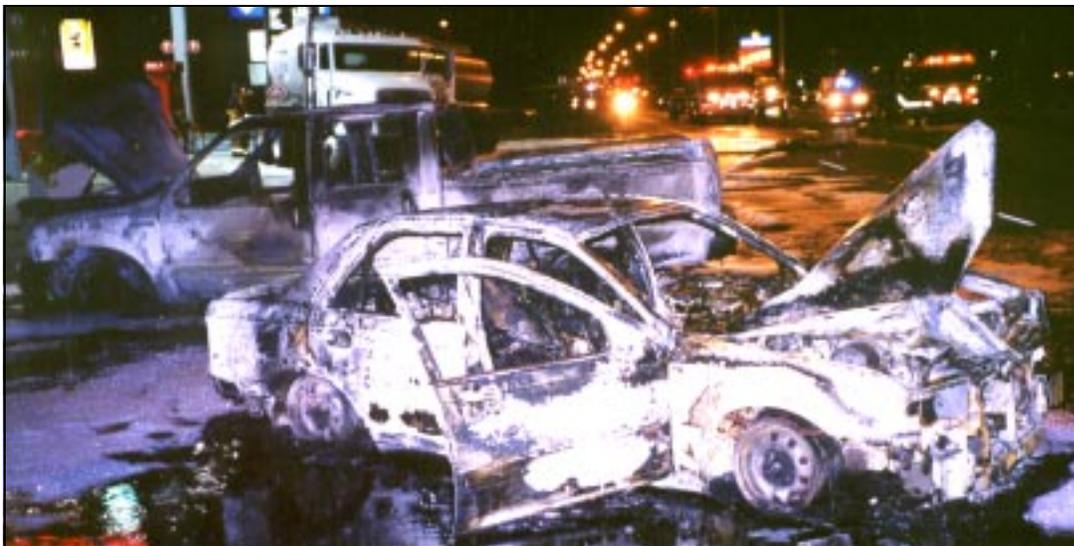
Figure 3. One of the sedans and the pickup after emergency responders extinguished the blaze. The Premium cargo tank truck is in the background.

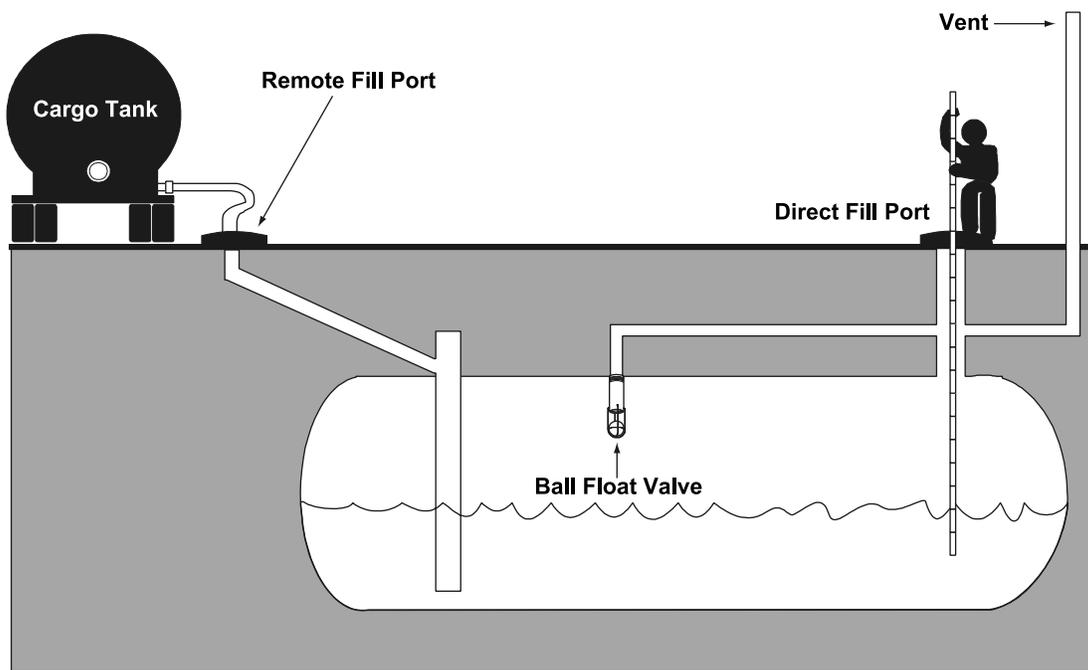
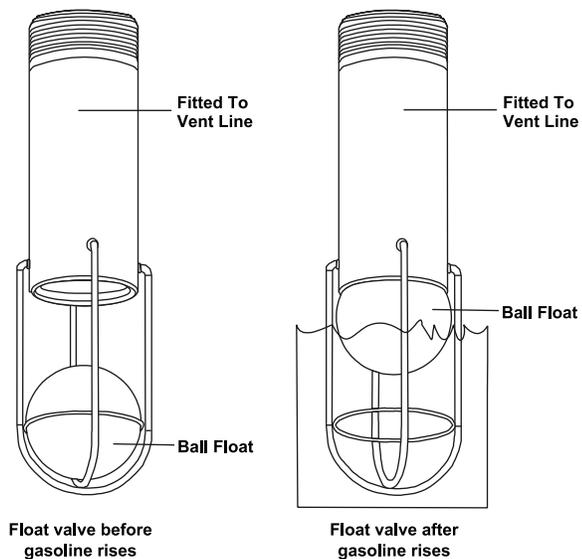
Federal regulations contained in 40 CFR 280.20 require that underground storage tanks be equipped with safeguards to prevent spilling and overfilling during gasoline transfer. Morrison elected to install float valves (figure 4) in the tank vents of the Fast Lane station storage tanks. The float valve rises as gasoline fills the tanks, eventually seating against the end of the vent pipe and restricting the vapor flow through the vent pipe, which causes pressure to build. The pressure in the tank works against the head of the liquid in the cargo tank and the transfer hoses, causing a reduction in the flow of gasoline. Because the operation of a float valve is pressure controlled, at a station having both direct and remote fill ports, such as Fast Lane station No. 741, only one fill port should be open during a gasoline transfer. If a second fill port is open, the vapor can escape through it, rendering the float valve safety feature ineffective.

The vent of the underground storage tank is equipped with a float valve, which is designed to rise as gasoline fills the tanks. At a predetermined level, the stainless steel ball float seats against the end of the vent pipe, restricting the vapor flow through the tank vent, which creates pressure in the underground tank that affects the flow of gas from the cargo tank. If the direct and the remote fill ports to an underground storage tank are both open during the gasoline transfer, the pressure will not build but will escape through the open fill port, which renders the float valve safety feature ineffective.

Figure 4. Top illustration is a cutaway of a typical service station having both direct and remote fill ports. Lower illustration shows a typical float valve, which was the type of safeguard against spills and overfills that the Morrison company had installed in many Fast Lane stations.
