## RAILROAD SPECIAL INVESTIGATION REPORT

MARYLAND TRANSIT ADMINISTRATION  
LIGHT RAIL VEHICLE ACCIDENTS AT THE  
BALTIMORE-WASHINGTON INTERNATIONAL  
AIRPORT TRANSIT STATION  
NEAR BALTIMORE, MARYLAND  
FEBRUARY 13 AND AUGUST 15, 2000

**Maryland Transit Administration  
Light Rail Vehicle Accidents at the  
Baltimore-Washington International  
Airport Transit Station  
Near Baltimore, Maryland  
February 13 and August 15, 2000**

**NTSB/SIR-01/02  
PB2001-917005  
Notation 7413  
Adopted December 11, 2001**

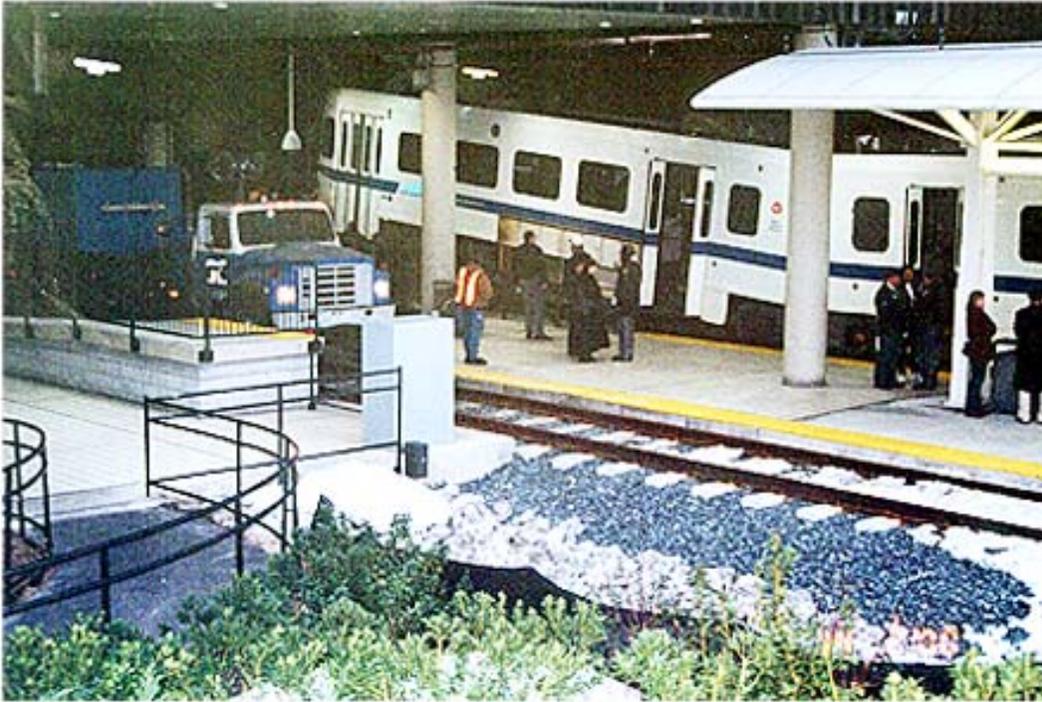
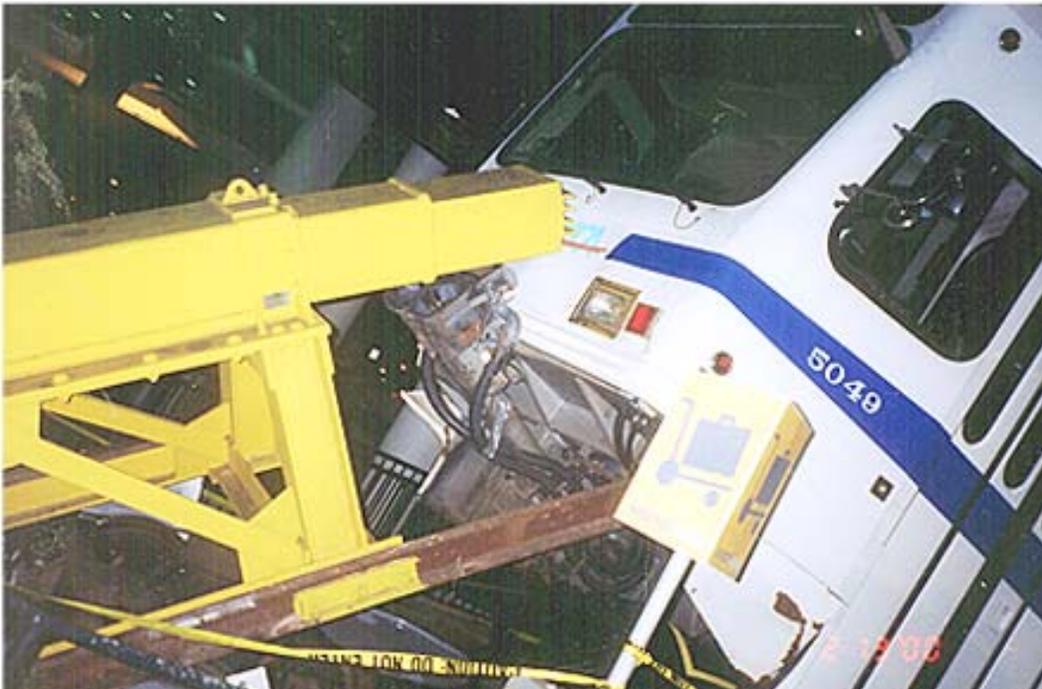
**Figure 2.** Two views of train 24 in the station following February 13, 2000, accident; top photo shows side view of train after it traveled into the end of the line, bottom photo shows close-up of front car resting on the bumping post.

**LRV.** The outside front center panel of the single LRV car that made up train 24 was dented inward 1 to 2 inches immediately below the windshield. The "A" (front) end of the two-segment car sustained localized exterior side-sheet panel distortion. The front propulsion truck had separated from the car body and was wedged against the rear support legs of the bumping post assembly. The pantograph assembly on the roof of the car body's "A" end was substantially damaged.

**Bumping Post.** As a result of the accident, both running rails apparently fractured at points immediately north of the bumping post assembly. The westernmost running rail was fractured at a bolt hole at the attachment of the bumping post assembly's front support leg. The easternmost running rail was fractured at a joint weld about 40 inches before the bumping post assembly. The bumping post had been pushed backward to the point at which its rear legs were firmly wedged against the vertical face of the concrete service platform that surrounded the track and ballast. The front of the bumping post assembly had rotated upward about 3 1/2 feet, having pivoted about its rear support leg members (forming an "A frame"). Despite being displaced, the bumping post assembly did not appear to be seriously damaged.

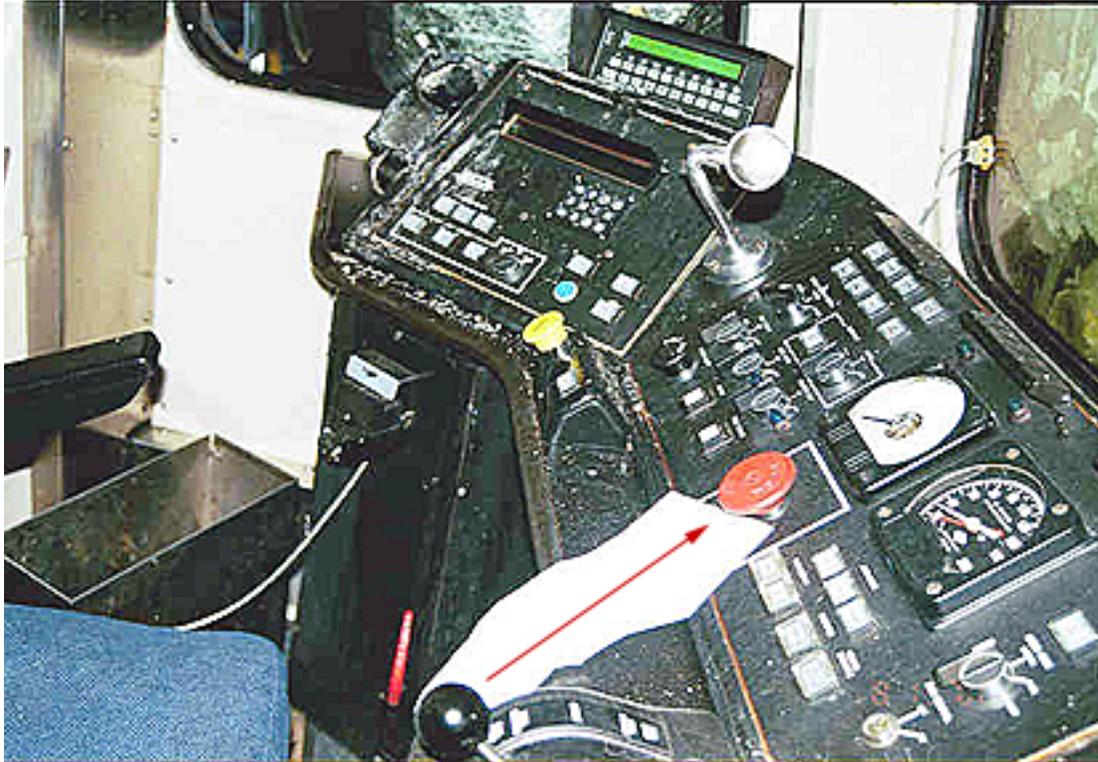
**Figure 3.** LRV cab interior; arrow indicates emergency stop button.

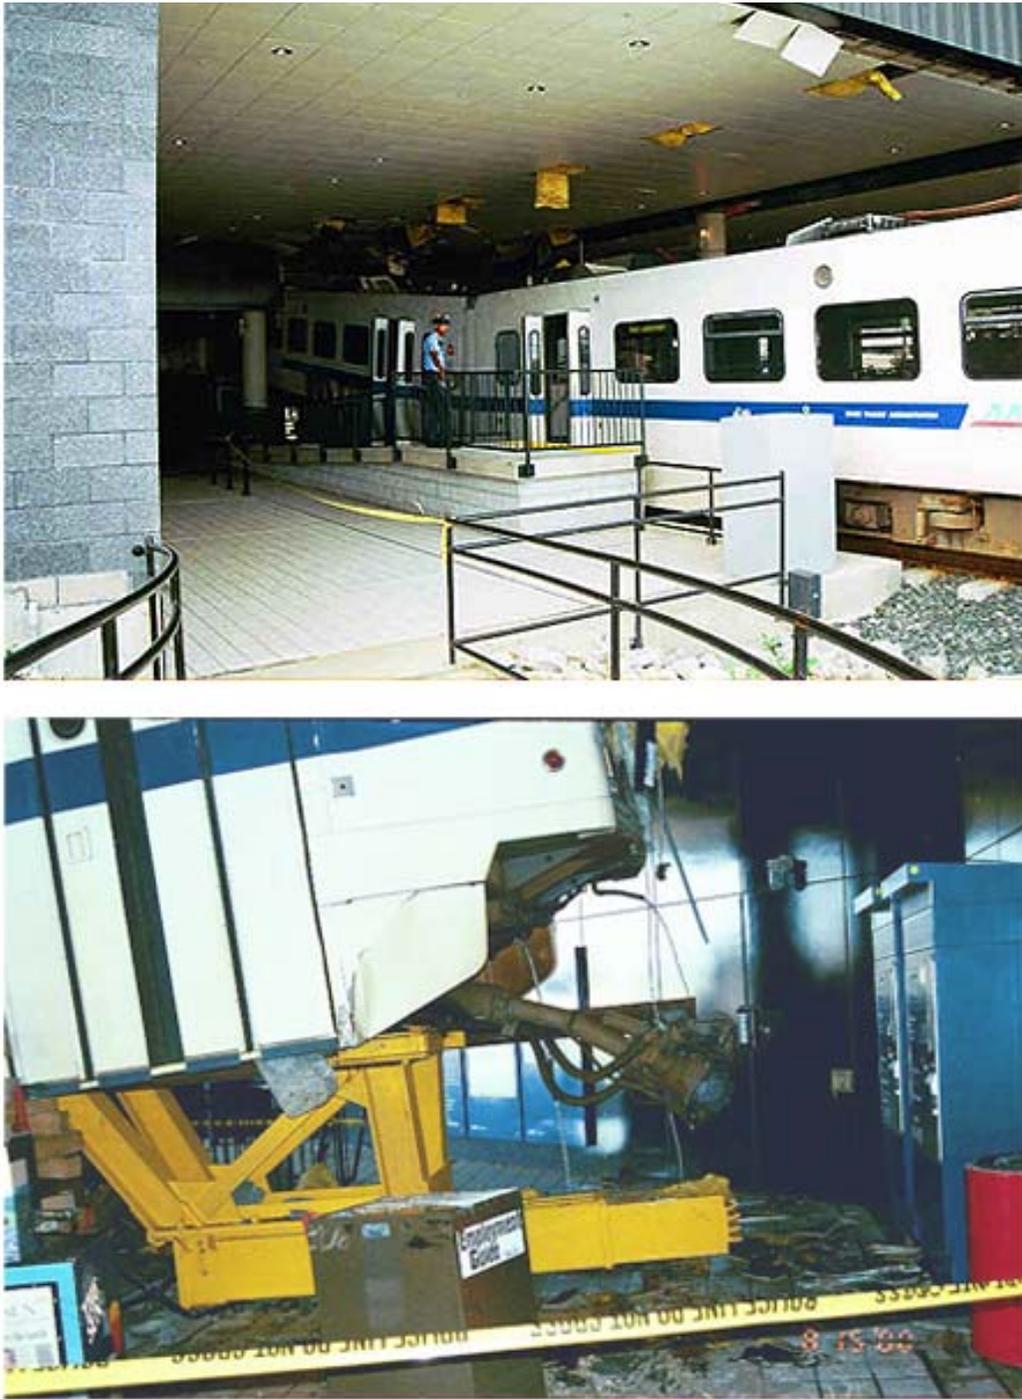
**Figure 4.** Two views of train 22 in station following August 15, 2000, accident; top photo shows side view of train after it struck the end of the line, bottom photo shows front car sitting on overturned bumping post.

**LRV 5006 (lead car).** The “A”-end coupler assembly and the related electrical and communications cables were extensively damaged. Many car body-mounted major components showed evidence of movement from impact by fractions of an inch. The slewing ring at the articulated (middle) truck was off center by about 1/16 inch. The triangular catenary anchor mounted to the airport building ceiling tore a long rectangular hole through the roof of the car’s “A” end. This hole destroyed the pantograph assembly and traction motor blower housing.

**Bumping Post.** Both running rails, to which to the bumping post apparatus support legs were secured, had fractured. One of the running rails appeared to have fractured at a bolt hole, and the other appeared to have fractured at a joint weld, about 57 inches before the front support leg of the bumping post apparatus. The bumping post apparatus sustained impact damage, consisting of visible scoring or scraping damage and loss of paint, measuring about 13 inches in length, on the hydraulic cylinder piston ram element in the area immediately adjacent to the cylinder casing face. The exposed length of the piston ram element was about 30 inches.<sup>19</sup>

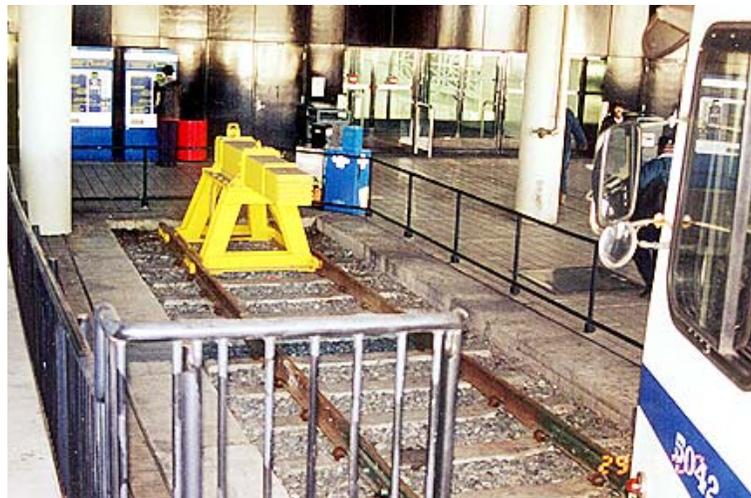
**Figure 5.** Type of Cullen-Western-Hayes, Inc., WH hydraulic bumping post assembly involved in both accidents.

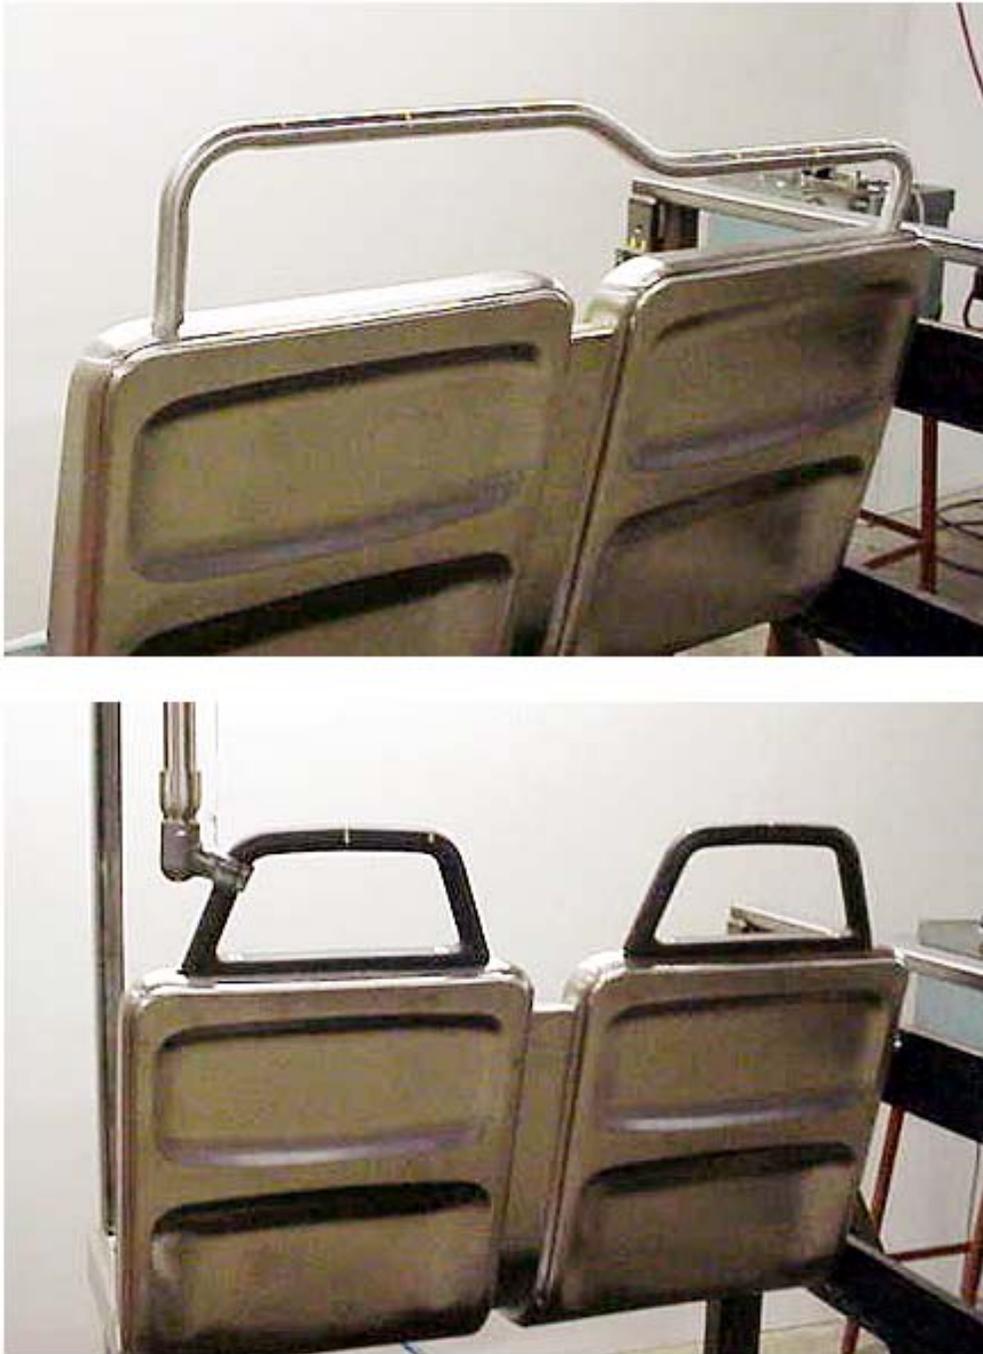
**Figure 6.** Top photograph shows LRV seats equipped with stainless steel grabrail (without a vertical stanchion); bottom photo shows seats equipped with thermoplastic grabrails (with a vertical stanchion).

**Grabrail Head Form Impact Testing.** This energy absorption testing, in which the grabrails were struck, longitudinally, by a 15-pound head form traveling at 15 mph, was conducted with Safety Board staff present. The tests were performed on two configurations of seats with stainless steel grabrails (with and without a vertical stanchion) and two configurations of seats with thermoplastic grabrails (with and without a vertical stanchion). Six different impact locations along the grabrails were tested. The testing produced a range of Head Injury Criteria<sup>49</sup> values, all of which were well below the threshold value of 1,000.<sup>50</sup> The highest recorded Head Injury Criteria value resulting from the testing was 377, which occurred when a stainless steel grabrail with a vertical stanchion was struck. The lowest value recorded from this testing was 76, which occurred when a thermoplastic grabrail without a vertical stanchion was struck.
