Runway Side Excursion During Attempted Takeoff in Strong
and Gusty Crosswind Conditions
Continental Airlines Flight 1404
Boeing 737-500, N18611
Denver, Colorado
December 20, 2008

NTSB/AAR-10/04
PB2010-910404

Aviation Accident Report

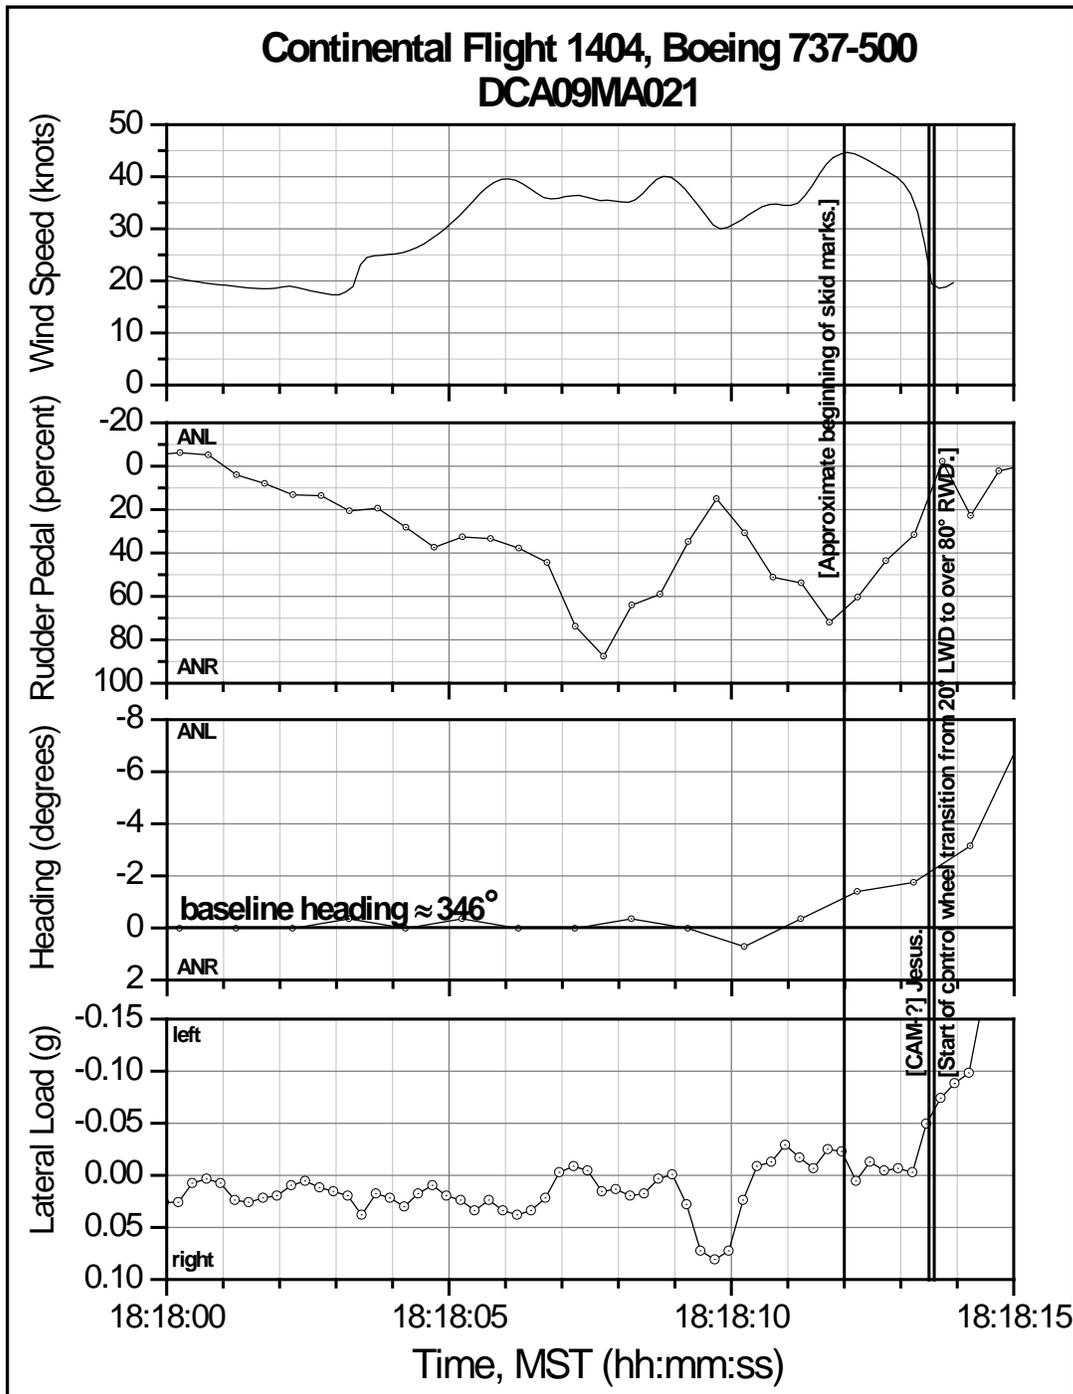
Figure 1. Graphs showing the estimated wind speeds and the airplane’s FDR-recorded heading, rudder pedal position, and lateral acceleration during the takeoff roll. The timing of the beginning of the skid marks, the “Jesus” comment, and the control wheel reversal are also shown.

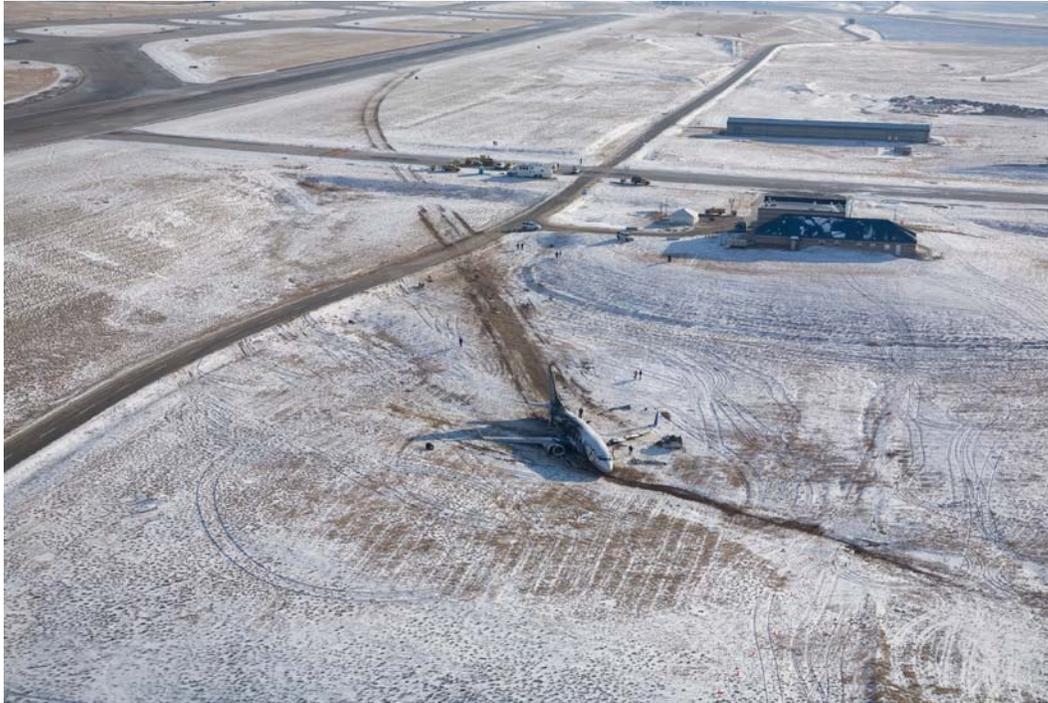
Figure 2. Aerial photograph (facing southeast) of the airplane wreckage. Ground scars are visible from the edge of runway 34R, across taxiway WC and the airport service road, and up to the wreckage. Fire station #4 is shown at the right edge of the photograph.

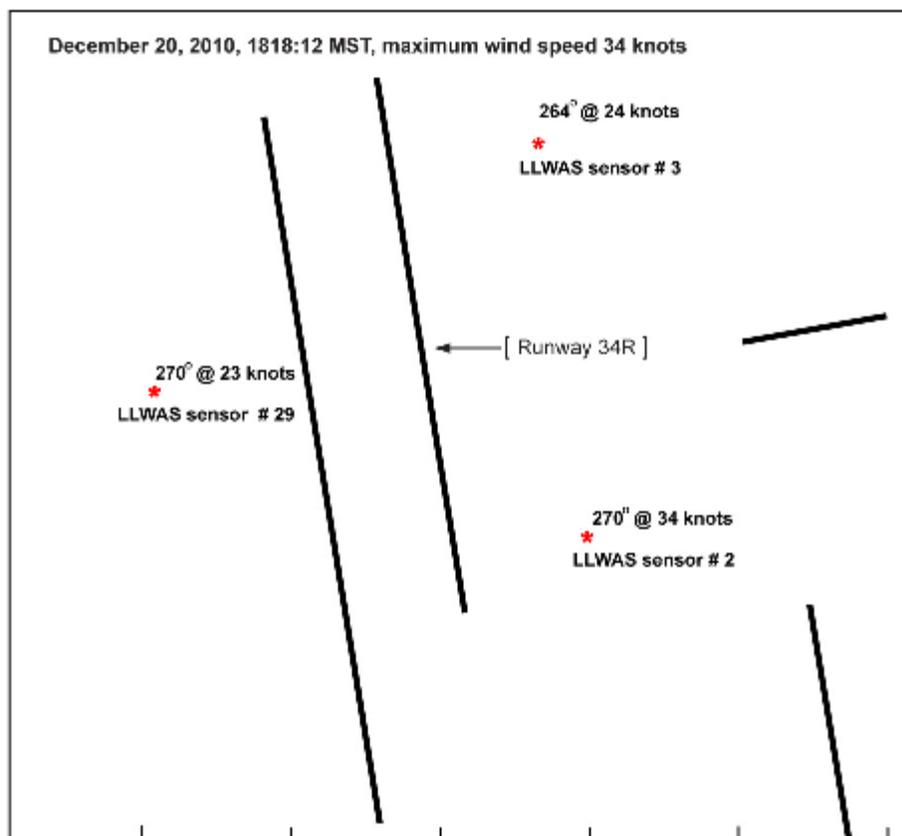
As shown in figure 4, the maximum wind speed recorded by DEN LLWAS sensors at the time of the accident was 34 knots, recorded by sensor #2, which is located closest to the approach end of runway 34R. The maximum LLWAS-reported wind around that time (40 knots) was also recorded by sensor #2, about 2 minutes before the accident.²⁹ (See the bold text in table 2.) With further processing (such as averaging wind values and factoring in winds recorded

Figure 4. This plot shows the reported winds from LLWAS sensors #2, #3, and #29 at 1818:12.

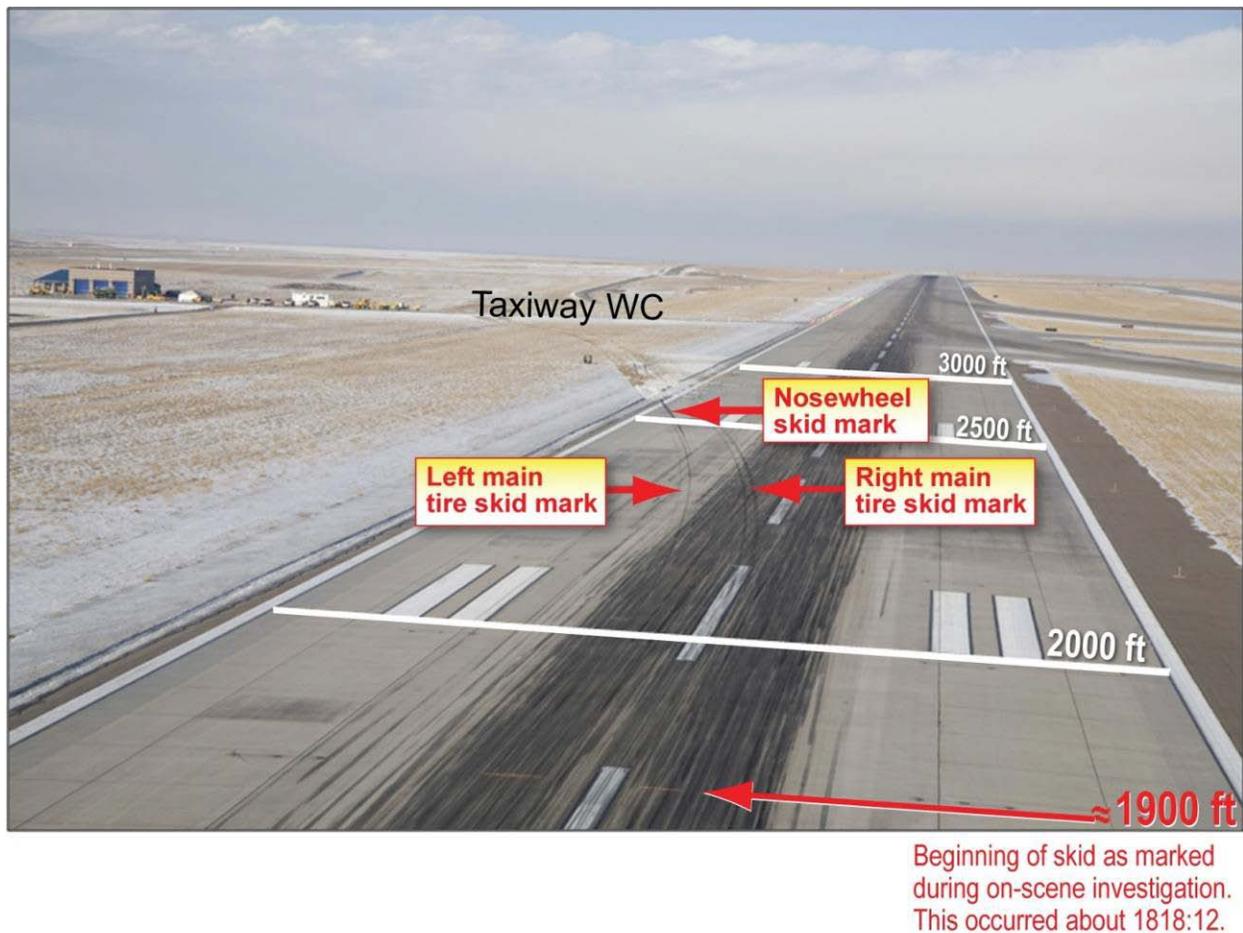
Figure 6. Aerial photograph (facing north-northwest) showing the tire skid marks veering left from the runway centerline to the edge of the runway pavement and the ground scars continuing from the runway. The distance from the approach runway threshold is shown in feet, and taxiway WC is depicted.

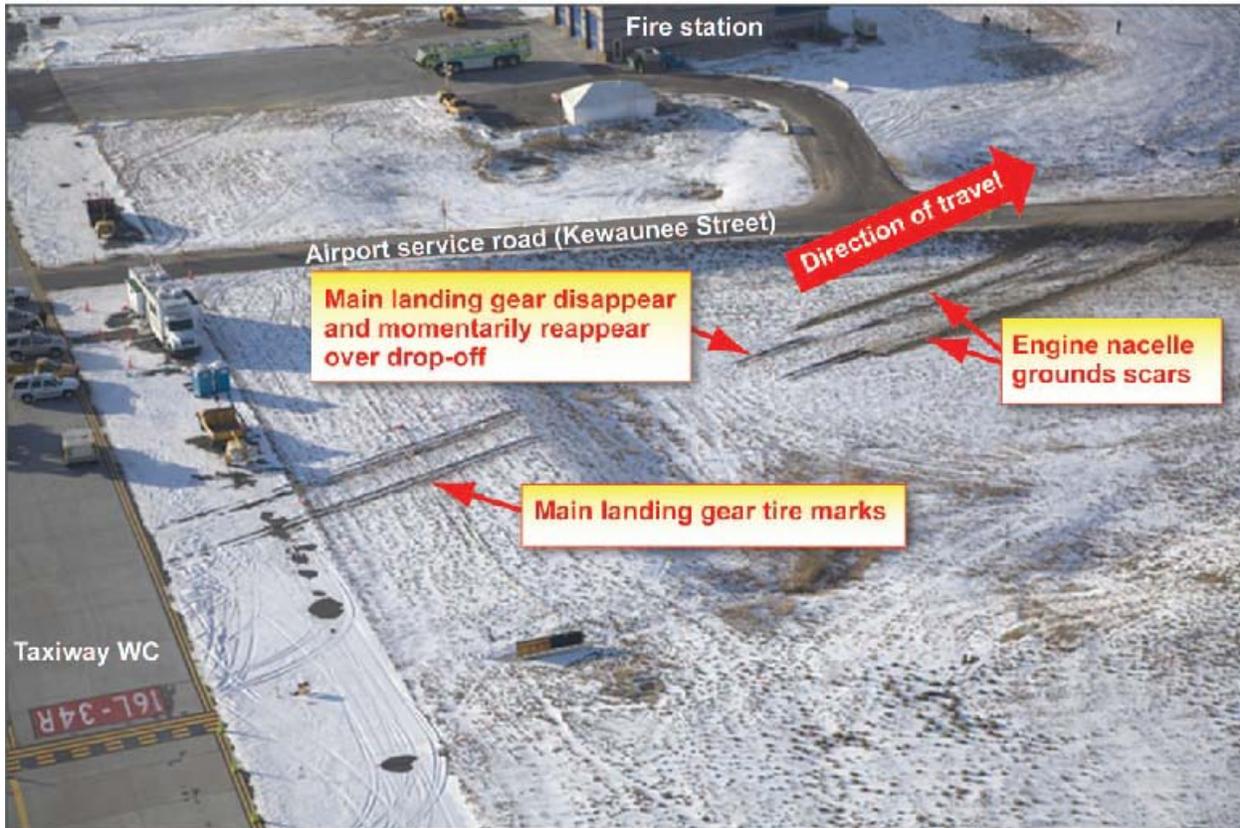
landing gear assembly; and portions of the left main landing gear. Figure 7 is an aerial photograph showing the tire tracks and ground scars between taxiway WC and the service road.

Figure 7. Aerial photograph (facing west-northwest) of the tire tracks and ground scars between taxiway WC and the service road. Note: the tire tracks and ground scars are interrupted where the terrain dropped off; shortly after the tire tracks reappear, engine ground scars begin.

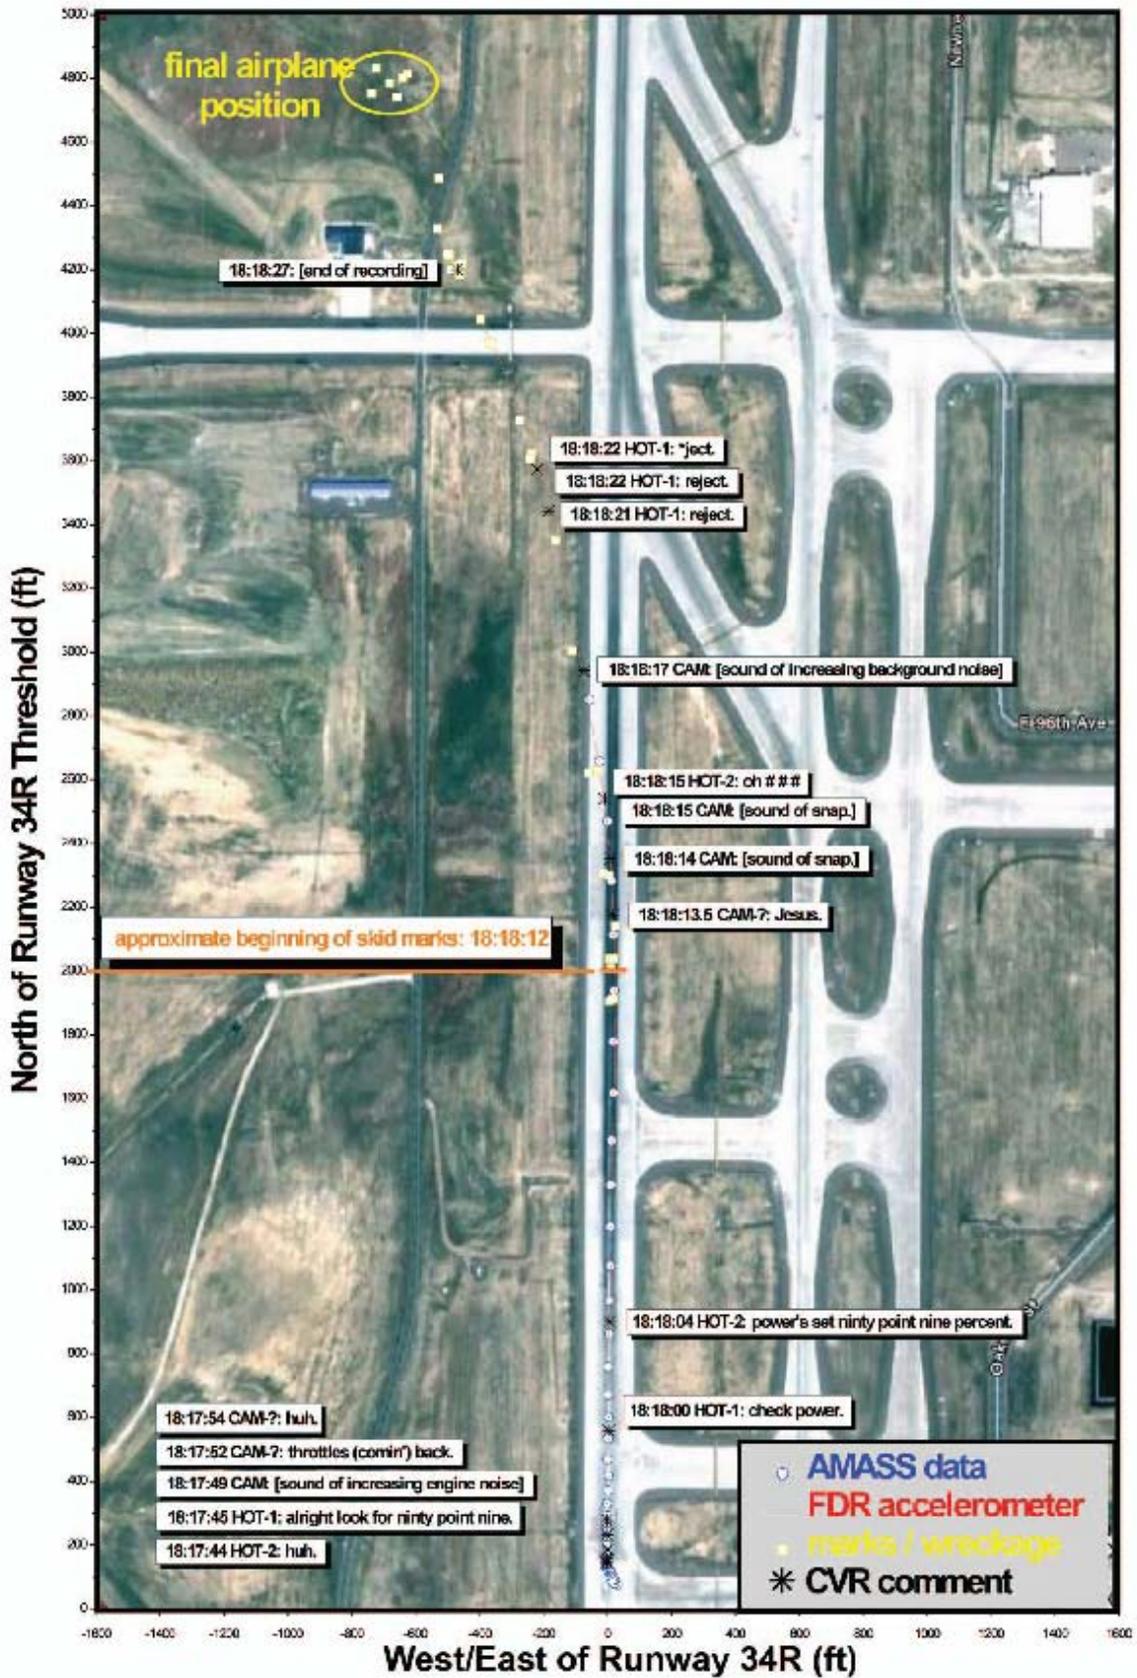
Figure 9. The results of the NTSB integration with CVR comments and ground marks/wreckage information overlaid on an aerial photograph of the pertinent airport features.

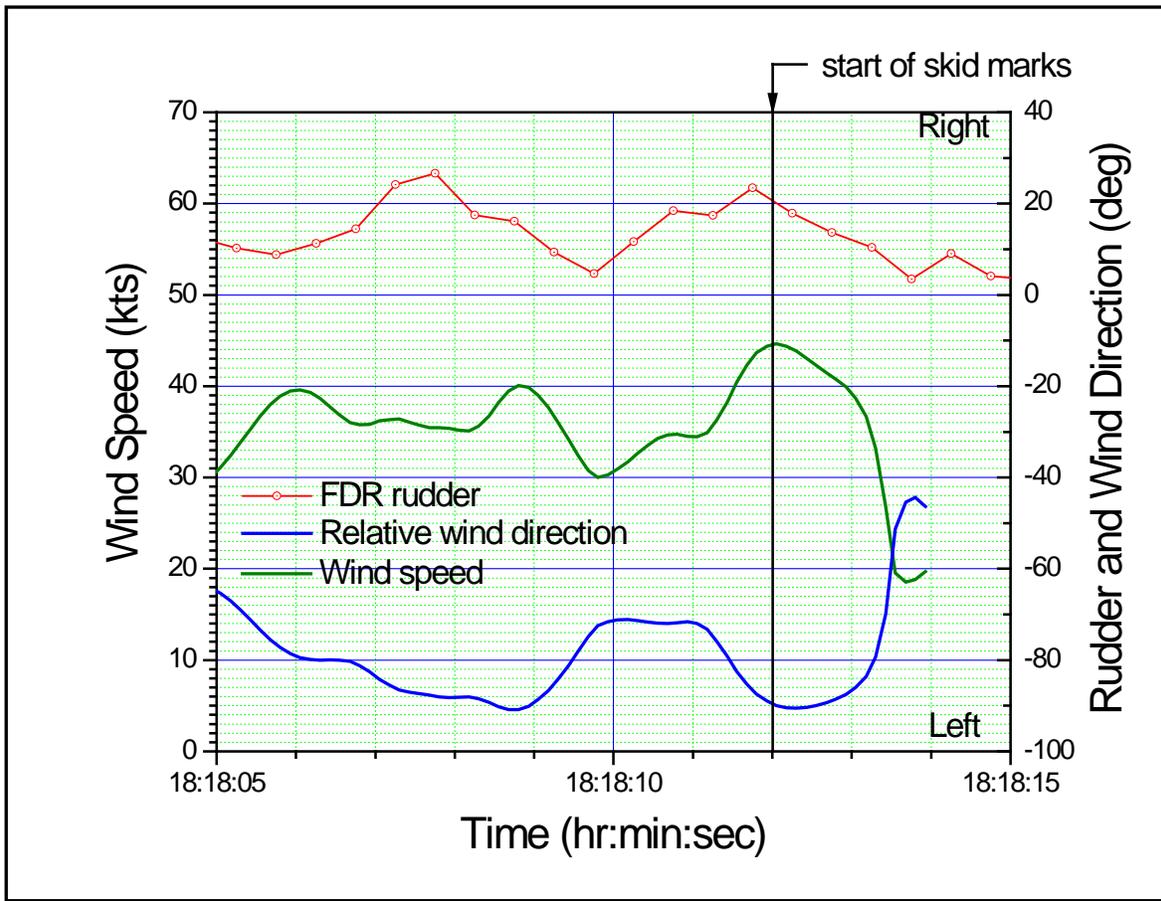
Performance calculations indicated that the airplane's rudder was capable of producing enough aerodynamic force to offset the weathervaning tendency created by the winds the airplane encountered during the accident takeoff roll.

Figure 10. Graph showing the NTSB's extracted wind speed and direction during the time of the runway excursion (1818:05 to 1818:15), with the FDR-recorded rudder deflection. The time of the first recorded tire skid marks is also shown.
