## PRELIMINARY REPORT

### HIGHWAY

### HWY13IH018

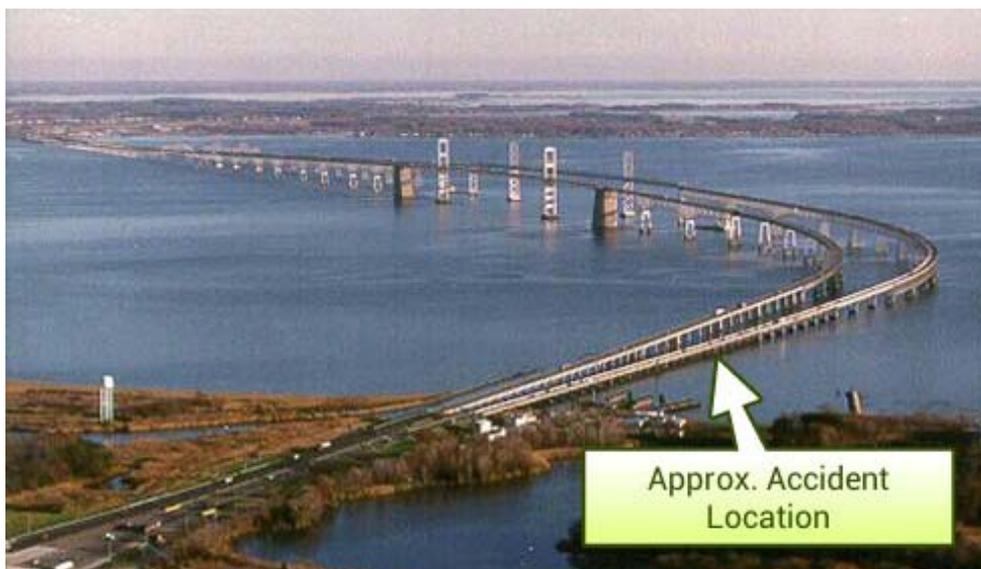
**Figure.** View of Chesapeake Bay Bridge looking east, showing point where accident took place
