National Transportation Safety Board

Marine Accident Brief

Allision of Container Vessel Rickmers Tokyo with Pier 11 at Port Richmond, Philadelphia, Pennsylvania

Accident no.	DCA-12-LM-004
Accident type	Allision
Vessel	<i>Rickmers Tokyo</i>
Location	Delaware River, Pier 11 at Port Richmond, Philadelphia, Pennsylvania 39°58.36' N, 75°6.58' W
Date	December 23, 2011
Time	1909 eastern standard time (coordinated universal time -5 hours)
Damage	<i>Rickmers Tokyo</i> : \$546,391 Pier: \$121,800
Injuries	None
Environmental damage	None
Weather	Clear, winds 9 knots northwest (310°), air temperature 48° F, skies 50% overcast
Waterway characteristics	Delaware River in accident area: approx. 1,900 feet wide with navigable channel 400 ft. wide
Current	Ebbing, from 1.5 knots when vessel got under way to 1.8 knots at time of allision

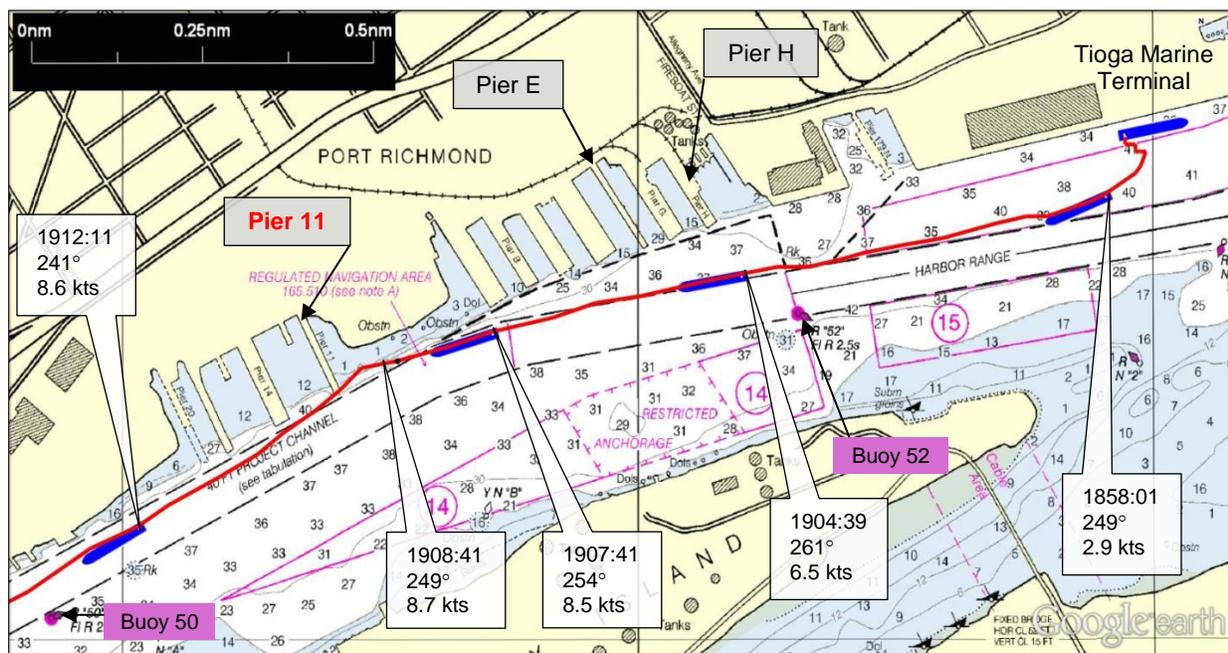
The ship was at the northern edge (right side) of the channel and heading 258°, transiting a section of the Delaware River channel designated as the Harbor Range, which had an outbound course of 260.5°. The river pilot then had the helmsman steady up on course 257° and ordered an increase in speed to slow ahead. Beginning at 1906:29 the river pilot issued several rudder orders mixed with three course commands, 257°, 255°, and lastly 254° at 1907:33, to adjust the ship’s heading.

Directly ahead was a 17.5° port turn at Port Richmond into the next outbound channel section to a course of 243°. Similar to the previous leg of the channel, this leg had numerous piers reaching as close as 50 feet from the right side of the 400-foot-wide navigation channel. By 19:08:17 the river pilot had missed the turn, the vessel had departed the navigational channel to starboard, and the pilot noticed a black shape ahead of the vessel. At 19:08:25 the river pilot ordered successive rudder commands of port 10° and port 20° to move the vessel away from the right bank.

At 19:08:21 the master went to the starboard bridge wing to better ascertain the nature of grey “tree” shapes he saw ahead and at 19:08:41, after the river pilot’s port 20 command, ordered “hard to port” in an attempt to avoid hitting Pier 11. The river pilot next ordered half ahead to increase flow across the rudder. After the forward starboard side of the vessel struck the end of Pier 11 at approximately 1909, he issued a series of starboard rudder orders in an effort to prevent additional damage by swinging the vessel’s stern away from the pier end. Once clear, the river pilot ordered an engine speed reduction back to slow ahead.

Portion of NOAA chart 12313, Delaware River, Philadelphia and Camden Waterfronts, including the allision location. Labels indicate the scaled *Rickmers Tokyo* in blue and the trackline in red as well as time, heading, and speed data for the vessel at selected points in its transit.

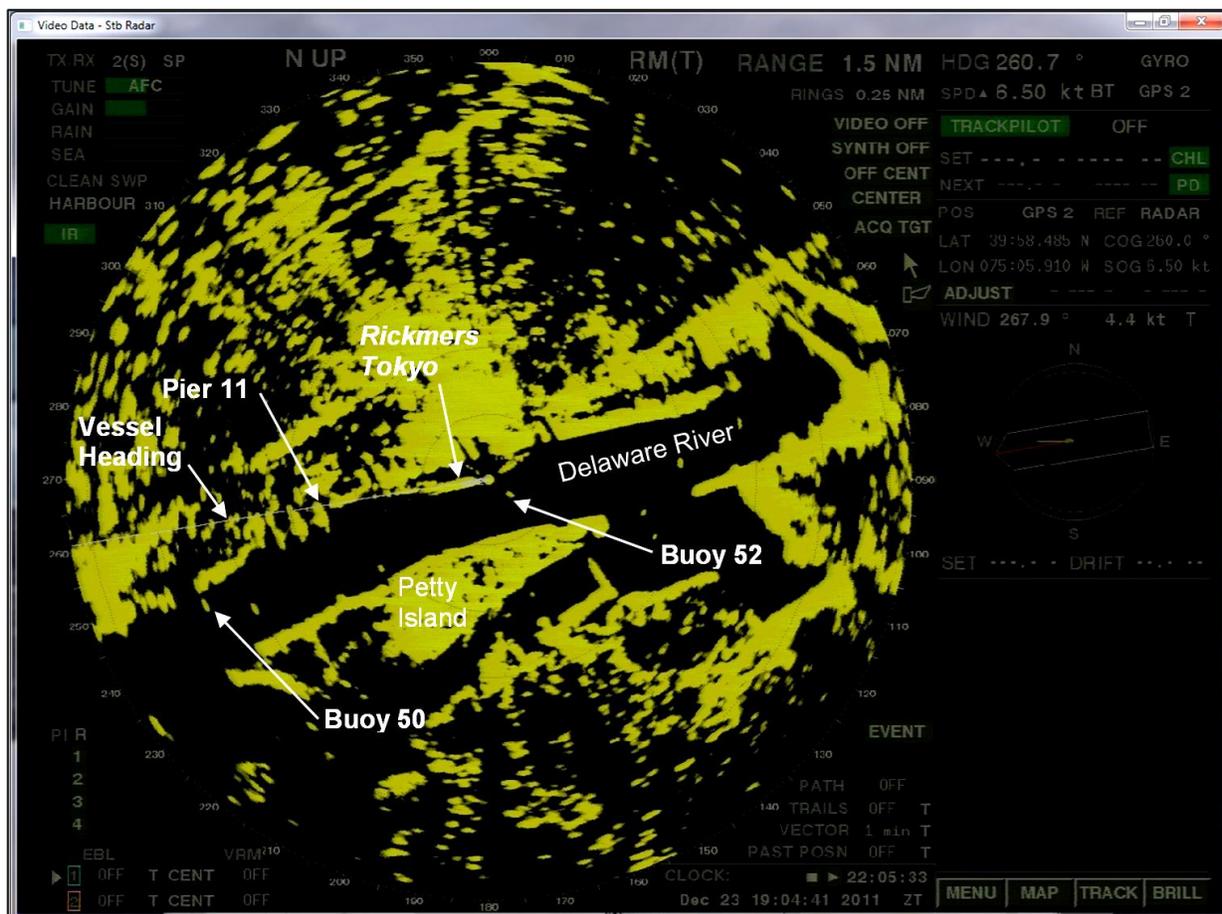
After taking the conn and transiting the Harbor Range at 260.5° , the river pilot issued only course changes to 254° before taking action to avoid Pier 11, but a change to at least 243° was required to begin the next channel leg. Radar images taken from the VDR clearly showed the vessel heading, river bank, piers and buoys along the channel minutes before the allision with Pier 11.

Rickmers Tokyo starboard radar VDR screen capture at 1904:41 with relevant landmarks, navigation aids, and geographic features identified.

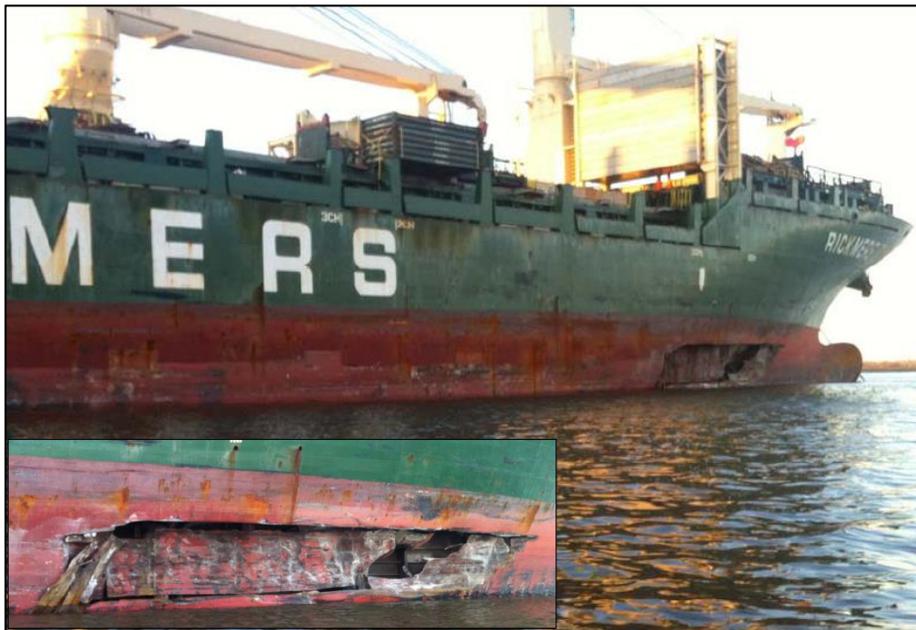
Starboard side damage to the *Rickmers Tokyo*, with inset image showing close-up of sheet steel piling stuck in the aft portion of the hull penetration.

The *Rickmers Tokyo* allision with Pier 11 caused the vessel’s shell plating to be torn open as the starboard side of the ship just above the waterline scraped along the southeast corner of Pier 11. Damages were as follows:

- *Rickmers Tokyo*: Approximately 3-foot by 92-foot open tear to the starboard bow. Along this length the internal frames were damaged and the shell plate was set inward 3 feet, penetrating the no. 1 and no. 2 ballast tanks and leaving them open to the sea. Additional damage to the shell plate and internal frames in way of the starboard side water ballast tanks no. 4 and no. 5 above the waterline also occurred.
- Pier 11: 10-foot by 20-foot section of sheet steel bulkhead piling torn away.

According to the vessel operator, the initial repair cost for damage to the vessel was \$546,391. A surveyor's report estimated the damage to the pier was \$121,800.

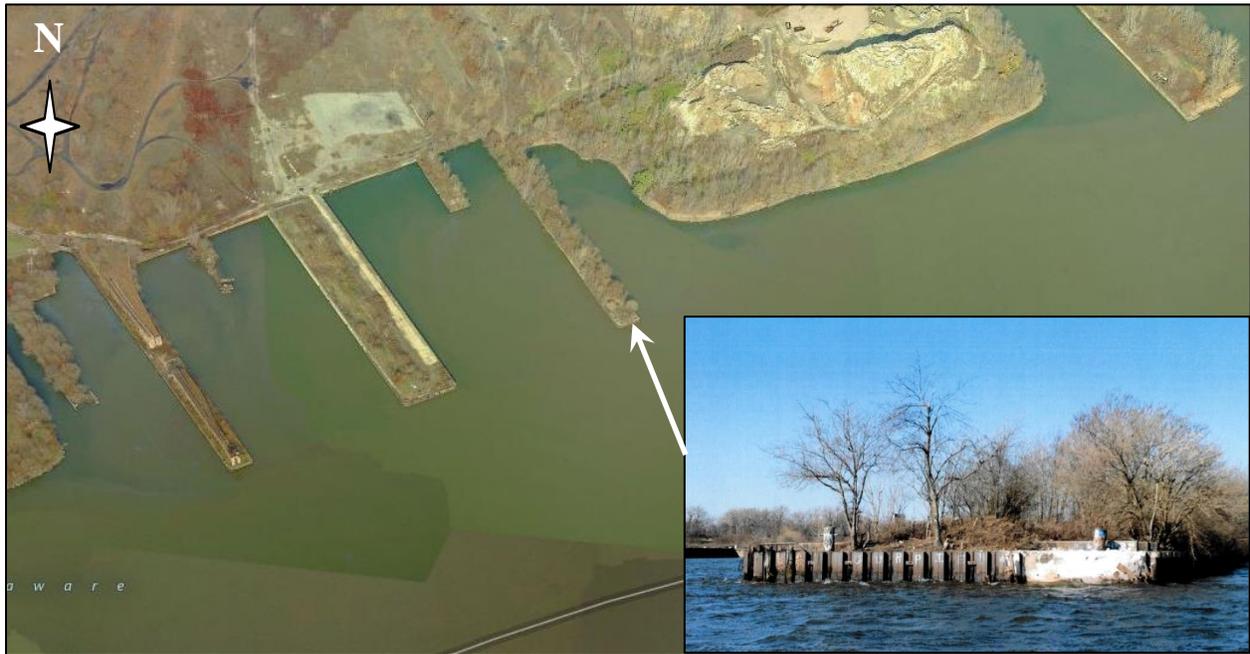
Both Pier 11 and adjacent piers were abandoned with no installed lighting. With the low level of ambient light, the piers lacked contrast with the river and the shore. Additionally, the city lights of downtown Philadelphia were directly behind this pier set when proceeding downriver, producing background lighting. With the exception of the trees on the pier, which the master noticed before taking evasive action, the piers had a relatively low profile against the city lighting.

Birdseye view of Pier 11 vicinity with inset image showing the damage to the southeast corner of Pier 11's corrugated steel pilings. The area on the right side of the pier that appears white is damage due to the allision.
