National Transportation Safety Board

Marine Accident Brief

Sinking of Fishing Vessel *Mary Kay*

Accident no.	DCA-12-LM-022
Accident type	Sinking
Vessel	Commercial fishing vessel <i>Mary Kay</i>
Location	Dixon Entrance, Alaska (54°38.015' N, 132°04.334' W), Near Cape Chacon, Prince of Wales Island, Alaska
Date	July 26, 2012
Time	2300 Alaska daylight time (coordinated universal time – 8 hours)
Injuries	None
Damage	Total loss; value of vessel and salmon on board estimated as \$625,000
Environmental damage	2,500 gallons of diesel fuel
Weather	Clear; 55°F; no precipitation
Waterway characteristics	Near coastal waters, southeastern Alaska

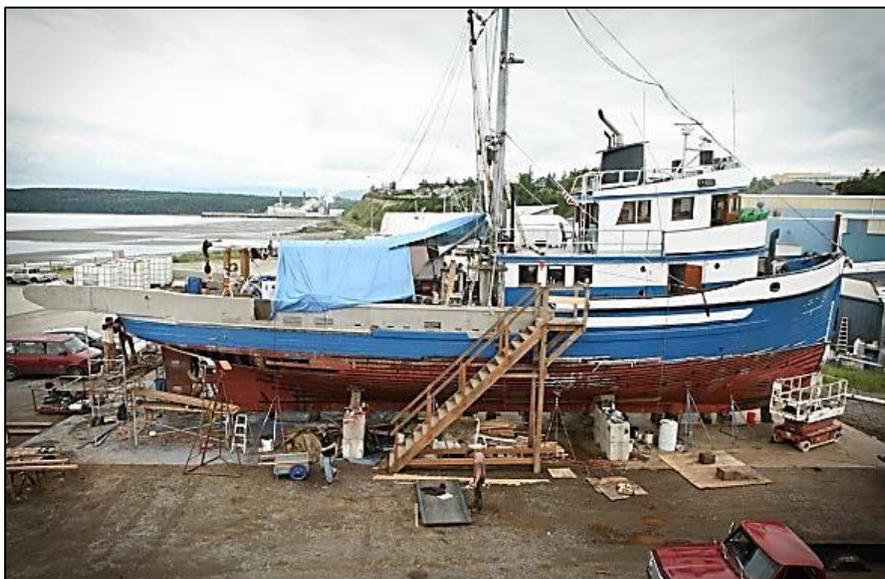
Mary Kay during its 2012 shipyard period in Port Townsend, Washington. (Photo by Port Townsend Shipwrights Co-Op)

Almost a month earlier, on July 1, 2012, the *Mary Kay* had returned to service following a 3-month shipyard period at Port Townsend, Washington. During this time, extensive modifications were made, which included adding a third fish hold, replacing worn-out bottom planking, removing a hydraulic bilge pump, and installing a refrigerated sea water circulation pipe. The addition of the third fish hold nearly doubled the vessel's capacity and likely changed its center of gravity.

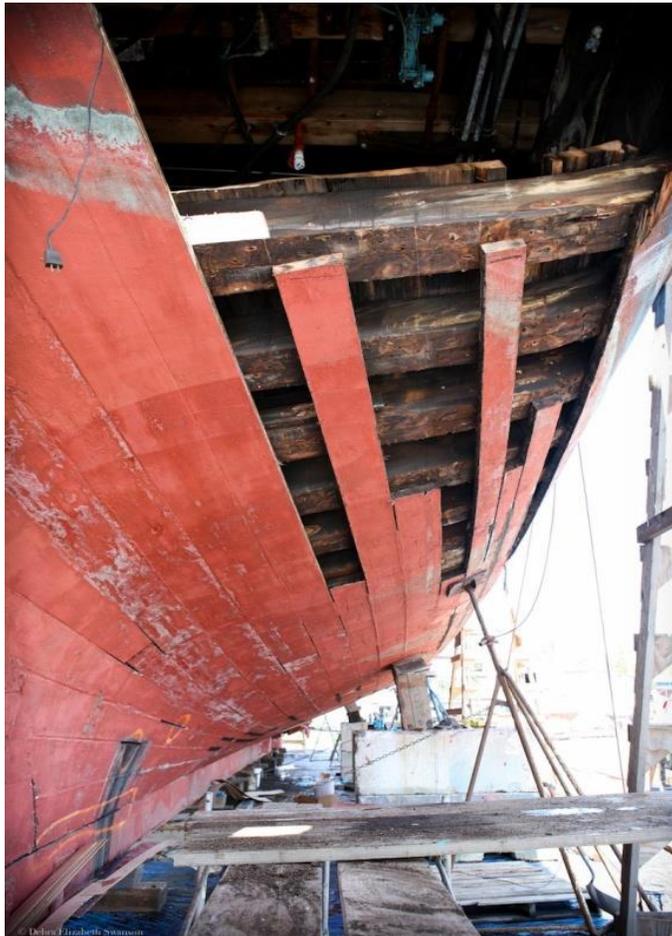
Replacing planks in the stern of the *Mary Kay*, June 2012. (Photo by Port Townsend Shipwrights Co-Op)

When the *Mary Kay* departed the Port Townsend shipyard facility on July 1, 2012, the vessel returned to service without a sea trial. After getting under way toward the first scheduled stop of Bellingham, Washington, the crew detected a leak on the bottom of the starboard fish hold and another leak in the lazarette. On arriving in Bellingham, the *Mary Kay* lost operational control and consequently allided with a dock in port. The damage to the hull of the *Mary Kay* was not investigated, perhaps because the estimated damage was less than the required reportable amount. The *Mary Kay* next visited Sitka, Alaska, on July 9, 2012, where the vessel grounded twice on the boat launch (made of cement) in Sitka harbor. It is unknown whether these groundings caused any damage to the hull, because, like in Bellingham, the incident was never reported and no formal damage inspection completed. Later that same month, on July 22, the *Mary Kay* was under way and returning to Sitka when water began leaking from the starboard fish hold and lazarette into the vessel's bilges. The helmsman set the vessel on autopilot, left the

The National Transportation Safety Board determines that the probable cause of the sinking of the *Mary Kay* was the captain's failure to identify and correct the source(s) of the through-hull leaks.
