NTSB ***SAFETY ALERT***

★ **Proper Use of Fiber or Nylon Self-Locking Nuts** ★

Inspecting nuts for age and condition and properly installing nuts is critical to ensuring tight connections

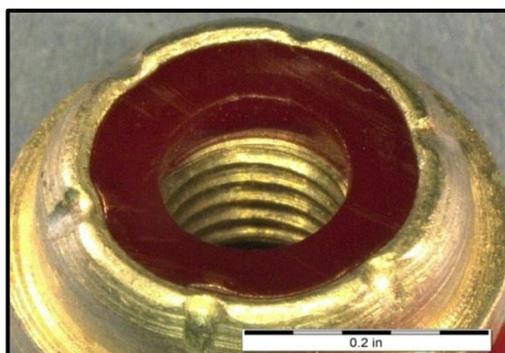
A new nylon insert.

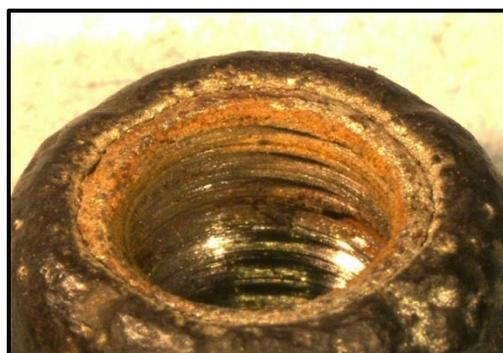
- Some pilots and maintenance personnel are not adequately inspecting or installing fiber or nylon self-locking nuts, which have fiber or nylon inserts incorporated into their construction to provide tight connections that will not loosen under vibration.
- Fiber or nylon self-locking nuts' ability to provide tight connections degrades with each use. They may not meet the minimum prevailing torque value, which can lead to loose connections or, eventually, liberate hardware and lead to accidents and incidents.

An old, degraded nylon insert.

- Comply with instructions in your aircraft's applicable maintenance manual or Federal Aviation Administration Advisory Circular 43.13-1B, [chapter 7](#), section 4, if there is no guidance on nut reuse in the manual.
- Confirm that the specified hardware is installed correctly.
- Ensure that adequate torque is required to spin the nut on the bolt. Be aware that binding in the assembly may produce a false indication of nut effectiveness.
- Throw out a nut that can be rotated on the thread by hand.
- Ensure that sufficient thread protrusion exists.
- Do not run a tap through the fiber or nylon insert because doing so removes the locking capability of the nut.

REMEMBER: WHEN IN DOUBT, THROW IT OUT!
