NATIONAL TRANSPORTATION SAFETY BOARD

SAFETY STUDY

CRASHWORTHINESS OF LARGE POSTSTANDARD SCHOOLBUSES

NTSB/SS-87/01

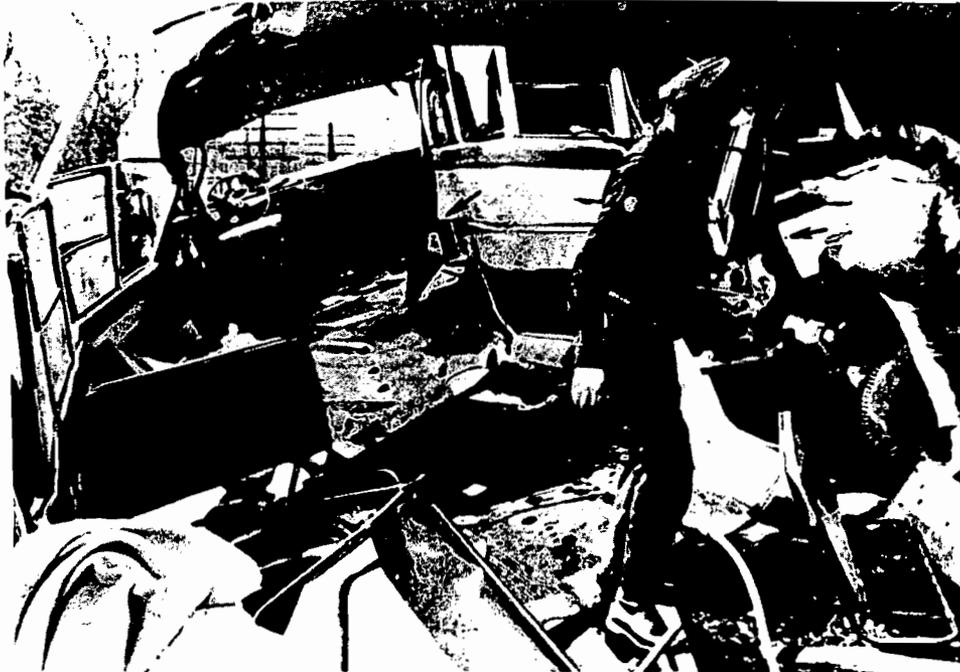
Figure 2.—Schoolbuses built before 1977 provide inferior crash protection to occupants. This prestandard schoolbus underwent massive structural failure during a grade crossing accident in Congers, New York, on May 24, 1972. Arrows point to exposed metal edges which resulted from weak seam joints.

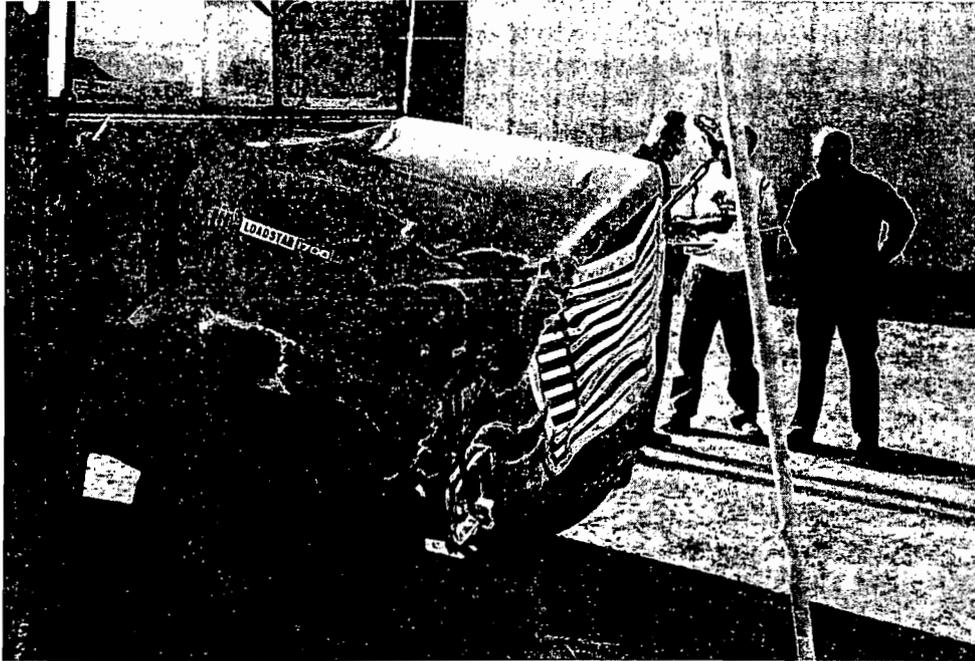
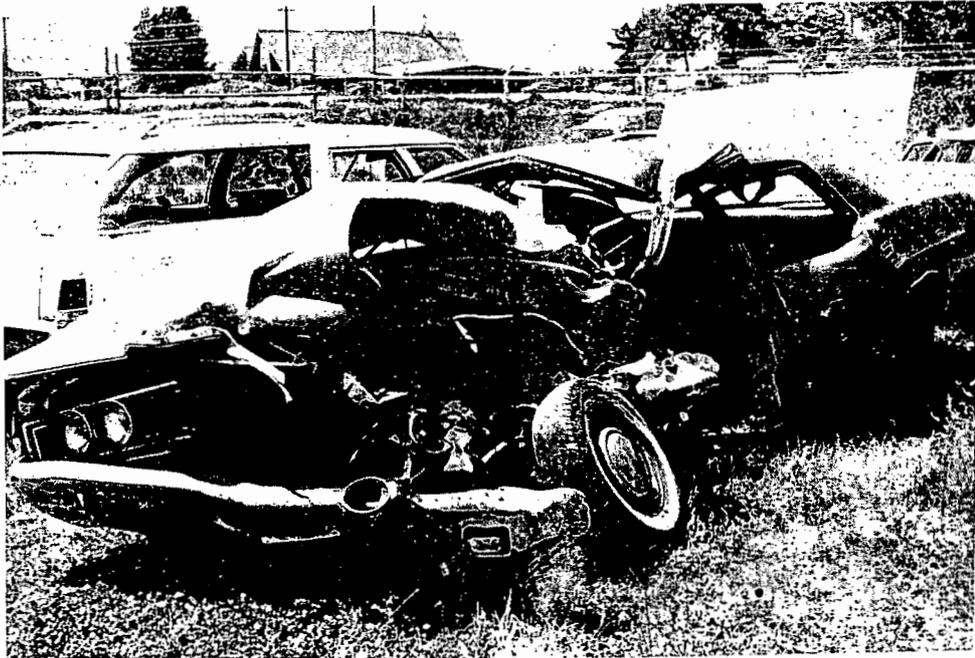
Figure 4.—The schoolbus generally sustained little damage in a schoolbus/passenger car collision, but damage was extensive to the car involved. As a result, car passengers were more likely to be injured than schoolbus passengers. The vehicles shown here were involved in a frontal crash outside Cornelius, Oregon. (See case 3.)

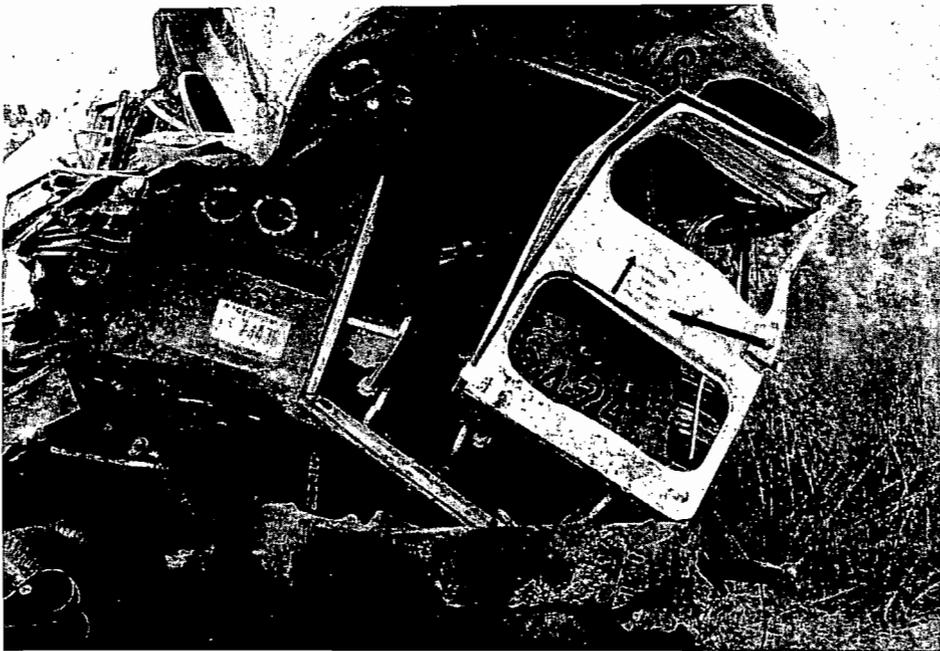
Figure 5.—Views of the Brunswick, Georgia, schoolbus (case 40) following the crash. This schoolbus underwent one of the most complex and violent crashes in the study. Considering the accident dynamics, the schoolbus body performed quite well. All of the moderate and serious injuries were attributed to the rear-end impact and subsequent crushing in that area.

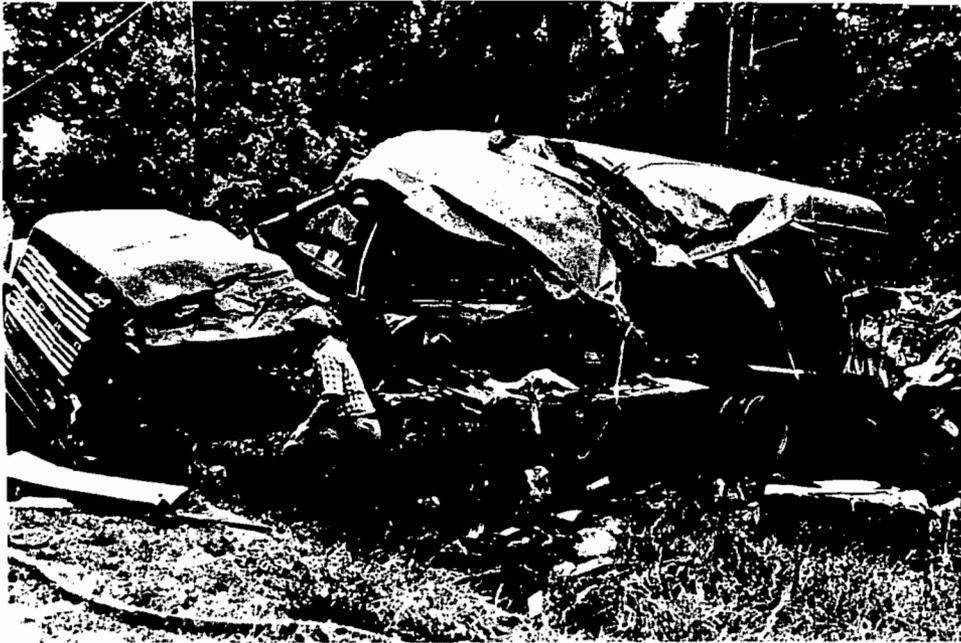
All of the six ejected passengers who died in the Safety Board's study were in this accident (a nonrollover) which accounted for more than half of all the ejections in the study. This case involved an extremely severe head-on collision with a tractor-semitrailer, followed by sideswipe penetration of the schoolbus body and failure of floor panels which created a huge gap in the schoolbus body. (See figure 6.)

Figure 6.—When the tractor-trailer sideswiped the side of this bus in Snow Hill, North Carolina, it tore open the bus and ejected several seats, along with their occupants (case 14). (Photo courtesy of the Goldsboro News Argus.)

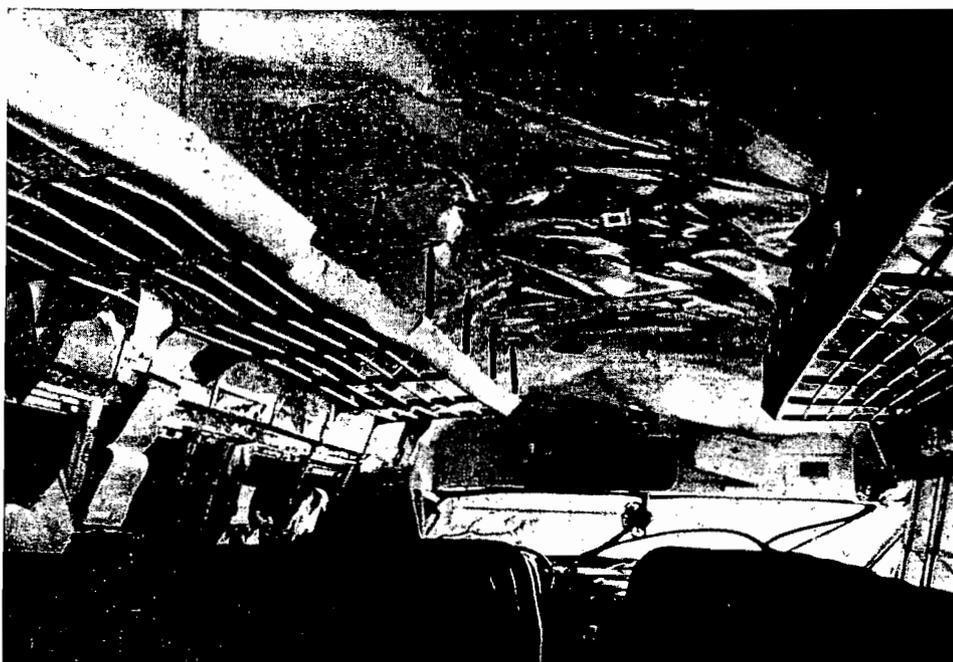
Figure 7.—Contact with metal luggage racks caused moderate injuries to five students in the Hobbs, New Mexico, noncollision rollover (case 26). The racks also caused minor injuries including deep line-type bruises on two students' backs, mirroring the rack rails.

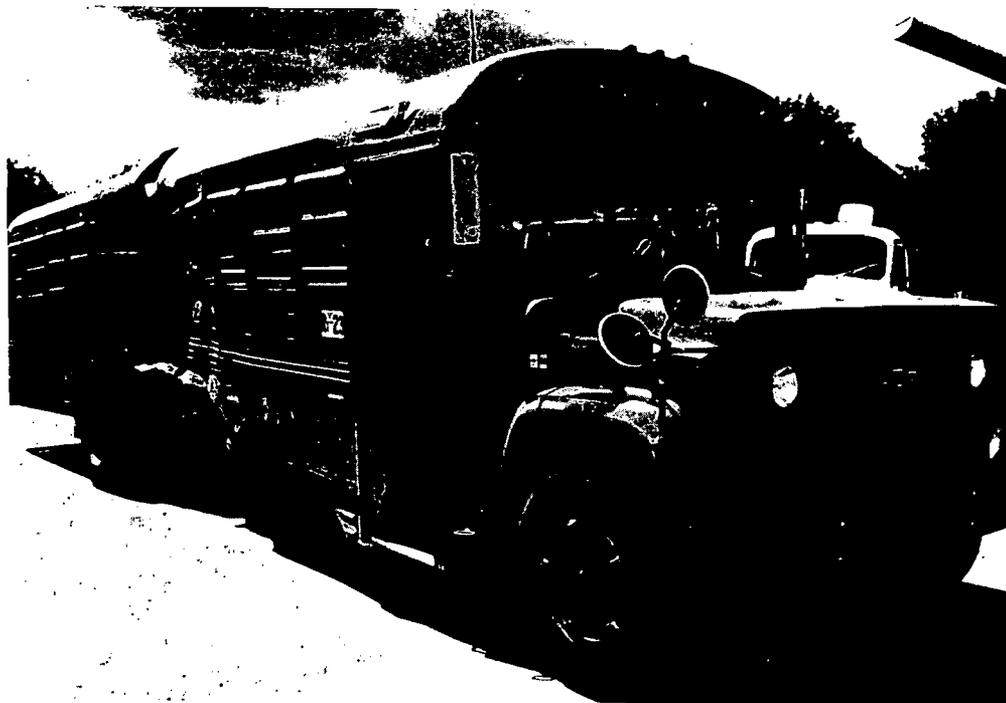
Figure 9.—The damage was caused by intrusion. As the schoolbus in the Woodside, Delaware, accident (case 21) attempted to make a left turn, it was struck by an on-coming tractor-trailer.

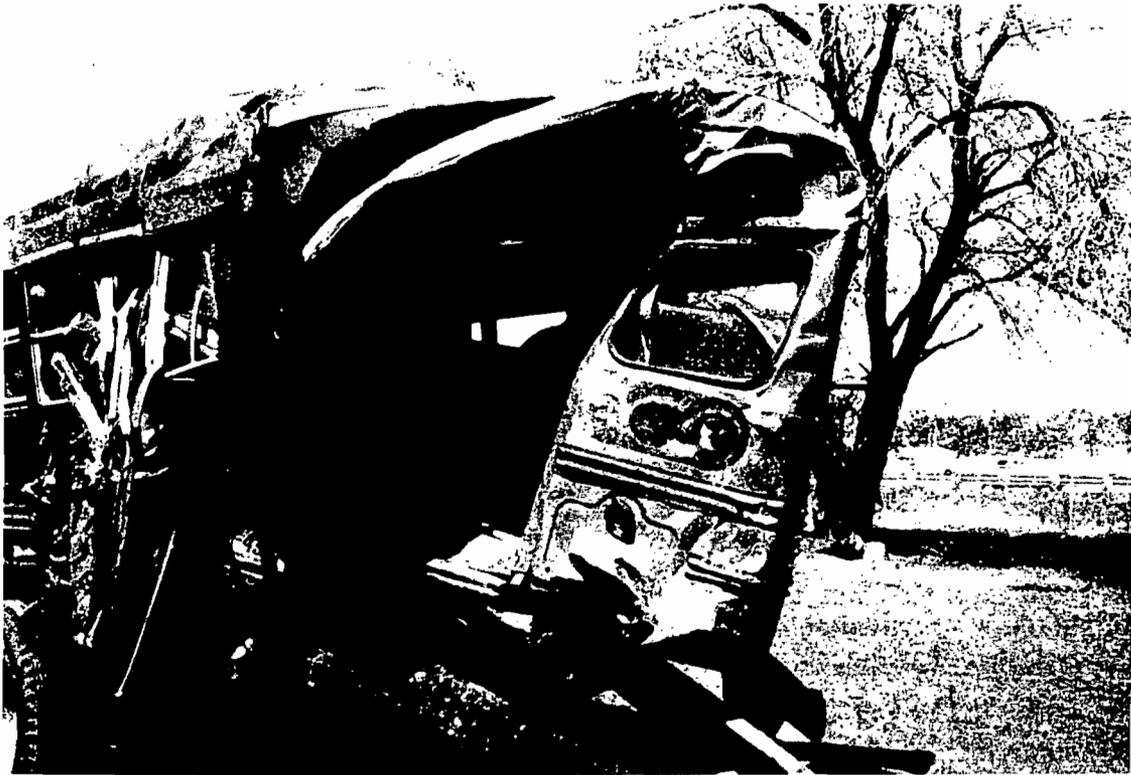
Figure 10.—Two students died in this rear-end crash which was followed by a rollover outside Tuba City, Arizona (case 43). The schoolbus was stopped to unload passengers when a tractor-semitrailer travelling about 59 mph crashed into its rear. The fatally injured students reportedly had been standing in the rear of bus in the crushed area.

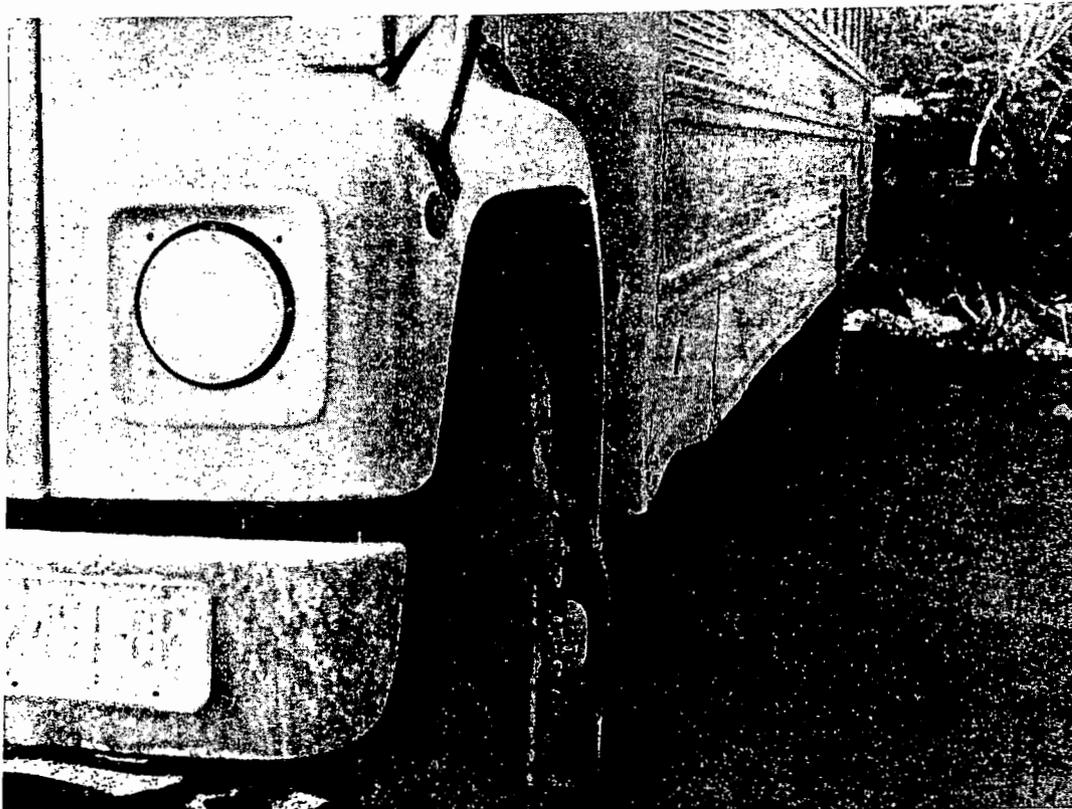
The belt-equipped bus (case 16) was involved in a minor sideswipe accident with a passenger car in Greenburgh, New York. All schoolbus passengers were wearing the available lap belts at the time of the accident, but little can be learned of the value of passenger restraints. Crash forces were so slight that the students' books and papers placed on the seats did not even slide to the floor at impact; damage to the bus was barely discernible. All of the passengers were uninjured, but they probably would have been uninjured even if they had been unrestrained. (See figure 11.) The Greenburgh case is included in this study because it is often cited by the media and advocates of seat belts on schoolbuses as an example of the lifesaving value of lap belts.

Figure 11.—The only damage to the schoolbus in the Greenburgh, New York accident (case 16) was minor damage to the front left side panels.

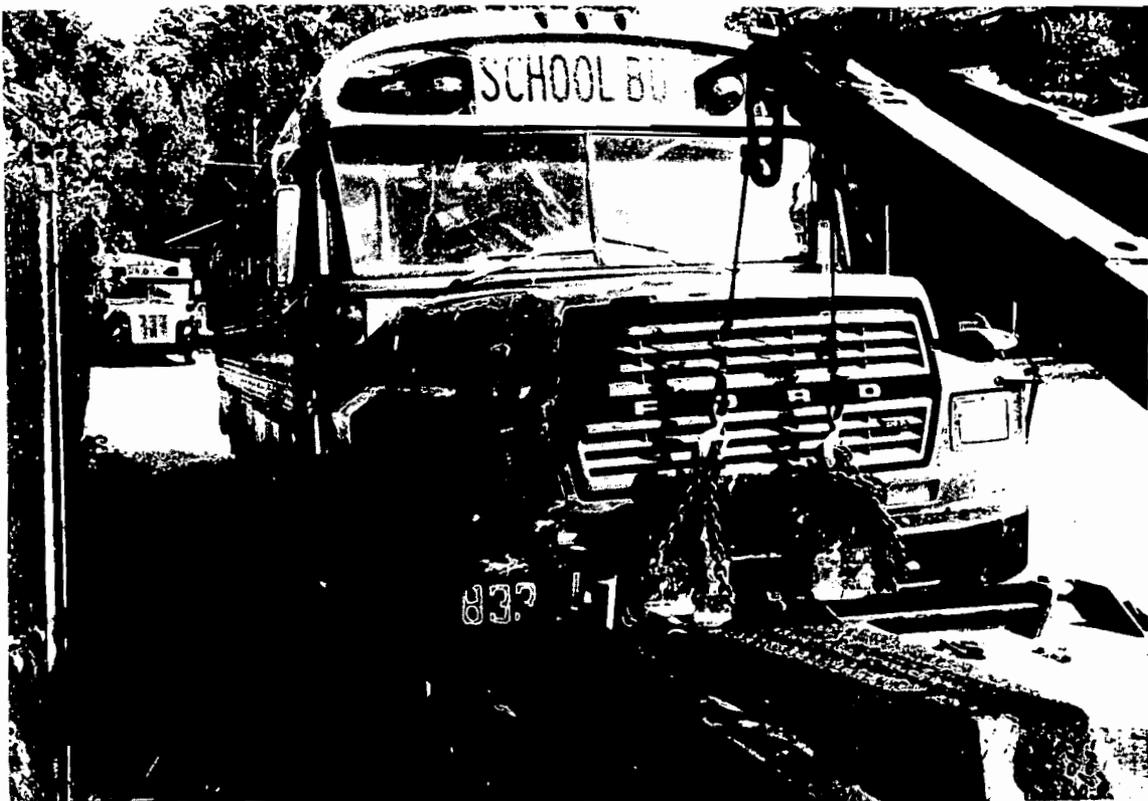
Figure 12.—The schoolbuses involved in noncollision rollovers in the study generally sustained little damage. The bus shown here (case 25) underwent a 270°-rollover down an embankment, in Point Pleasant, West Virginia, but maintained its structural integrity. Damage was minor and confined to the exterior, primarily the right front fender.

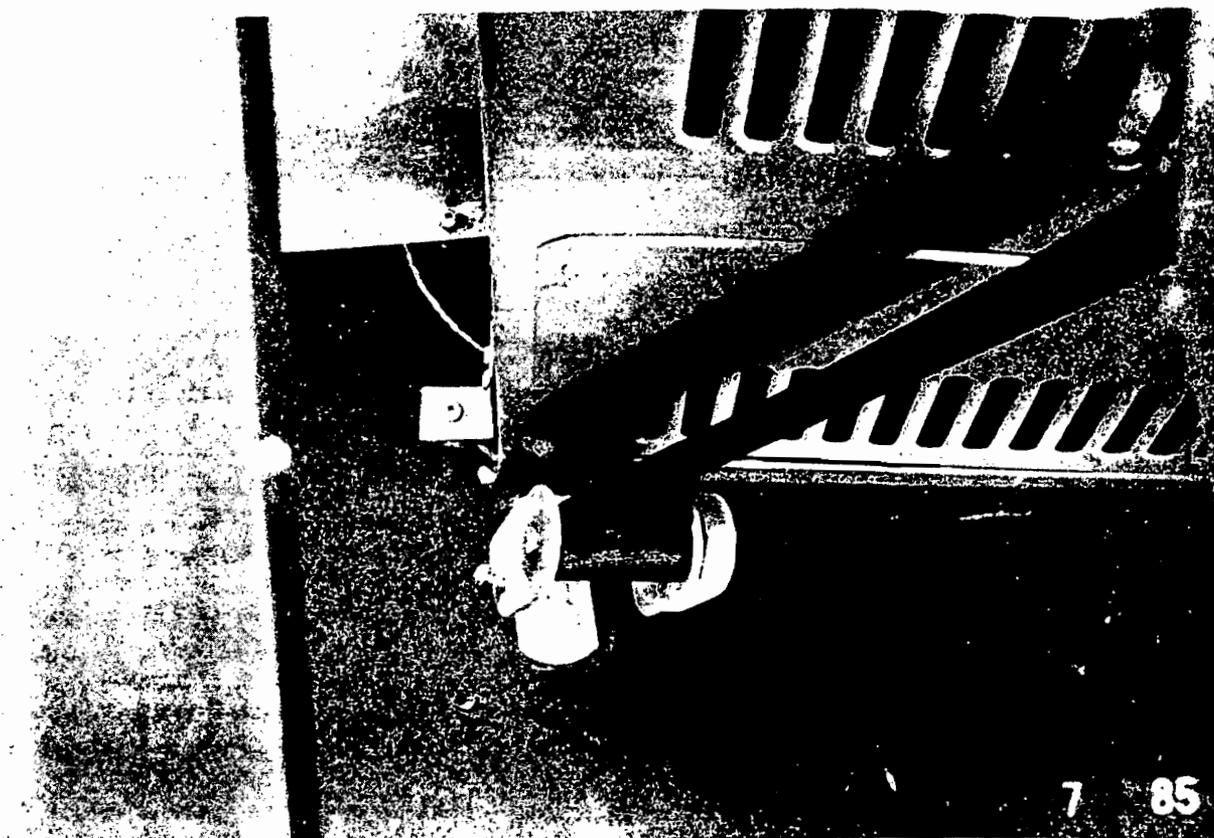
Figure 13.—The spring-loaded retractor on this schoolbus driver lap belt provides a feeling of snugness when the lap belt is worn. The retractor, however, does not lock the belt, and so additional webbing can be played out in a crash. The retractor's sole function is to store belt webbing when the belt is not in use, and keep the belt off the floor. Schoolbus drivers must manually adjust the belt before it provides proper restraint.

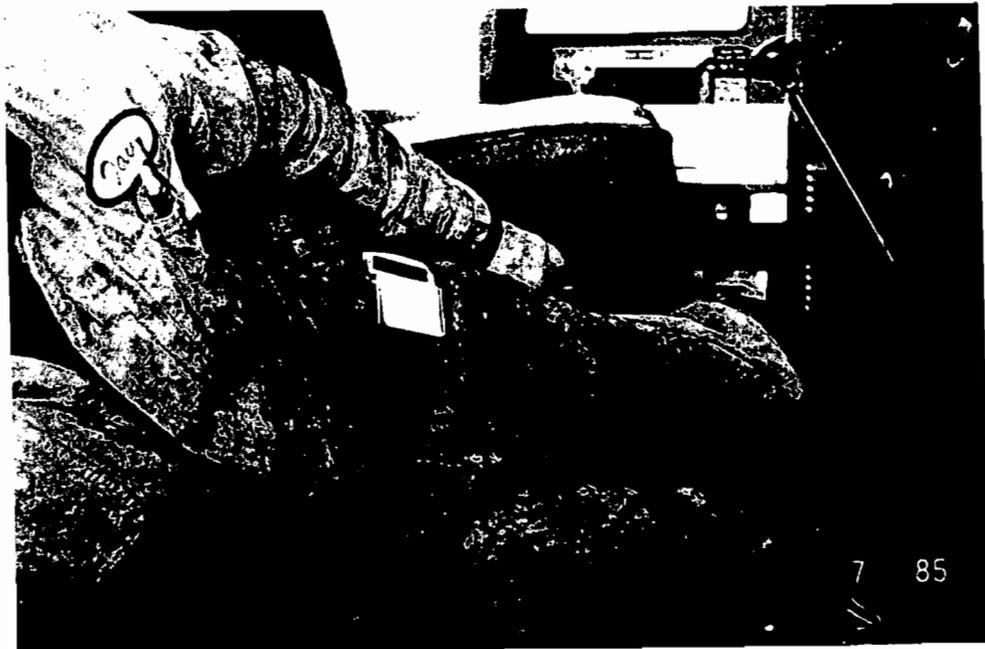
Figure 14.—These photographs illustrate how a schoolbus driver, who has failed to manually adjust his belt, can fall completely off the seat with the lap belt still around him.

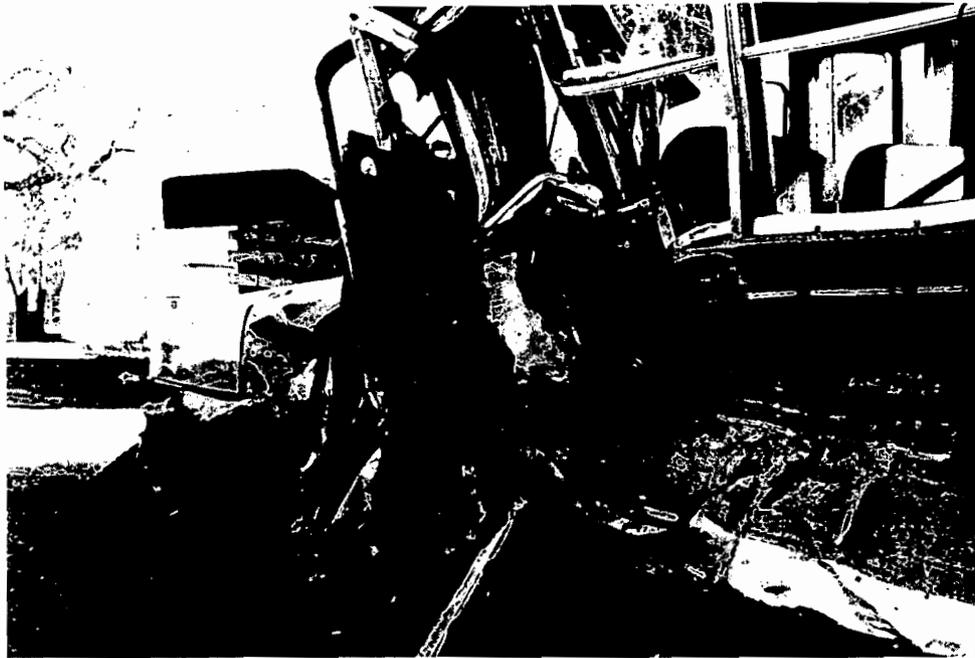
The second case occurred in Palmyra, Nebraska, when a tractor-semitrailer crossed the center line and struck the left front fender of a schoolbus travelling in the opposite direction. (See figure 15.) The schoolbus driver was seated in the direct area of impact and died of critical injuries inflicted when the steering assembly was displaced back into his seating position. His injuries included multiple pericardium trauma, multiple rib fractures, and bilateral fractures of the sternum. He had been restrained by a lap belt, but the circumstances of the accident were such that lap belt use was immaterial. (See case 11.)

Figure 15.—A schoolbus driver was killed in the Palmyra, Nebraska, accident involving a collision with a truck (case 11), but students were largely uninjured. Of the 20 passengers, 11 were uninjured and 9 sustained minor injuries only. All passenger injuries were caused by flying glass. The arrow points to the truck door embedded in the bus.

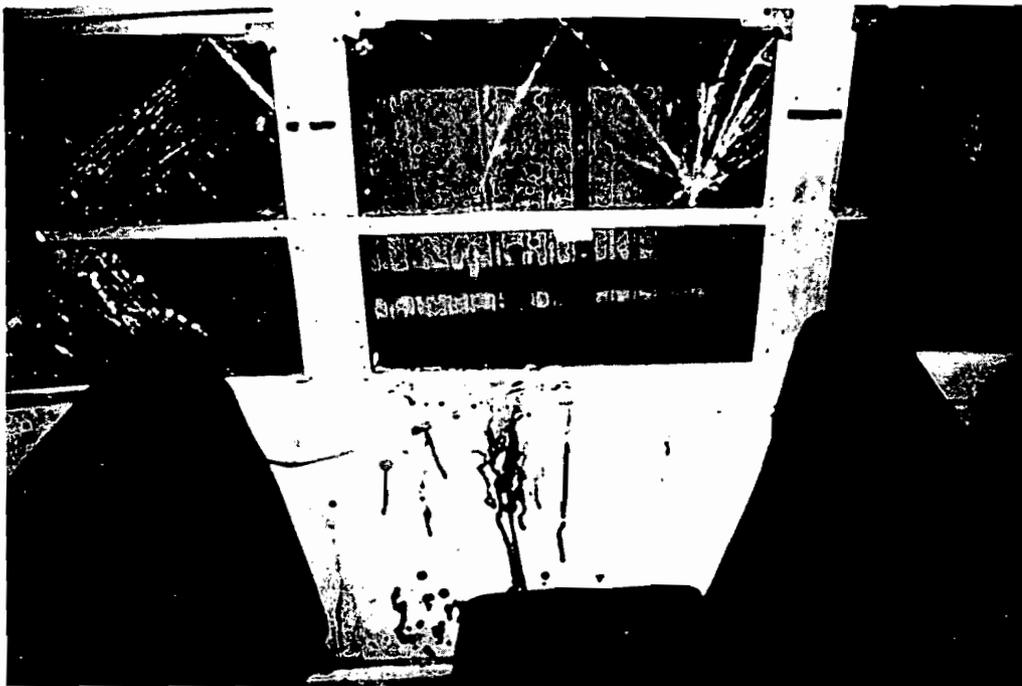
Figure 18.—Blood on fourth window and side wall in the St. Louis, Missouri, accident (case 13). The metal edge was exposed by access panel separation.

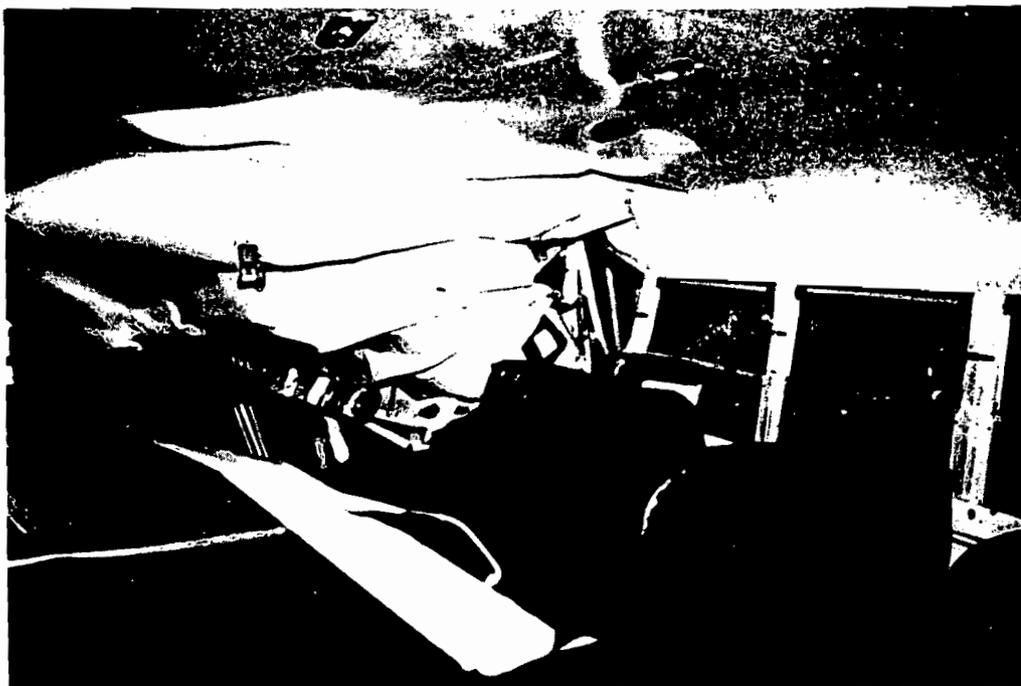
Figure 19.—A view of collapsed roof from inside the bus in the St. Louis, Missouri, accident (case 13). A maintenance access panel lies across seat at left. (It may have been moved to that position by rescuers.)

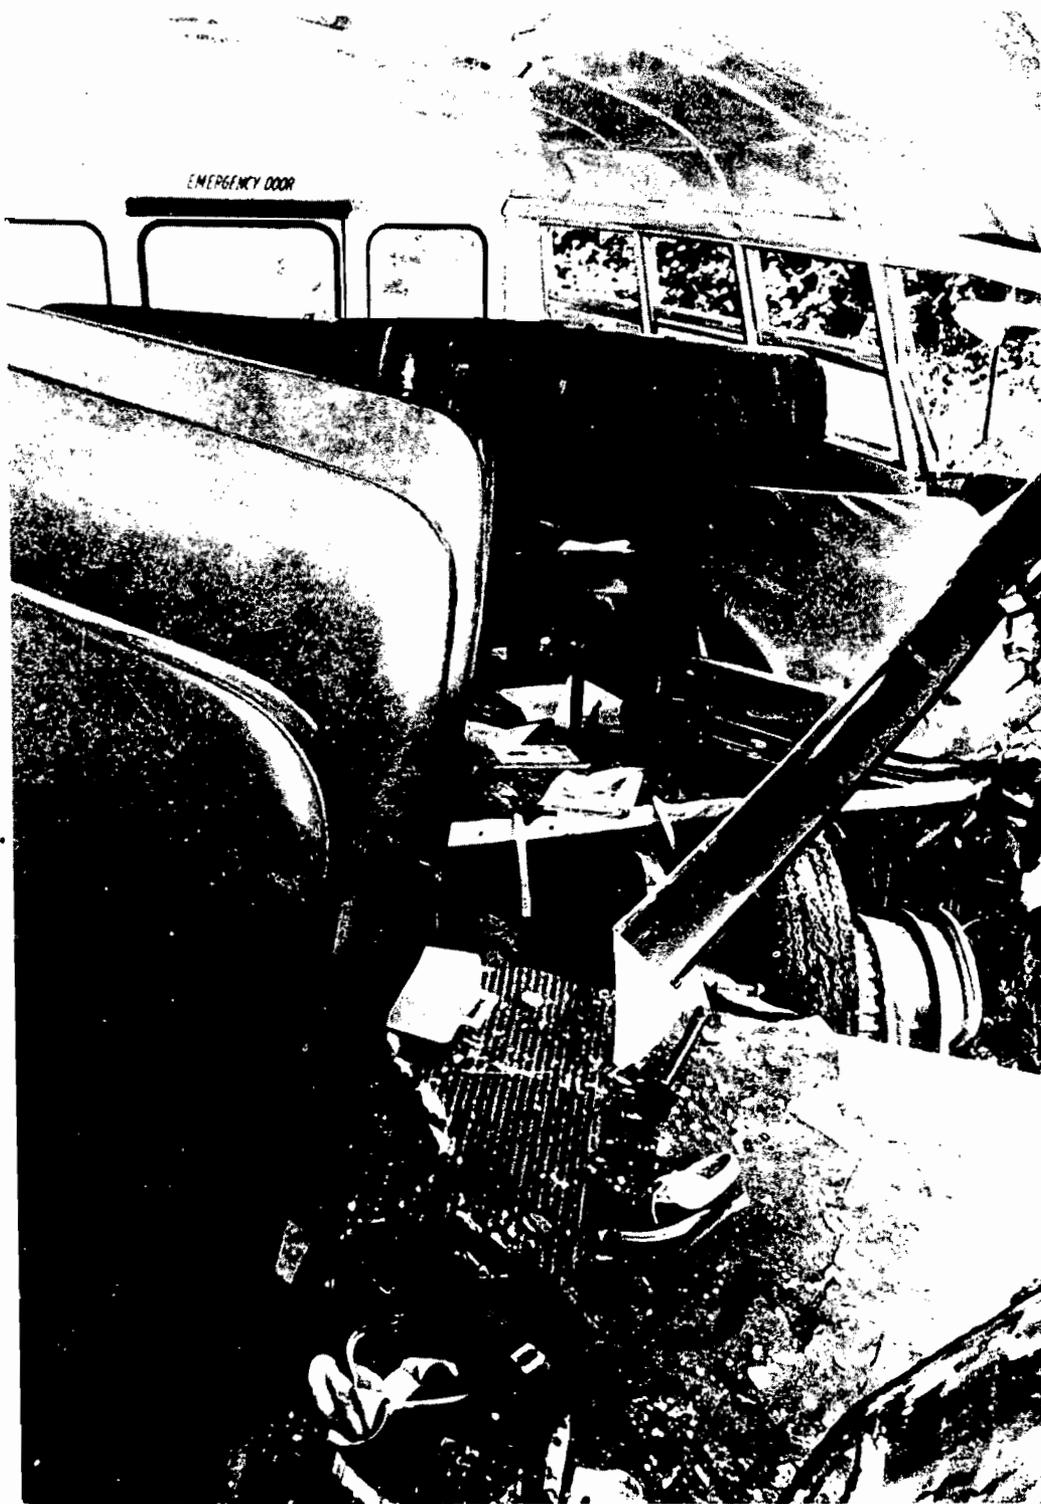
Figure 21.—Opening in schoolbus floor in the Snow Hill, North Carolina, accident (case 14).
(Photograph courtesy of the Goldsboro News Argus)

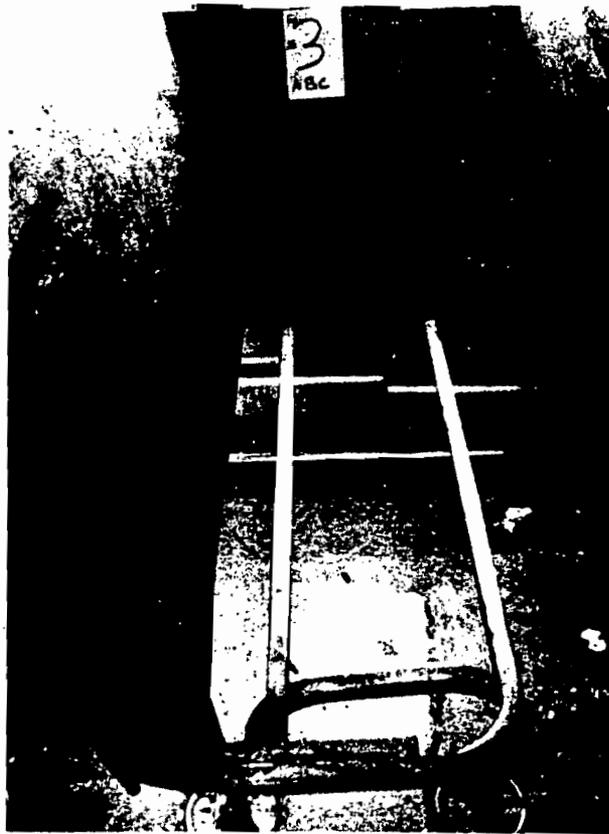
Figure 23.—If bottom seat cushions come loose, restrained and unrestrained passengers can come in contact with the exposed metal frame and sustain injuries. Passengers can also fall through the frame.

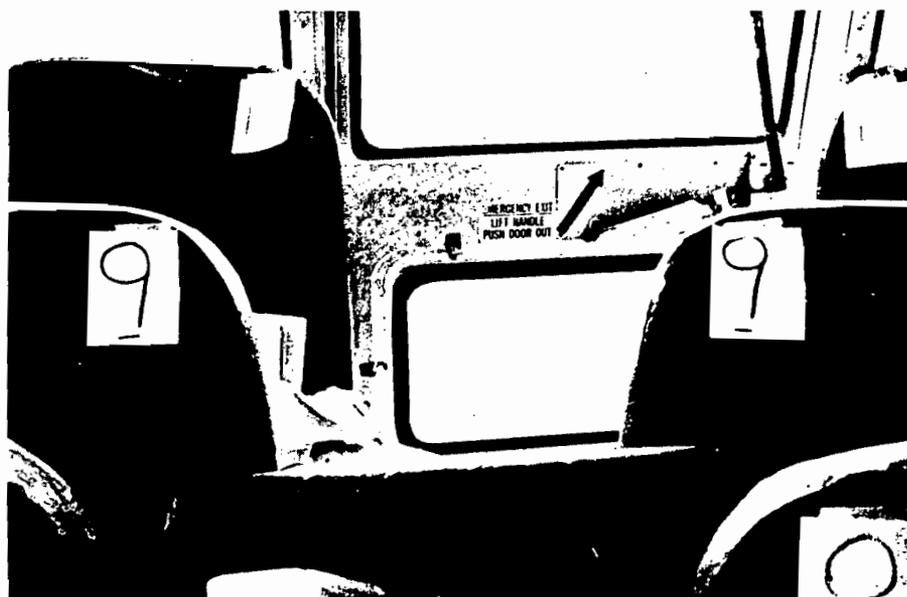
Figure 24.—Loose seat cushions can block aisles and hinder evacuation.

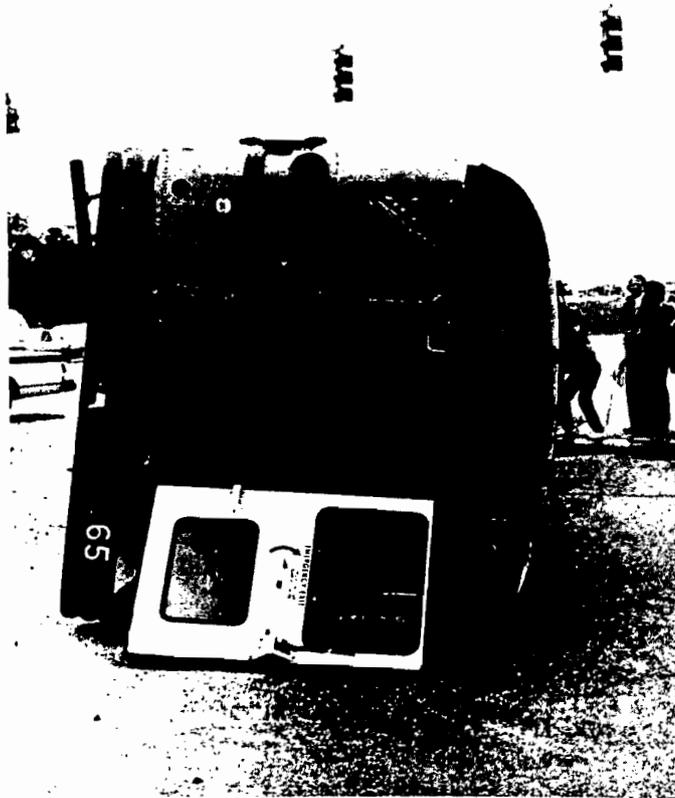
Figure 27.—The number of students who sustained minor injuries in the Fort Myers, Florida collision rollover (case 34) would not have been altered by lap belt use. The accident had at least three injury-causing events: side impact, a 90° counterclockwise lateral rotation, and a 90° overturn. Lap-belted passengers would have had ample opportunity to contact one another, the sidewalls, and the seat backs in front of them to sustain at least minor injuries.
