**National
Transportation
Safety Board**

Approach and Go-around Safety: The good, the bad, and the ugly

Robert L. Sumwalt, III

RAA Approach and Go-Around Safety Seminar

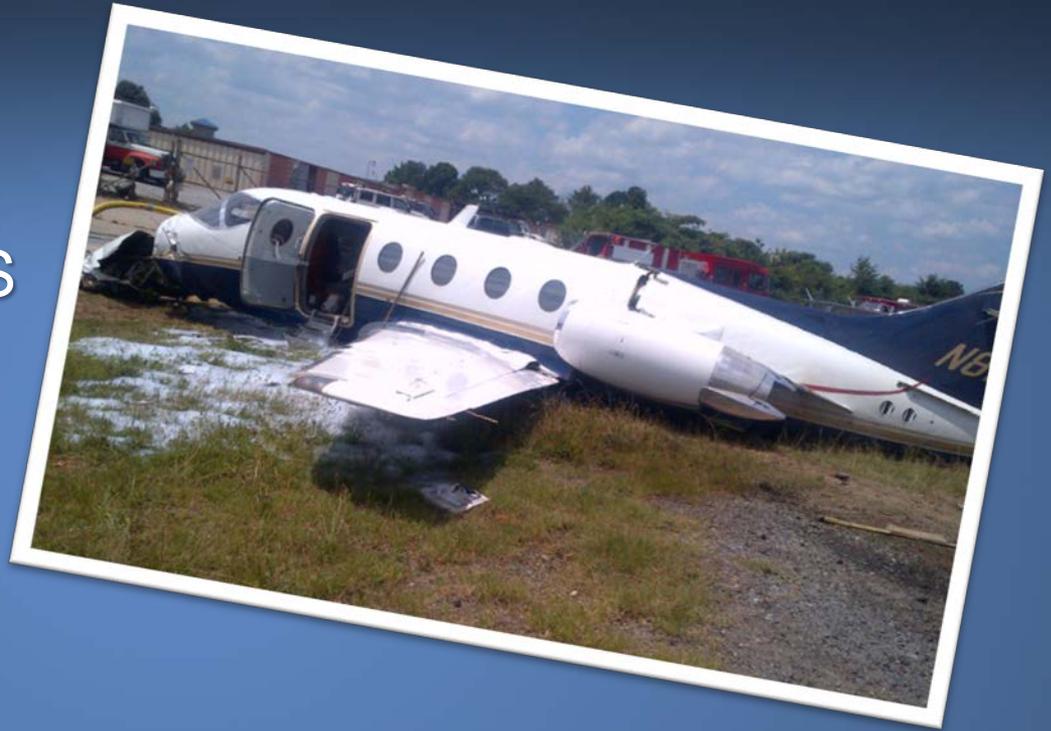
- ½ mile from displaced threshold = 194 kts GS
- 2150 FPM
- GPWS warnings
- Touched down with appx. 2970' remaining

“Contributing to the accident were the failure of either pilot to call for a go-around and the flight crew's poor crew resource management and lack of professionalism.”

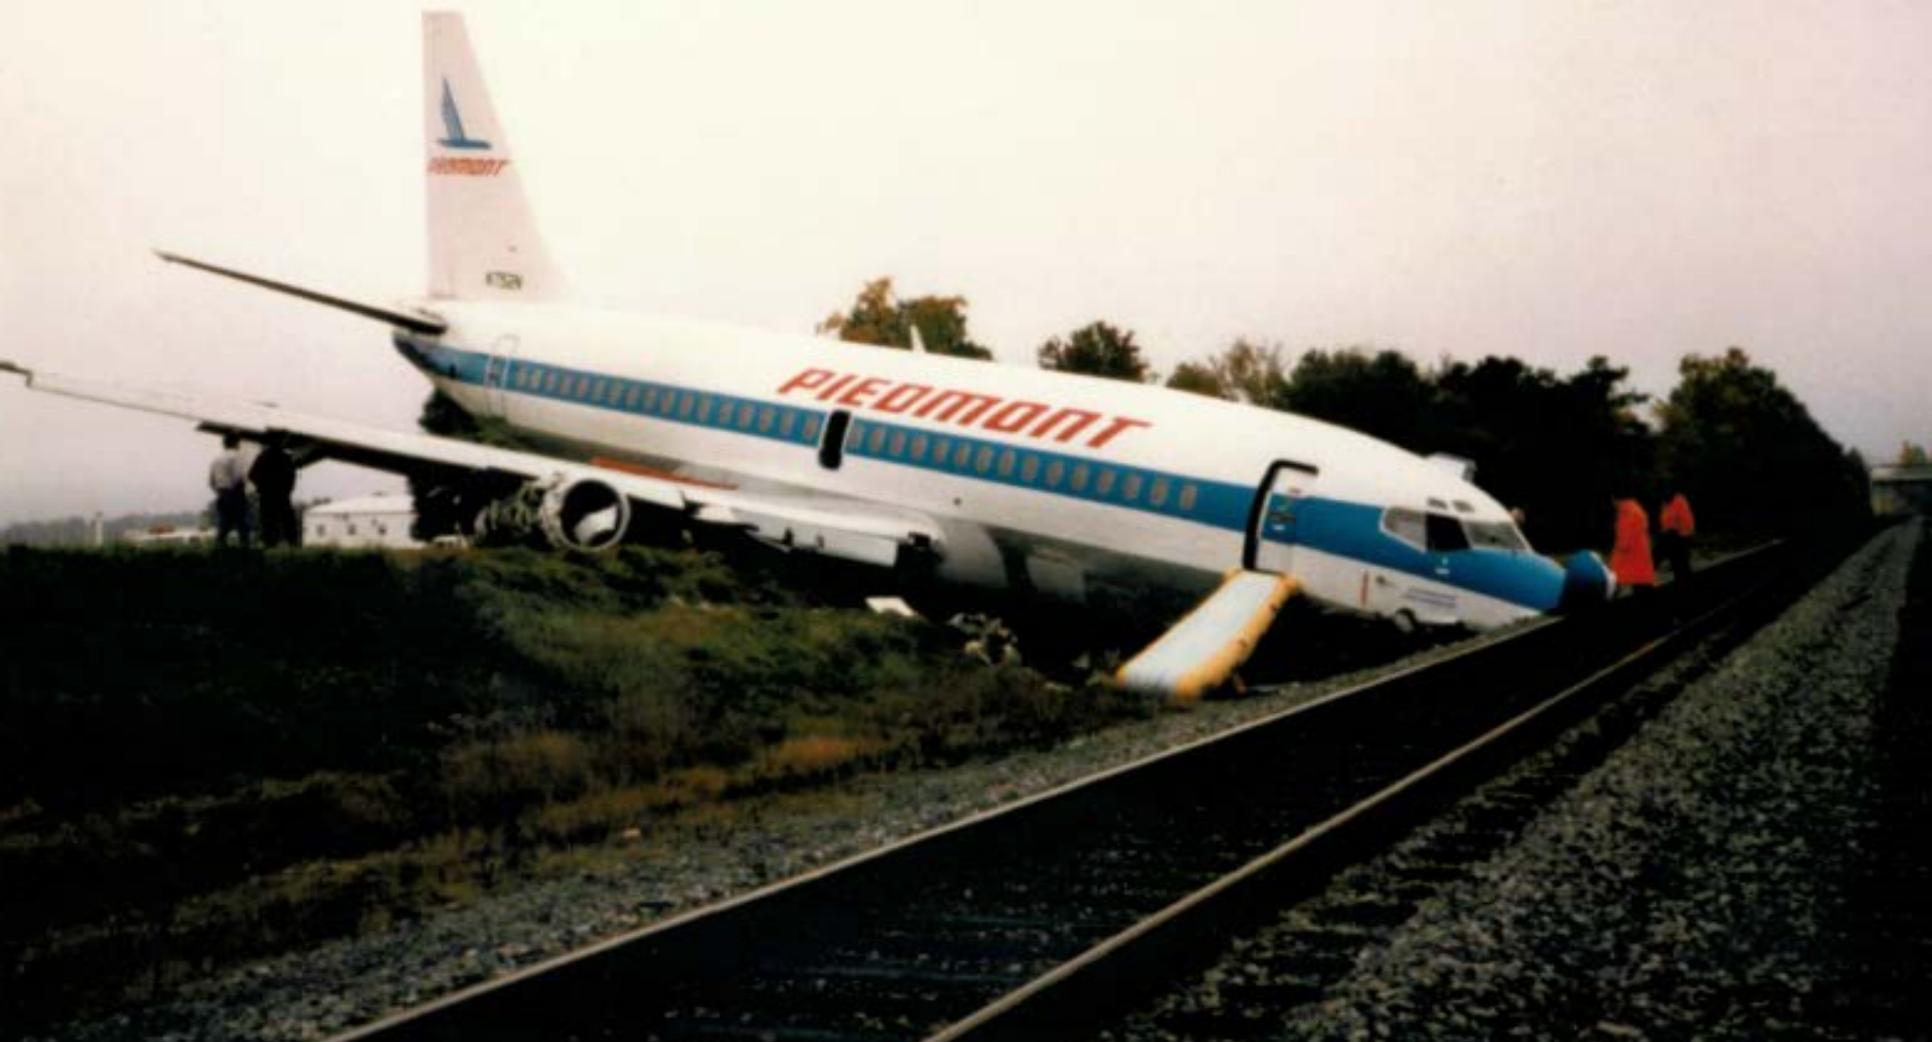
Piedmont flight 467

N752N, October 25, 1986

- Not configured until 500' AGL
 - ILS approach, 400 overcast, 2 miles, light rain, fog
- 200' AGL, “Whoop whoop, pull up”
- Crossed threshold at 165 kts ($V_{ref} = 131$)
- Touched down 3200 feet from threshold at 147 kts (4645' remaining)
- Departed runway end at appx. 72 kts.

- “The evidence indicates that the captain and the first officer were aware that the approach was unstable yet they continued the approach instead of executing a go-around.”

“The probable cause of the accident was the captain’s failure to stabilize the approach and his failure to discontinue the approach to a landing that was conducted at an excessive speed beyond the normal touchdown point on a wet runway.”

- Captain's failure to optimally use airplane decelerative devices
- Lack of effective coordination
- Poor frictional quality of last 1500 feet of runway

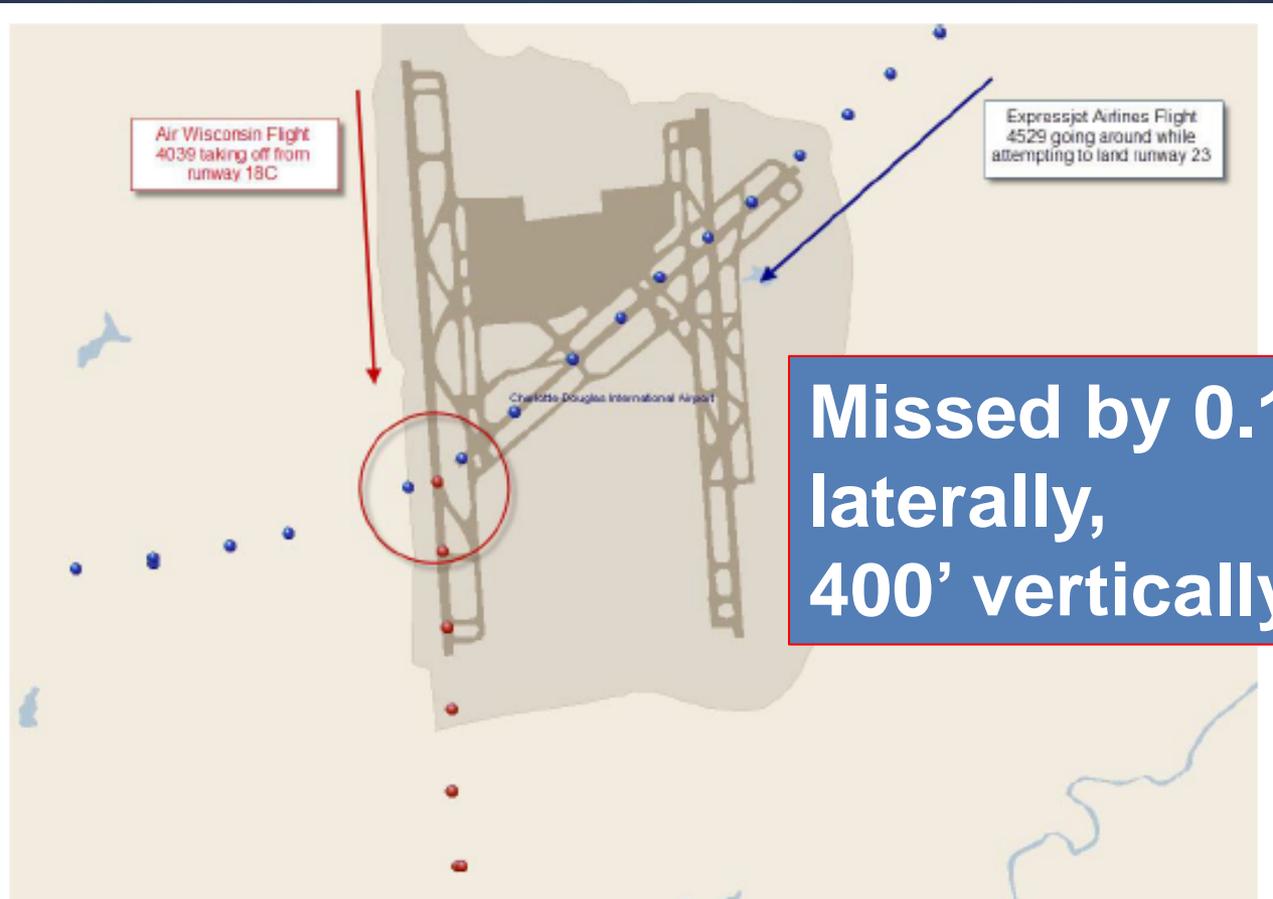
CLT – July 14, 2012

**Missed by 0.16 nm
laterally,
400' vertically**

Figure 4. Expressjet flight 4529 (blue dots) executed a go-around while attempting to land on runway 23. Air Wisconsin flight 4039 (red dots) was simultaneously cleared for takeoff from runway 18C.

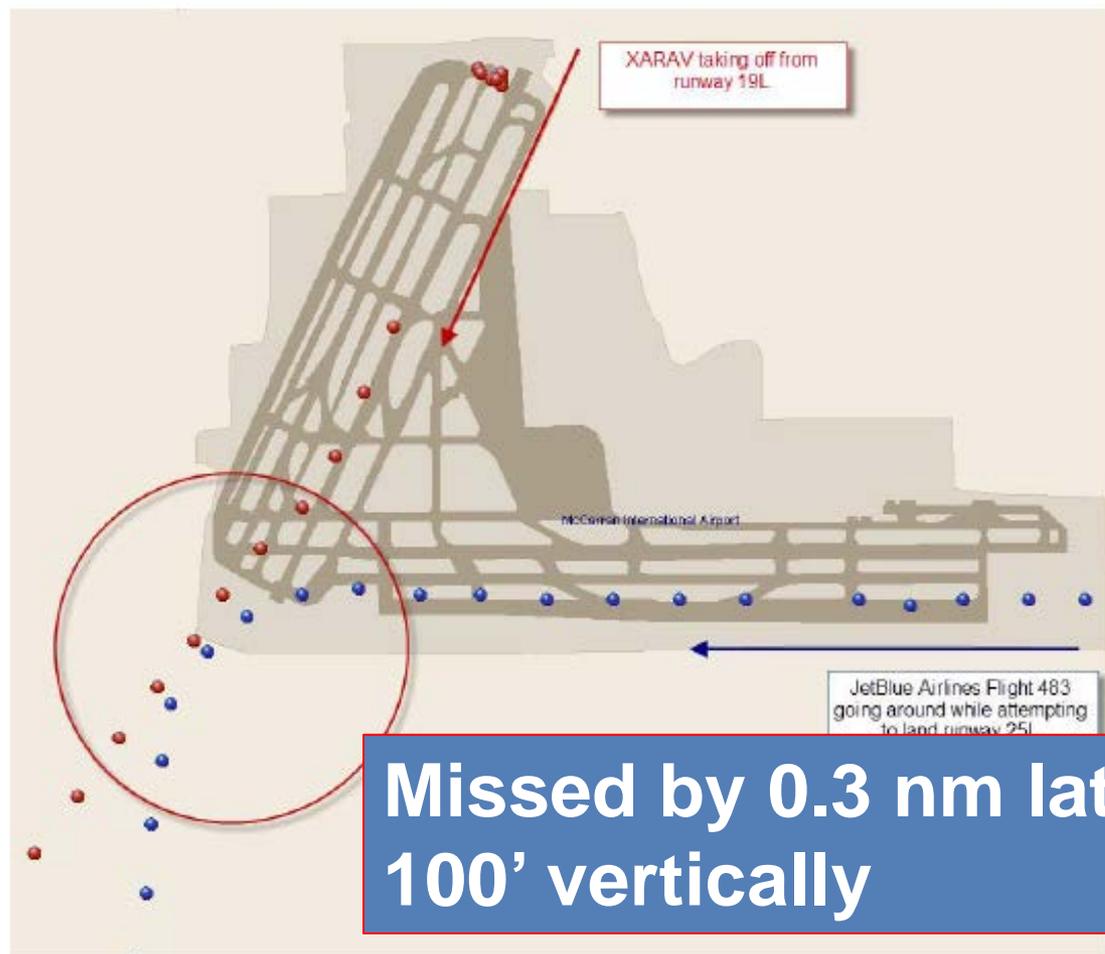
LAS – April 26, 2012

Figure 5. Jet Blue flight 483 (blue dots) executed a go-around from runway 25L. XARAV (red dots) was simultaneously departing from runway 19L.

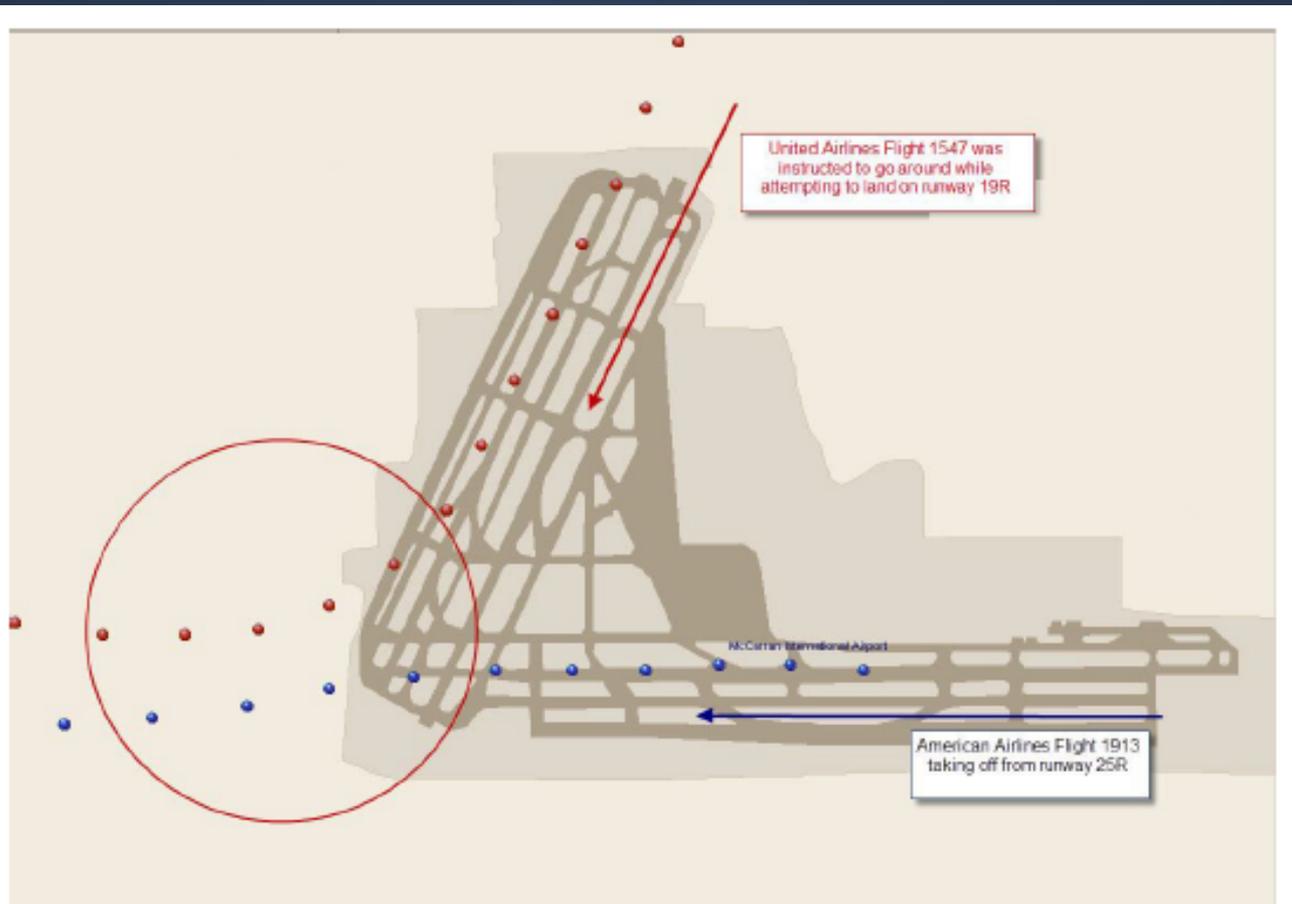
LAS – January 27, 2006

Figure 6. United Airlines flight 1547 (red dots) executed a go-around while attempting to land on runway 19R. American Airlines flight 1913 (blue dots) was simultaneously cleared for takeoff from runway 25R.

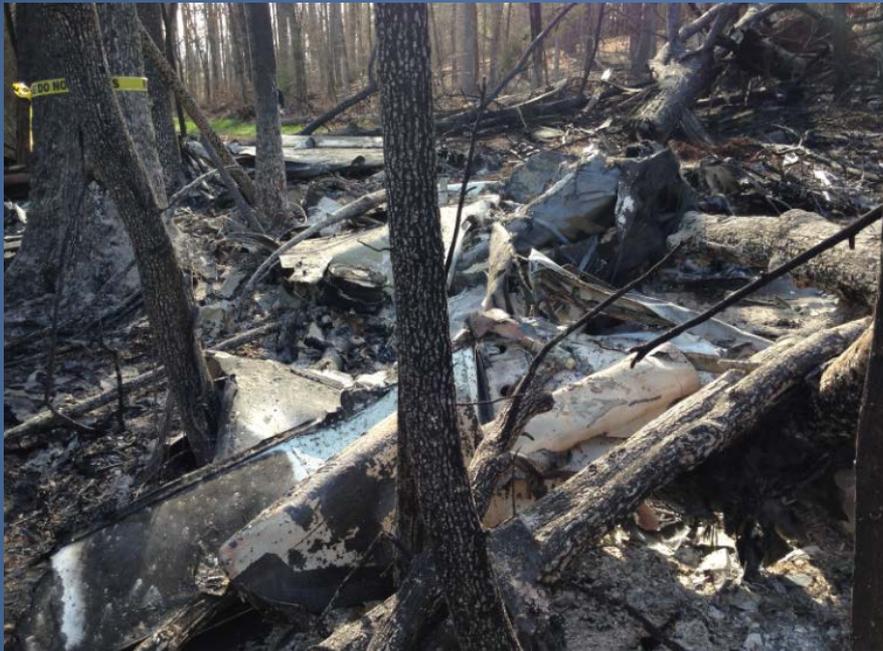
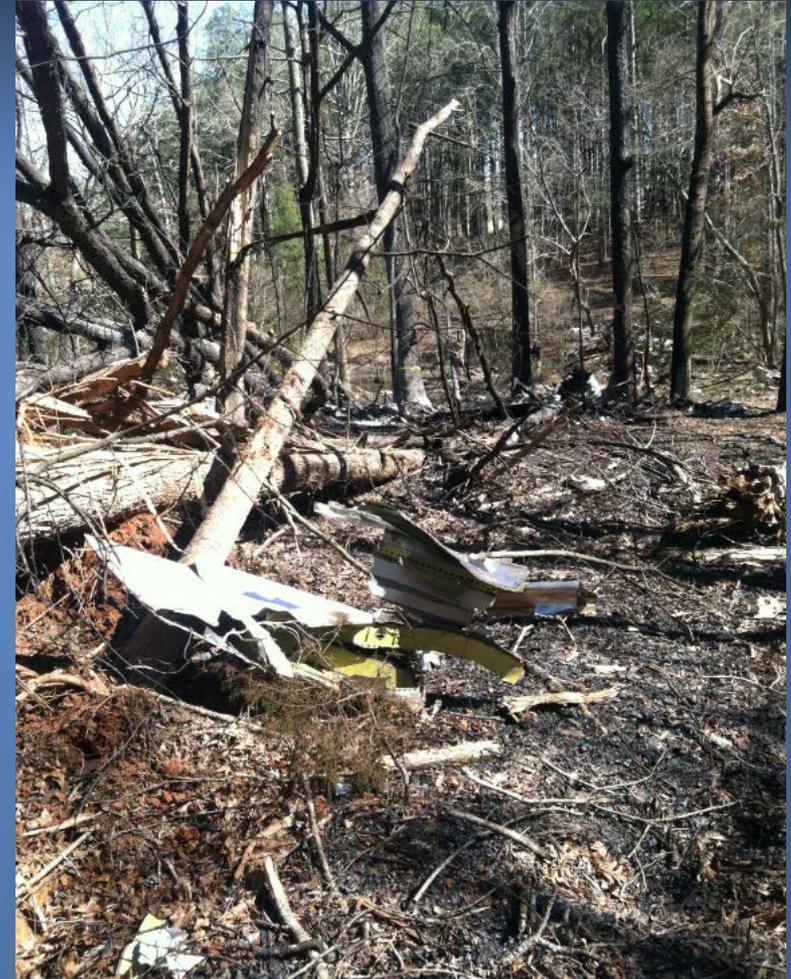
Thompson, GA

- Last radar return showed aircraft about $\frac{1}{2}$ mile from runway at appx. 250' AGL.
- “Witnesses reported that the airplane appeared to be in position to land when the pilot discontinued the approach and commenced a go-around.”
- Struck concrete utility pole $\frac{1}{4}$ mile past runway at appx. 60 feet AGL.

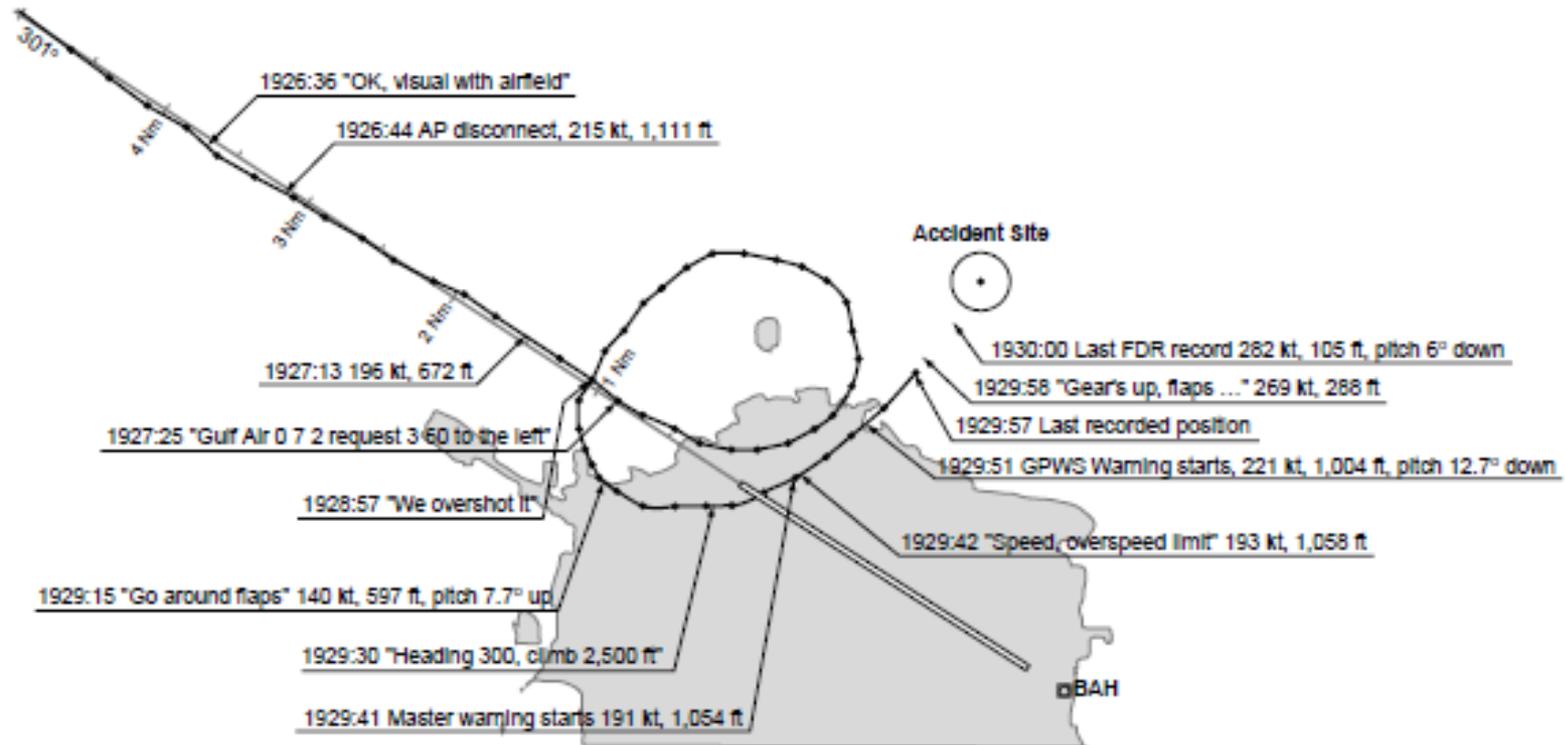
Flight Path of Gulf Air Airbus A320 and Selected Cockpit Voice Recorder Data and Flight Data Recorder Data; Muharraq, Bahrain; Aug. 23, 2000
