**National
Transportation
Safety Board**

A Tale of Two Cities

**The San Francisco Crash
The Birmingham Crash**

Robert L. Sumwalt, III

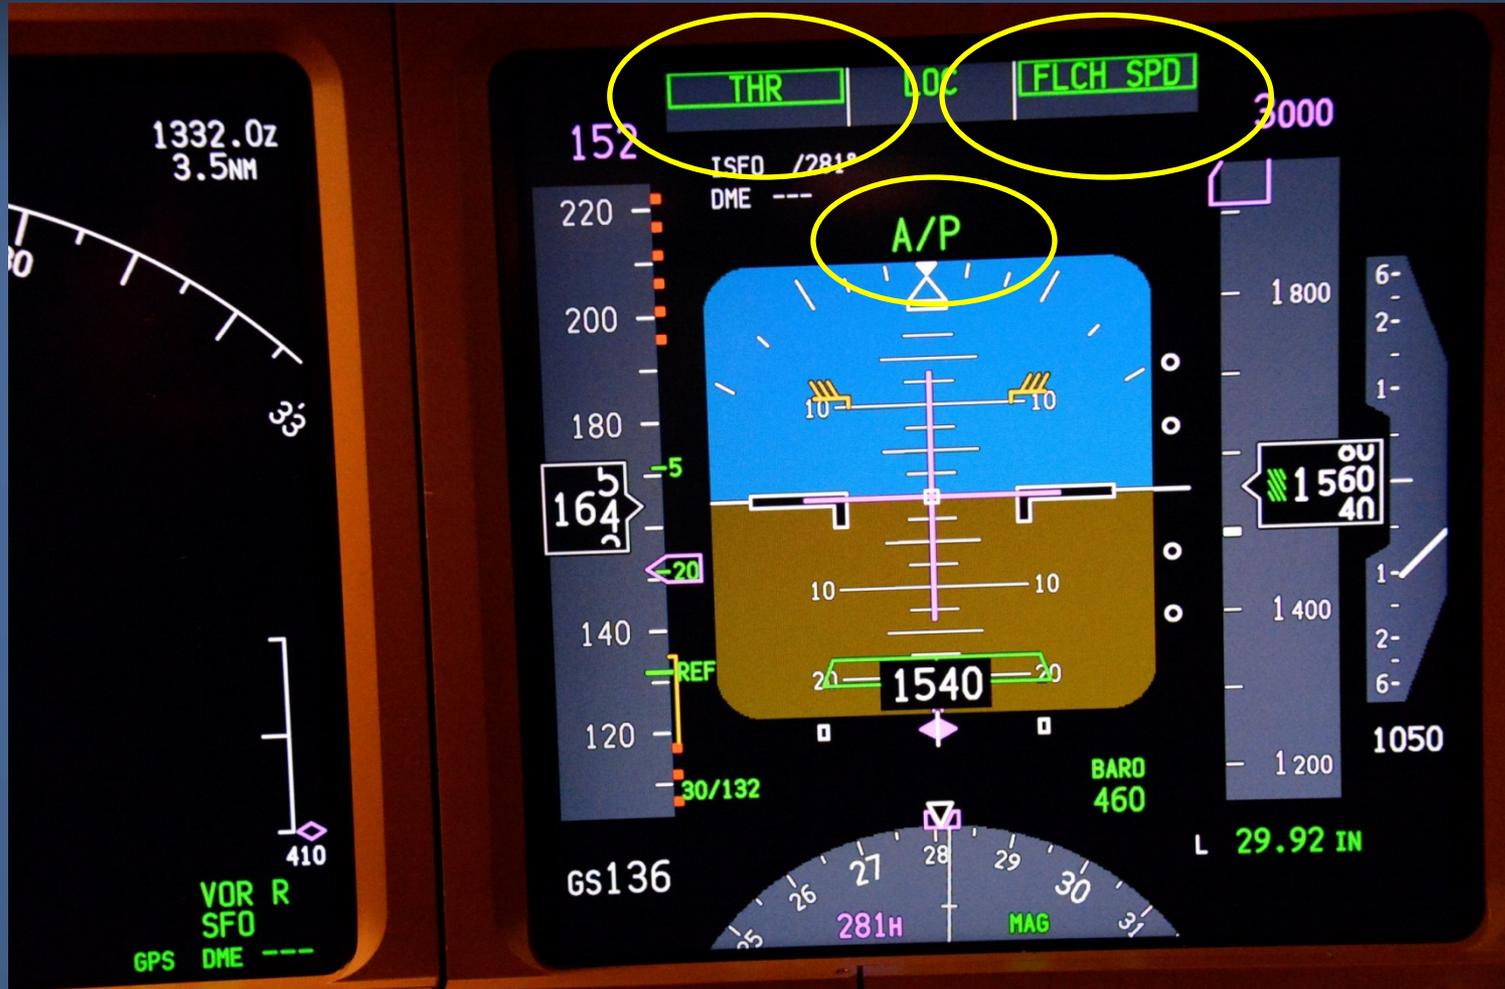
Final Approach: FLCH SPD Selected

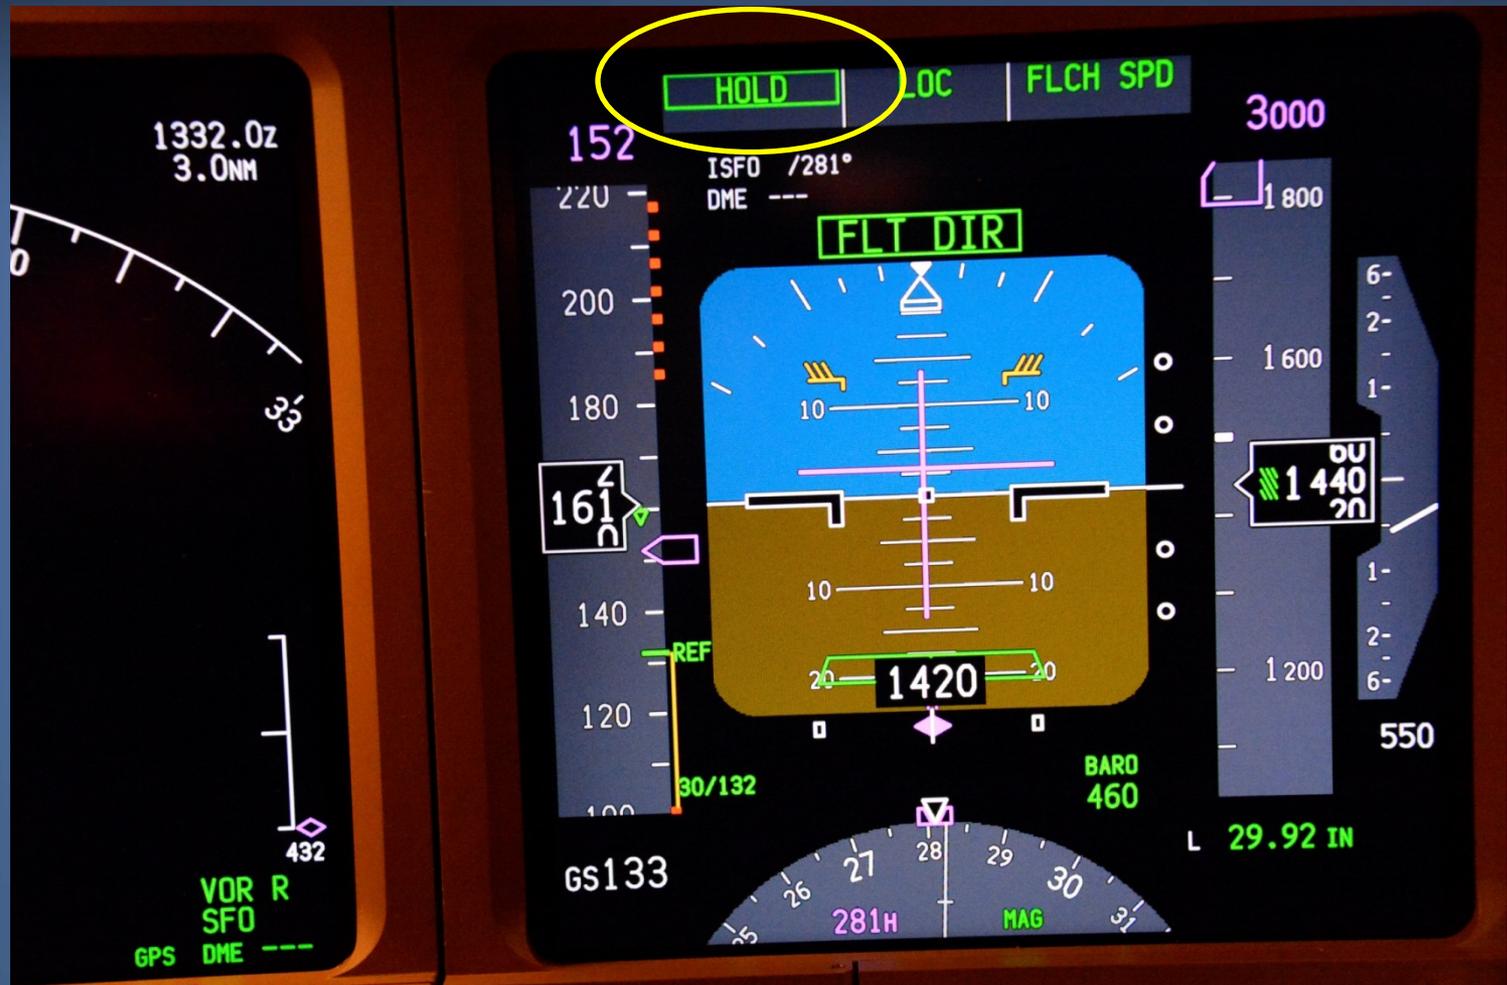
Final Approach: A/T in HOLD mode

- If the autothrottles are disconnected, if speed gets too slow, the autothrottles will reactivate (“wake up”) and increase speed.
- If autothrottles are armed in their normal operating mode, but in HOLD mode, if speed gets slow, the autothrottles will not wake up.

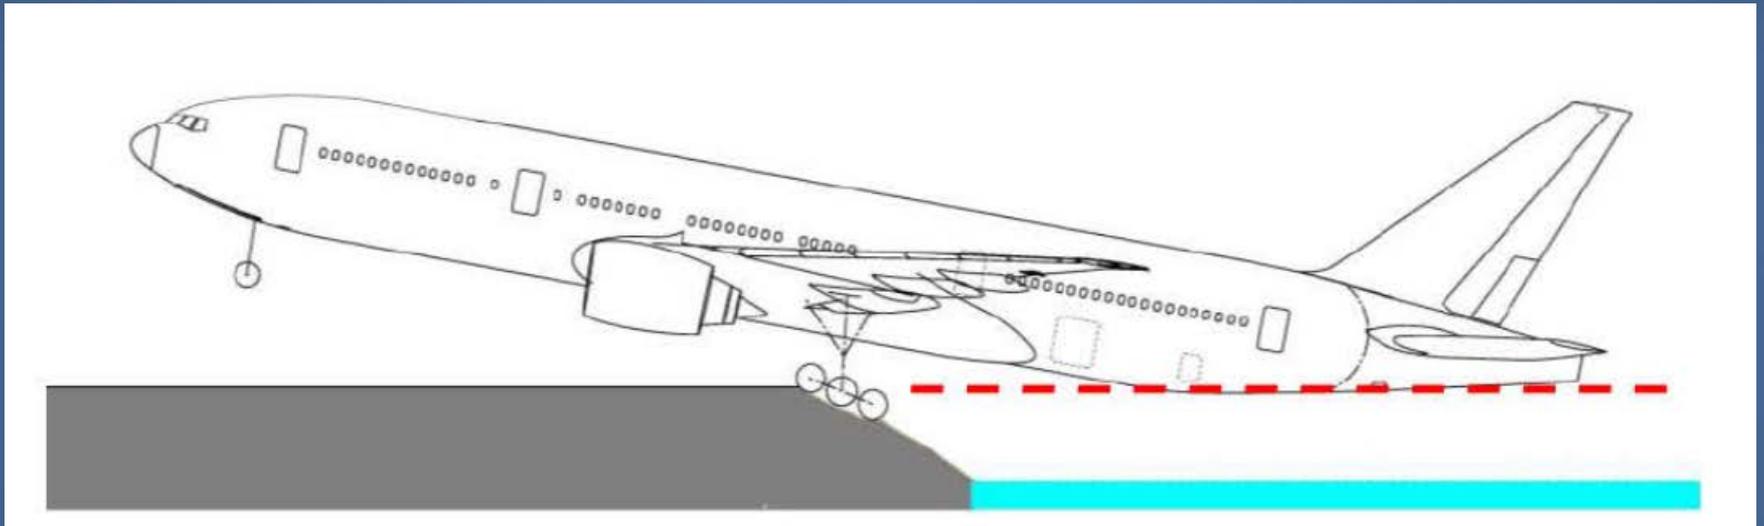
Final Approach

- PM – “speed” at 90 ft and 110 knots
- PM – added go-around thrust
- Column full aft
- Stick shaker activated
- Airplane did not have the performance to go around at that point

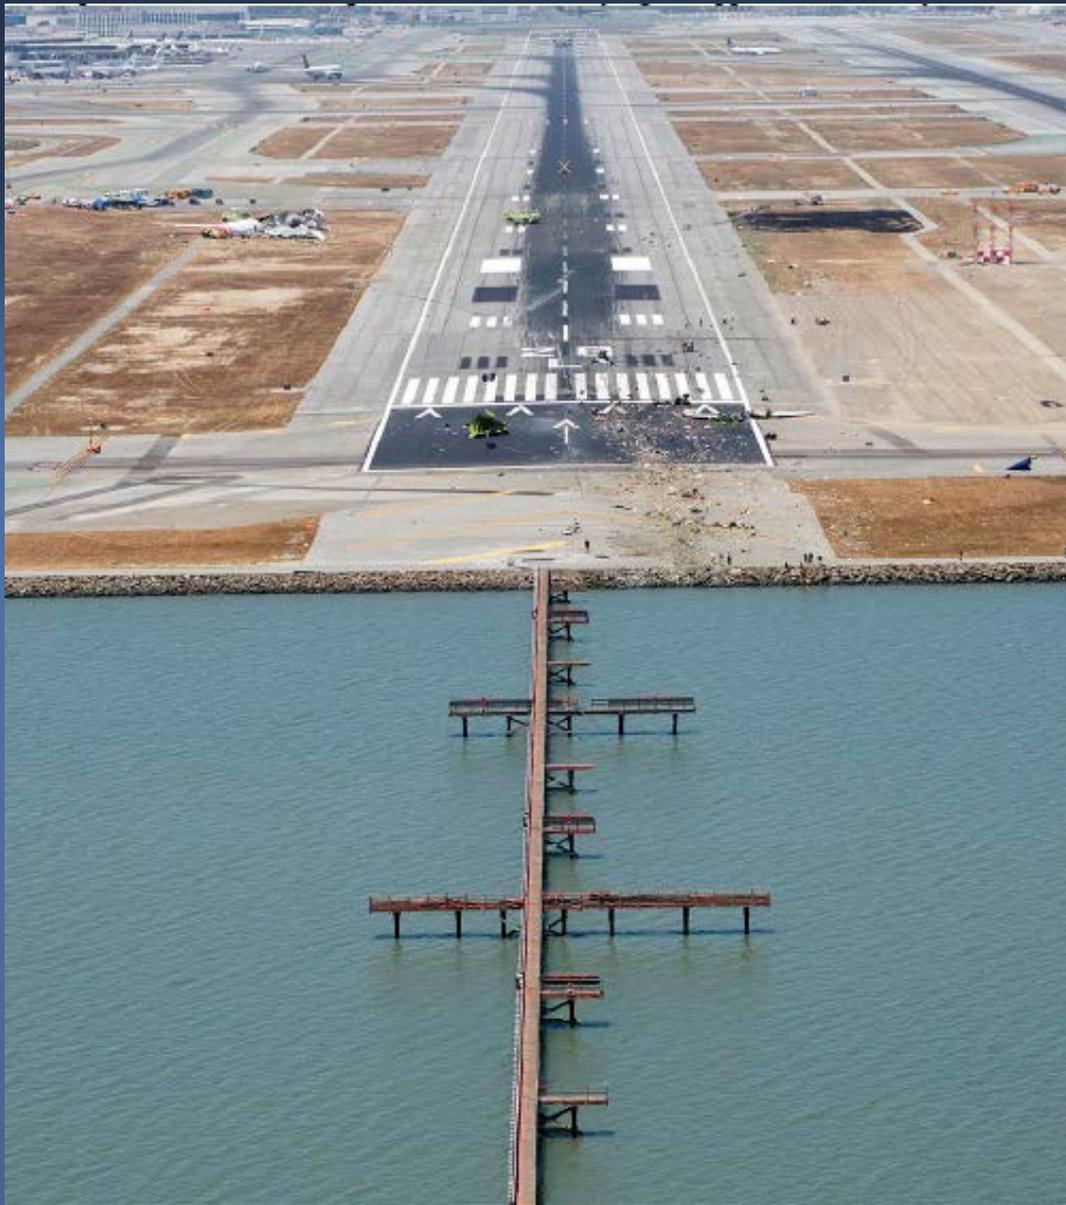
Estimated aircraft position at impact with seawall

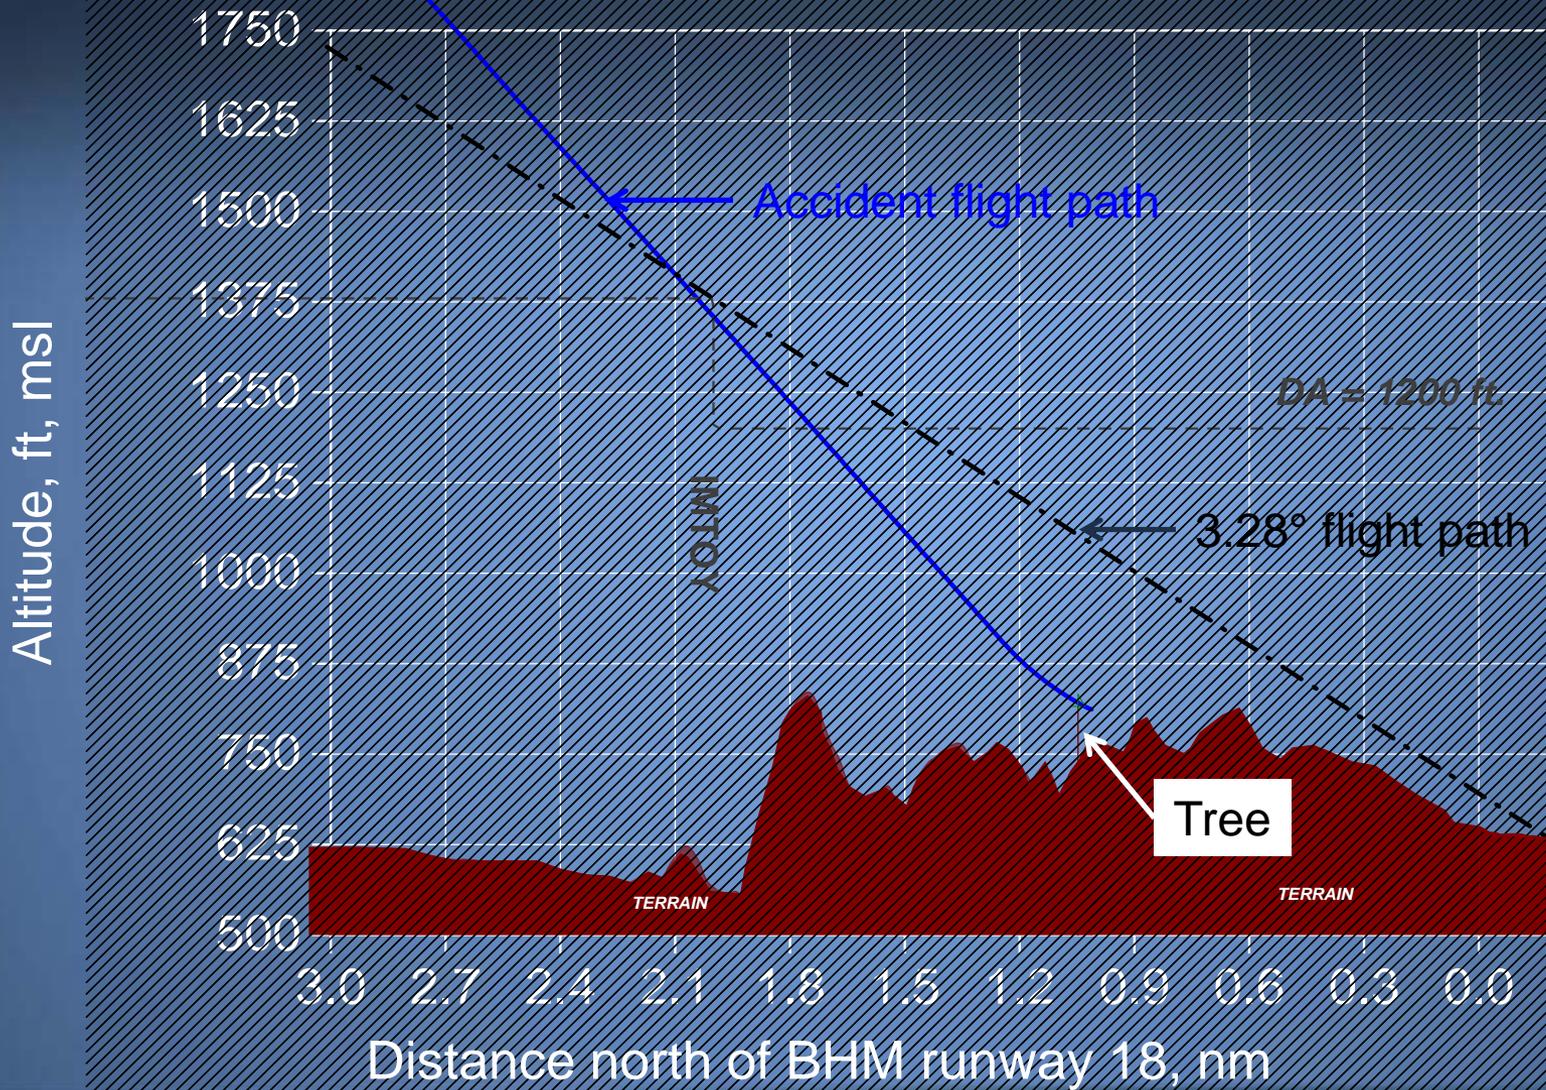
EGPWS Terrain Clearance Floor

- Newer TAWS software would have provided a “too low terrain” caution alert 6.5 seconds sooner and 150 feet higher.
 - Because of the excessive descent rate and not knowing how aggressively the pilots would have responded, the effect on the accident could not be determined.
- An escalating series of TAWS alerts before impact with terrain or obstacles is not always guaranteed due to technological limitations, which reduces the safety effectiveness of the TAWS during the approach to landing.

- Advise operators that, in certain situations, an escalating series of TAWS warnings may not occur before impact with terrain or obstacles.
- Encourage operators to review their procedures for responding to alerts on final approach to ensure that these procedures are sufficient to enable pilots to avoid impact with terrain or obstacles in such situations.
