**NTSB** National Transportation Safety Board

*Office of Aviation Safety*

# Flap System and Asymmetry

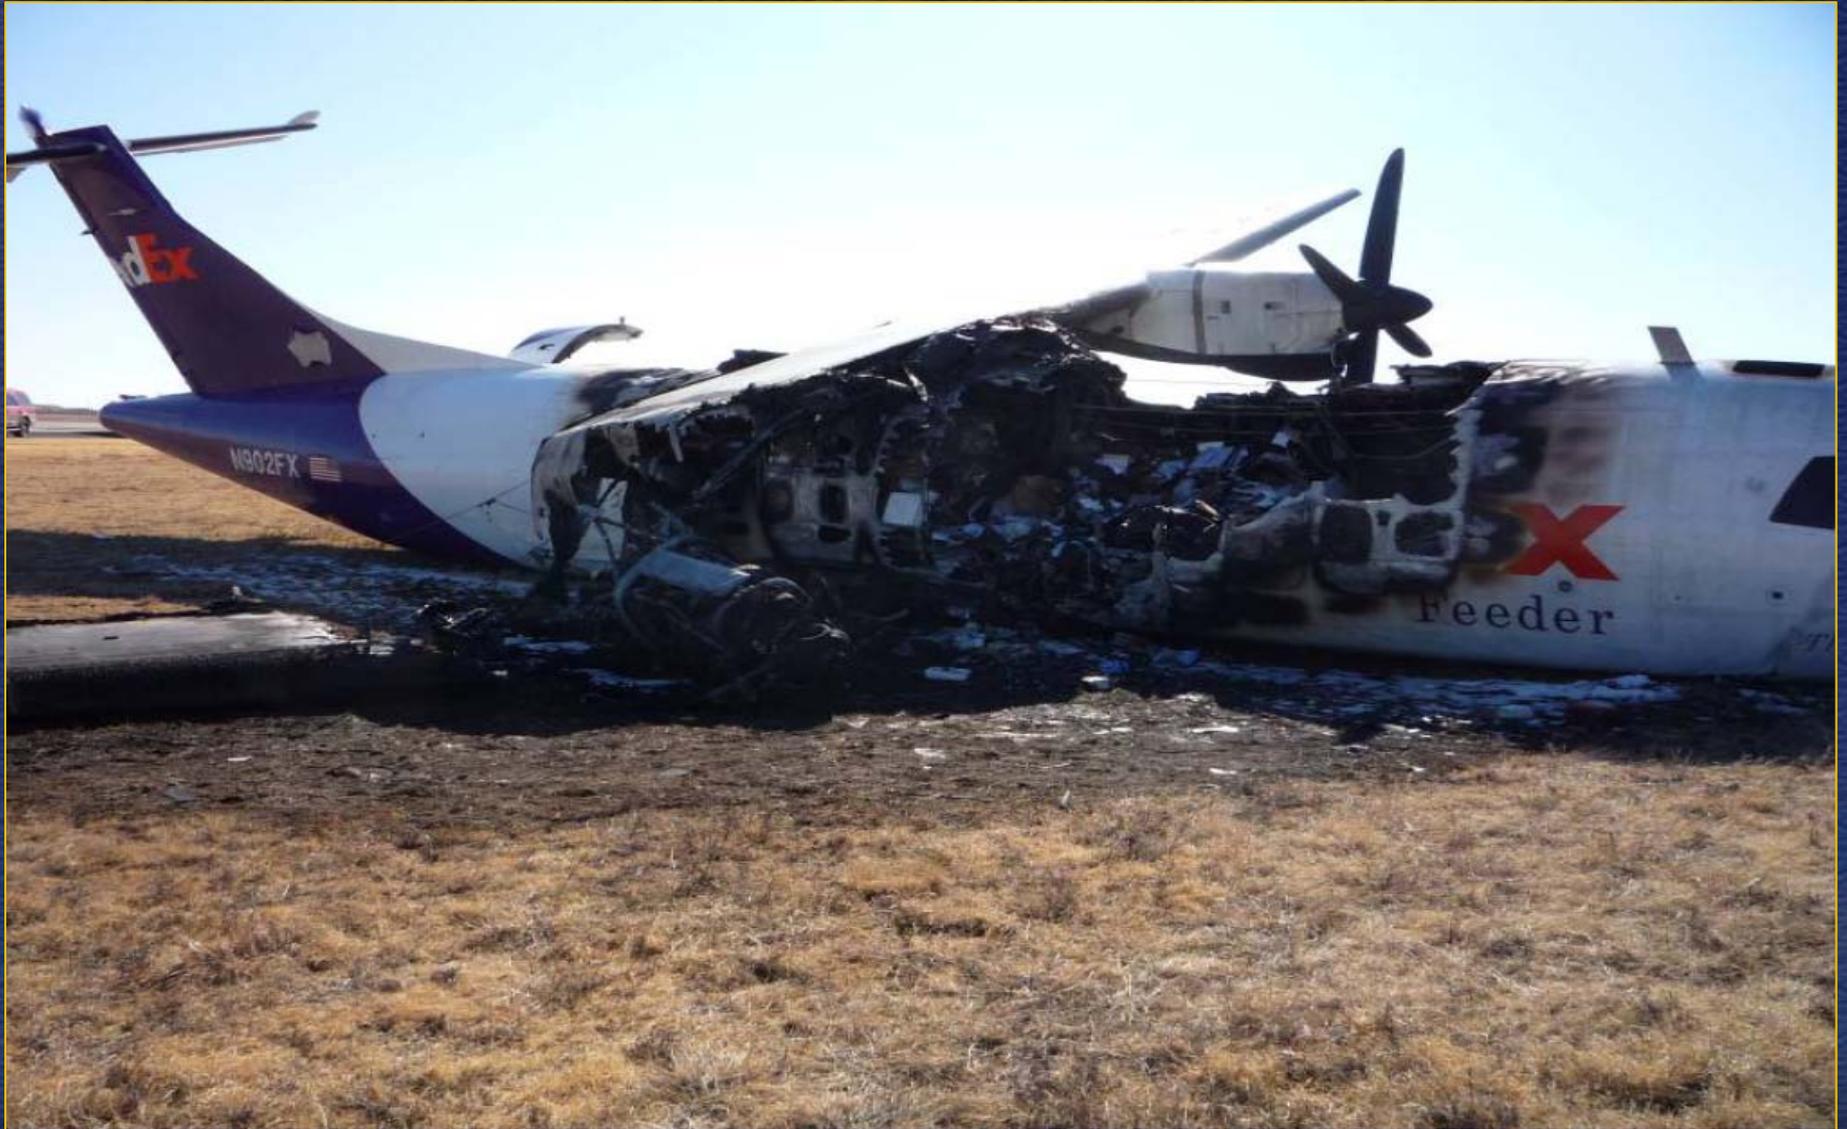
- ATR service history
  - 1 previous flap asymmetry on different ATR 42, landing uneventful, reason undetermined
- Potential reasons
  - Contaminated hydraulic fluid
  - Restricted movement of flaps
  - Actuator jamming
