**NTSB** National Transportation Safety Board

# Loss of Train Detection

Signal & Train Control Investigation

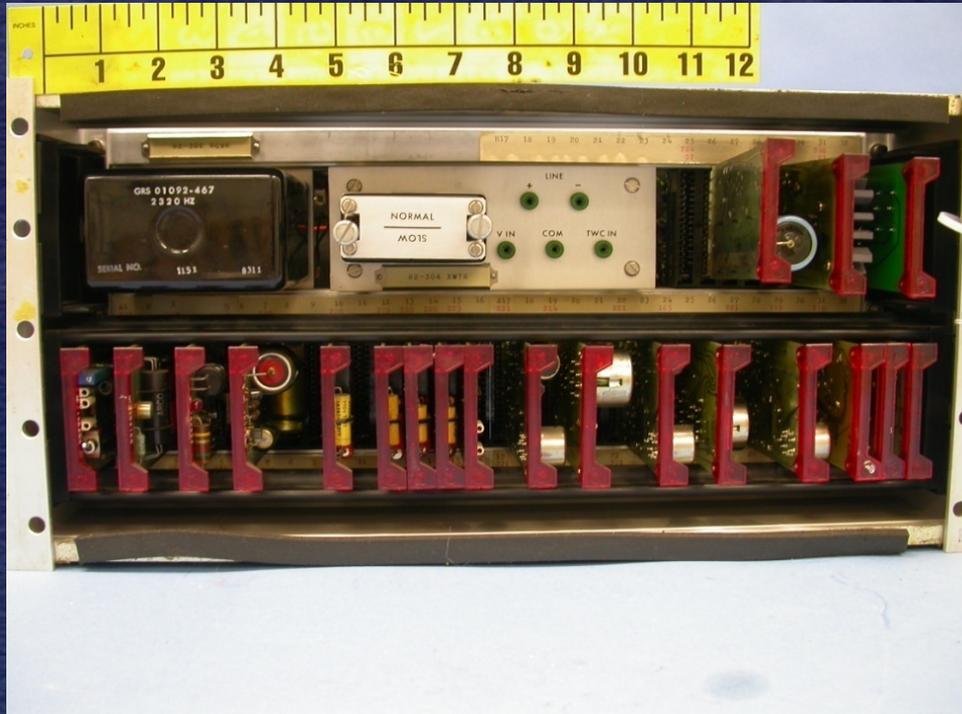
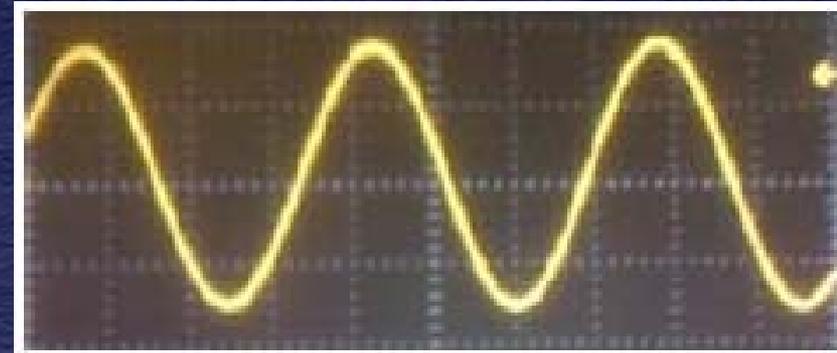
# GRS Track Circuit Modules

Valid track circuit signal

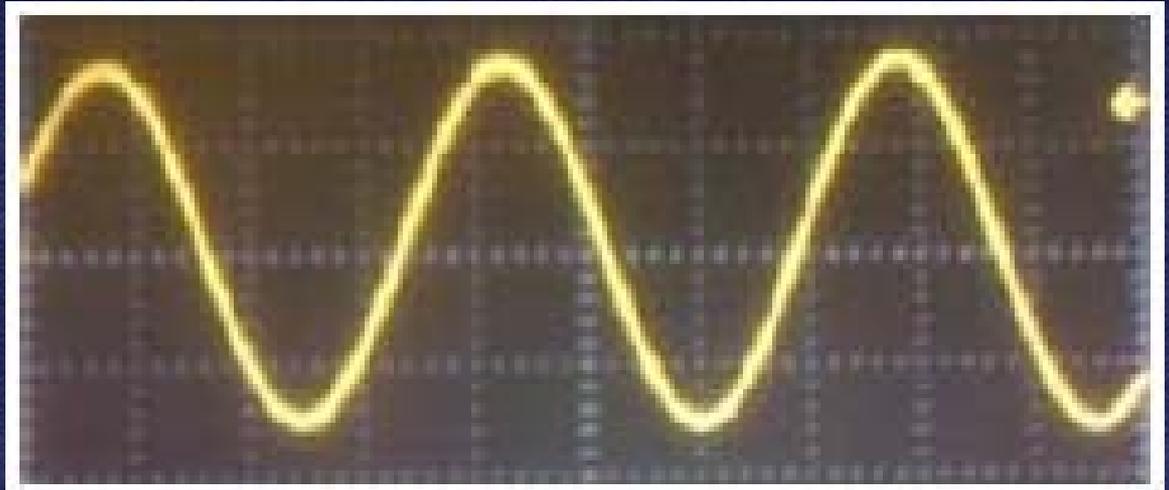
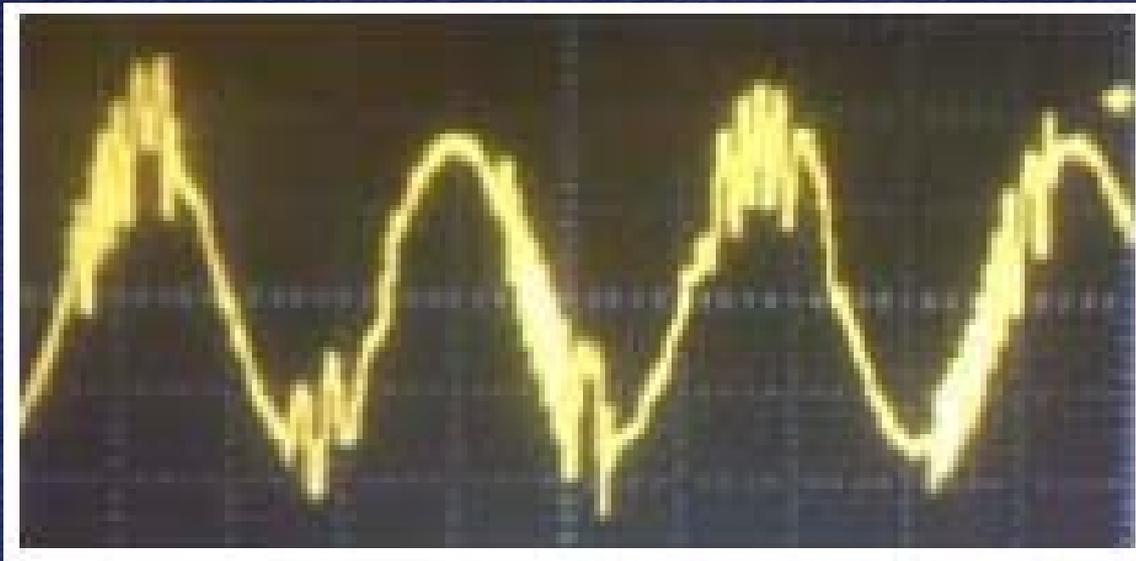
Valid track circuit signal

Track circuit signal with parasitic oscillation

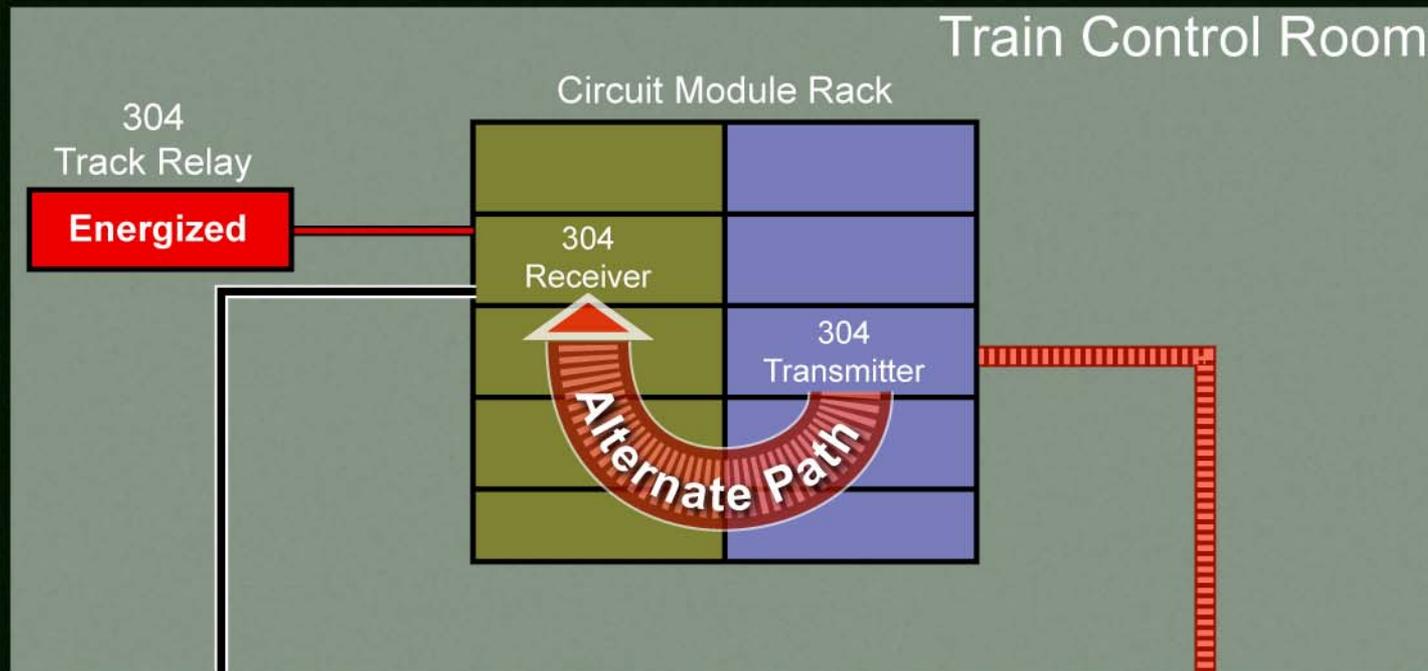
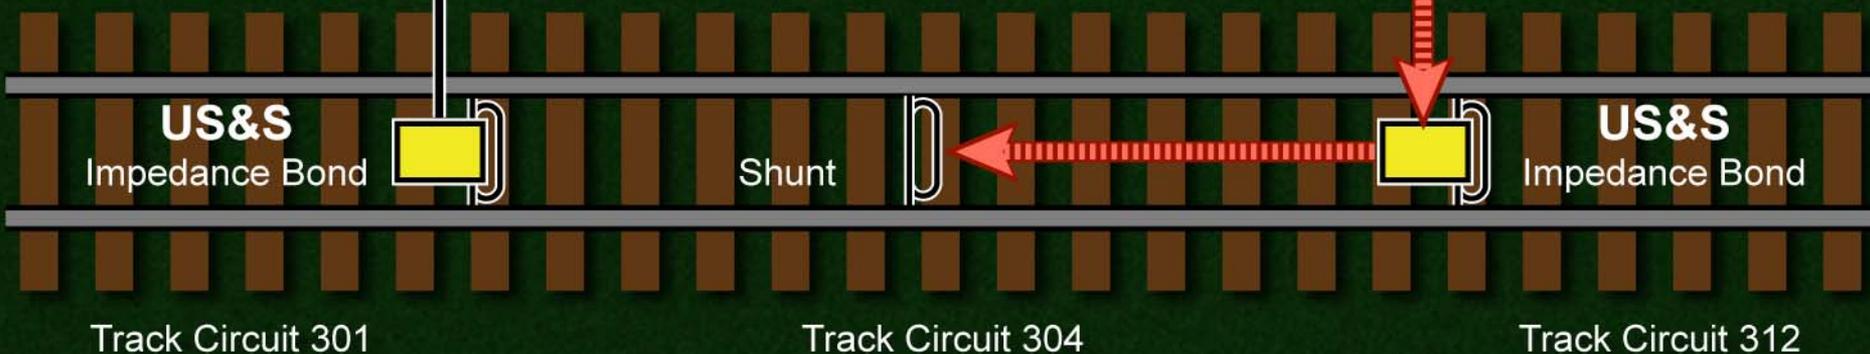
- GRS modules exhibit parasitic oscillation with US&S impedance bonds

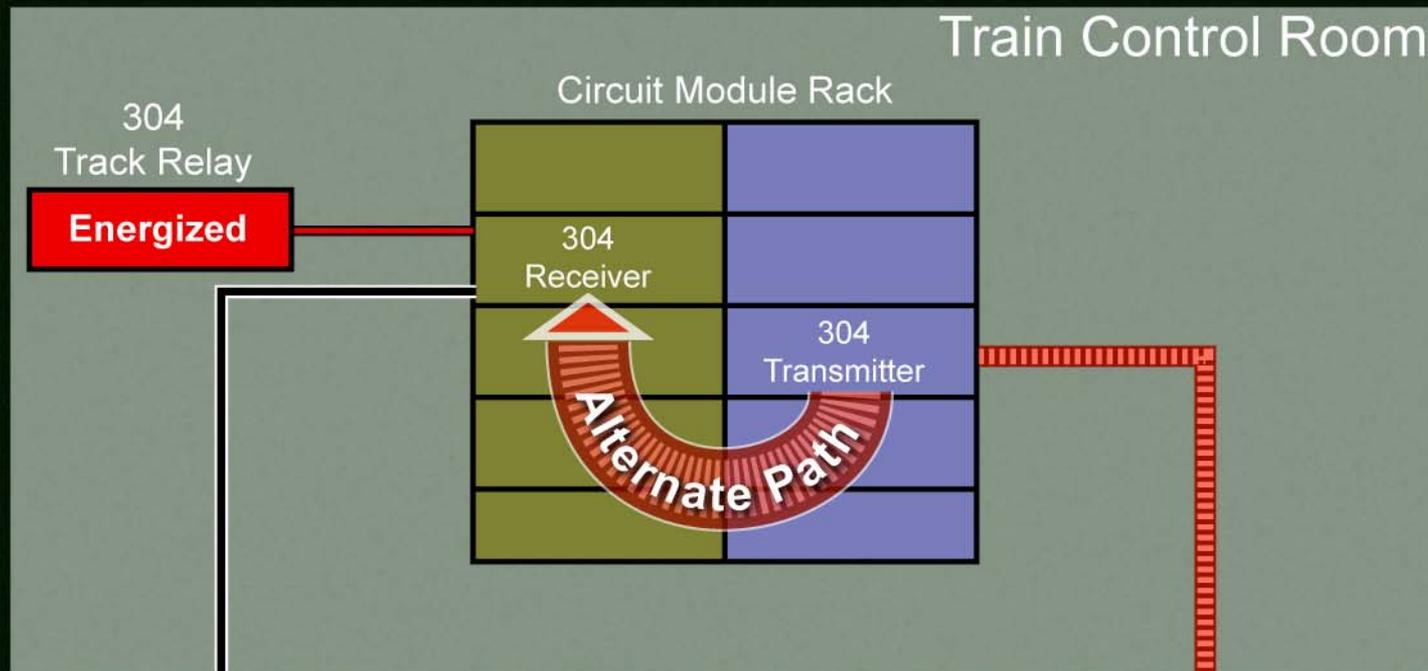
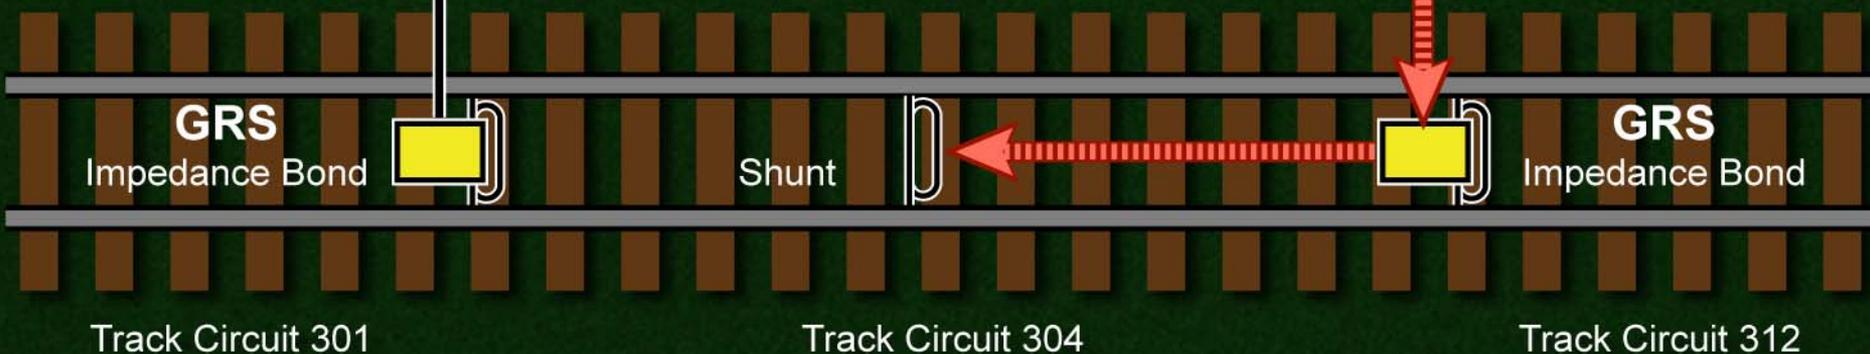
- GRS modules exhibit parasitic oscillation with GRS impedance bonds

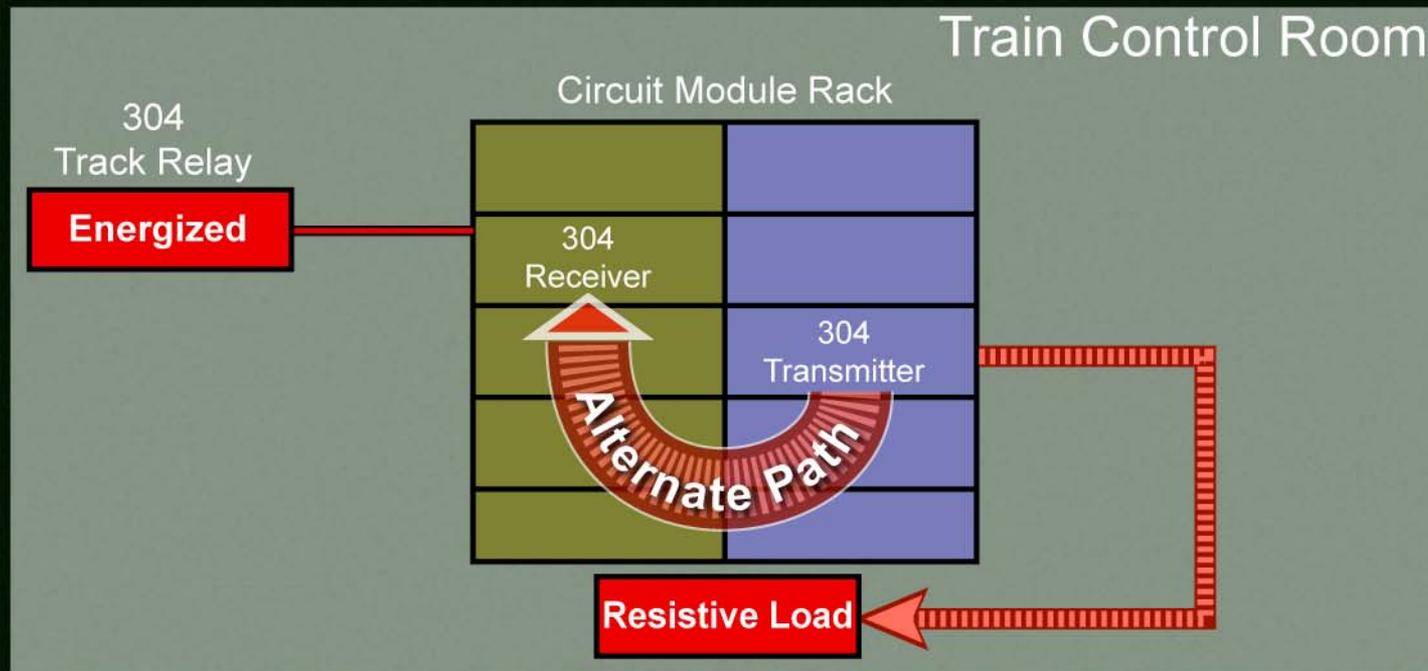
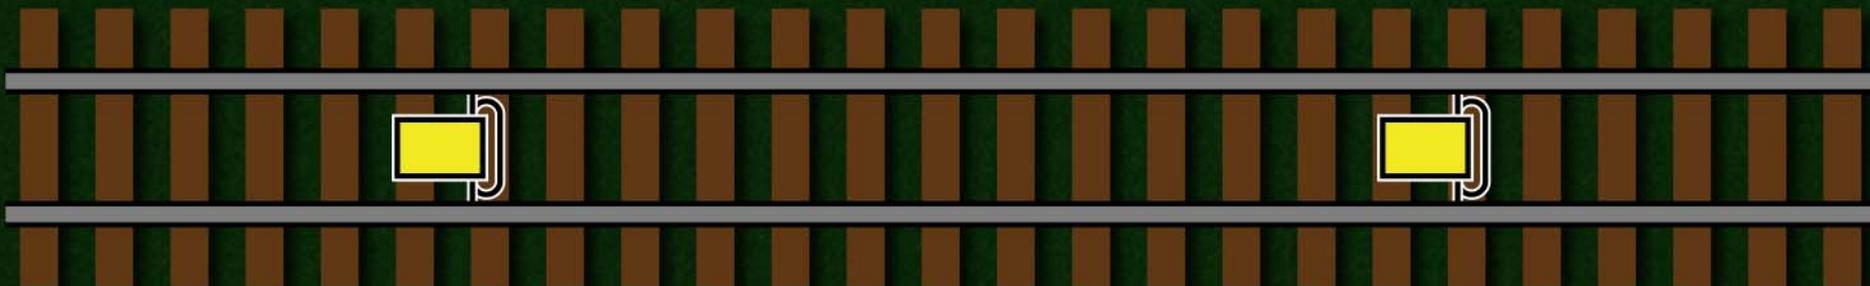
- GRS modules exhibit parasitic oscillation with resistive load

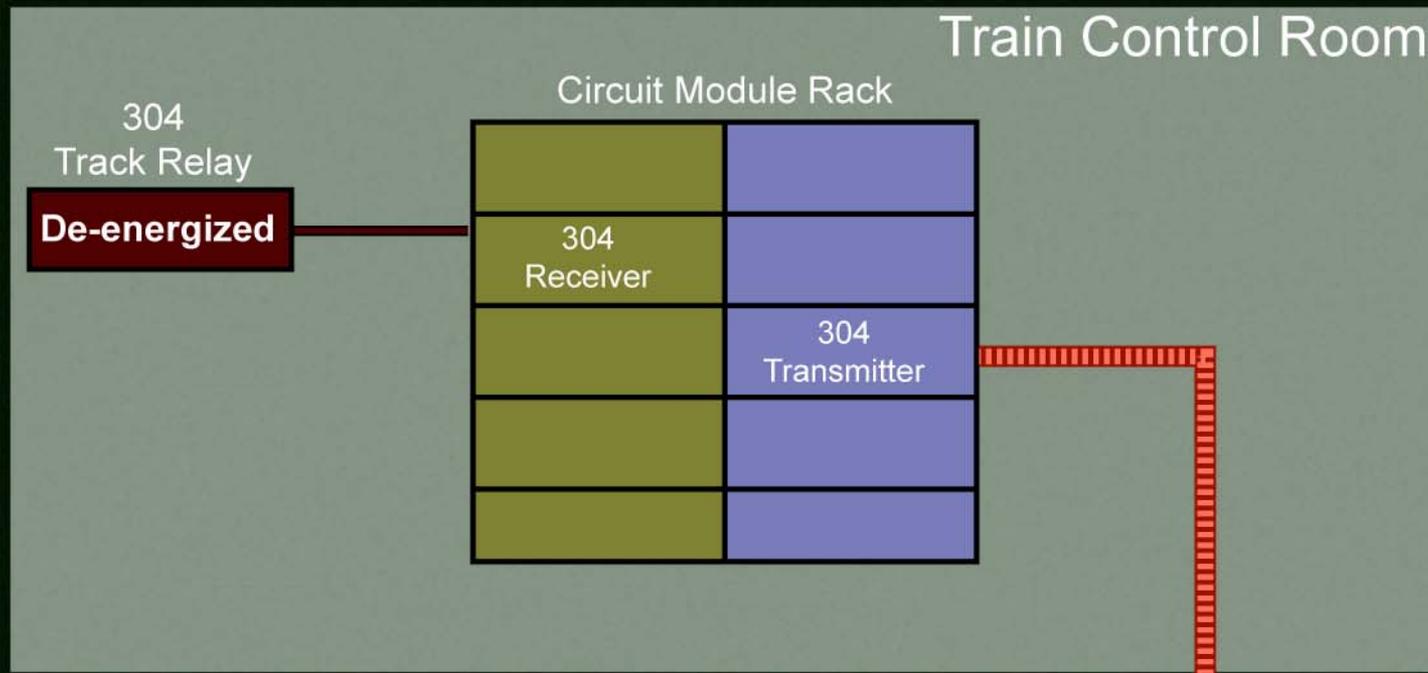
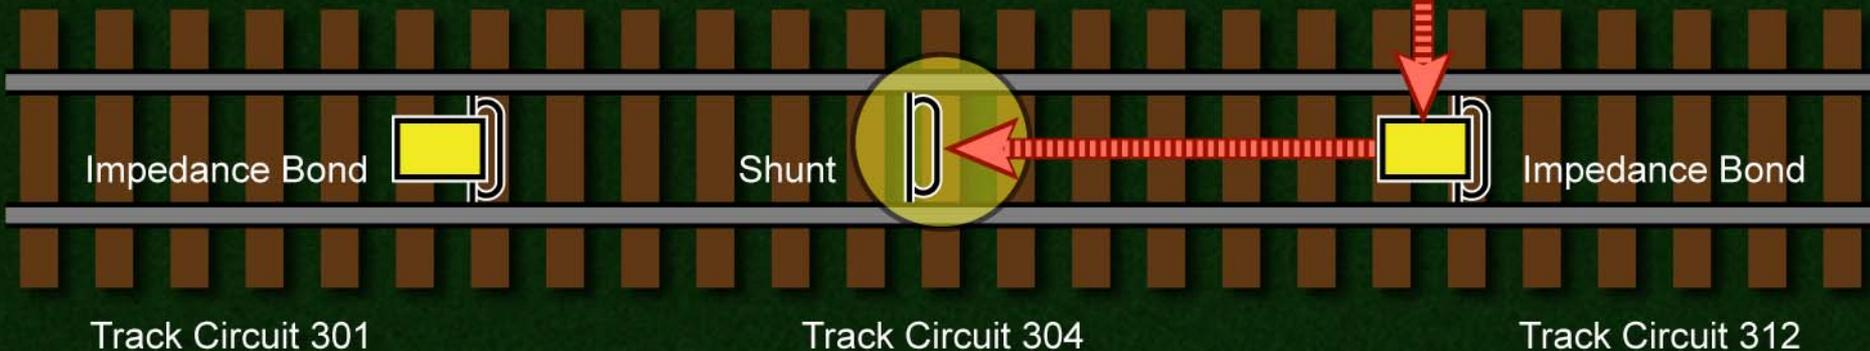
# Shunt Test of Track Circuit

- During the investigation, accident track circuit consistently failed to detect a shunt placed in the middle
- If proper procedures had been used after impedance bond replacement it would have failed and track circuit not placed in service
