**National
Transportation
Safety Board**

Technologically Advanced Aircraft Accident Case Studies

Allison Diaz, ASI
Eastern Region – Aviation

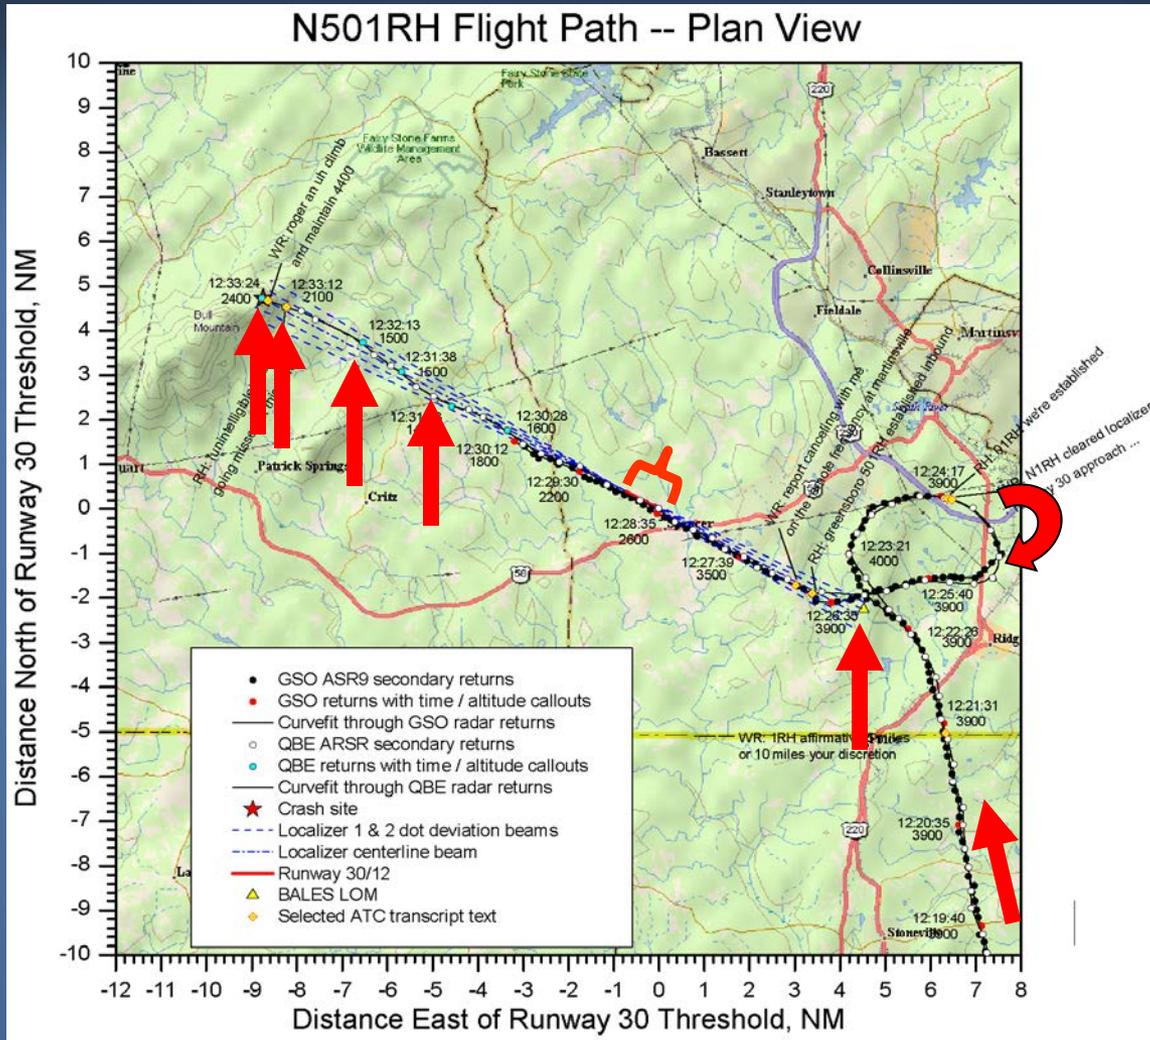
N501RH Flight Path -- Plan View

- No CVR
- Navigated to BALES
- Failed to notice autosequence to MTV
- Did not cross-check
- Did not execute published MAP

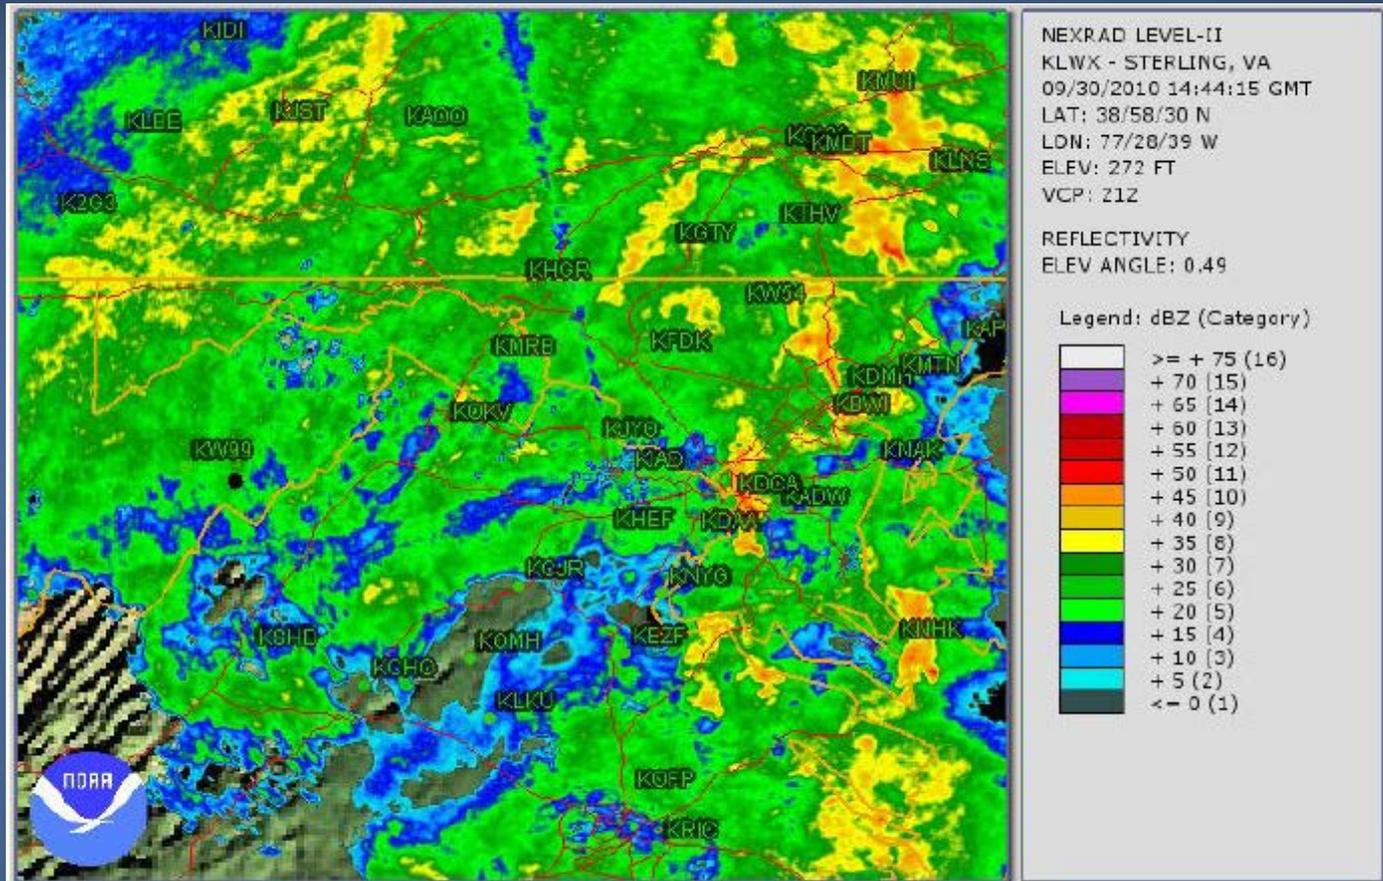
Figure 7 – KIAD WSR-88D 0.5° elevation scan for 1044 EDT

- PIREPs – moderate to severe turbulence
- AIRMETs Sierra & Tango
 - IFR
 - Mountain obscuration
 - Moderate turbulence
- Witness: 300' ceiling, < 1/4 mi. vis

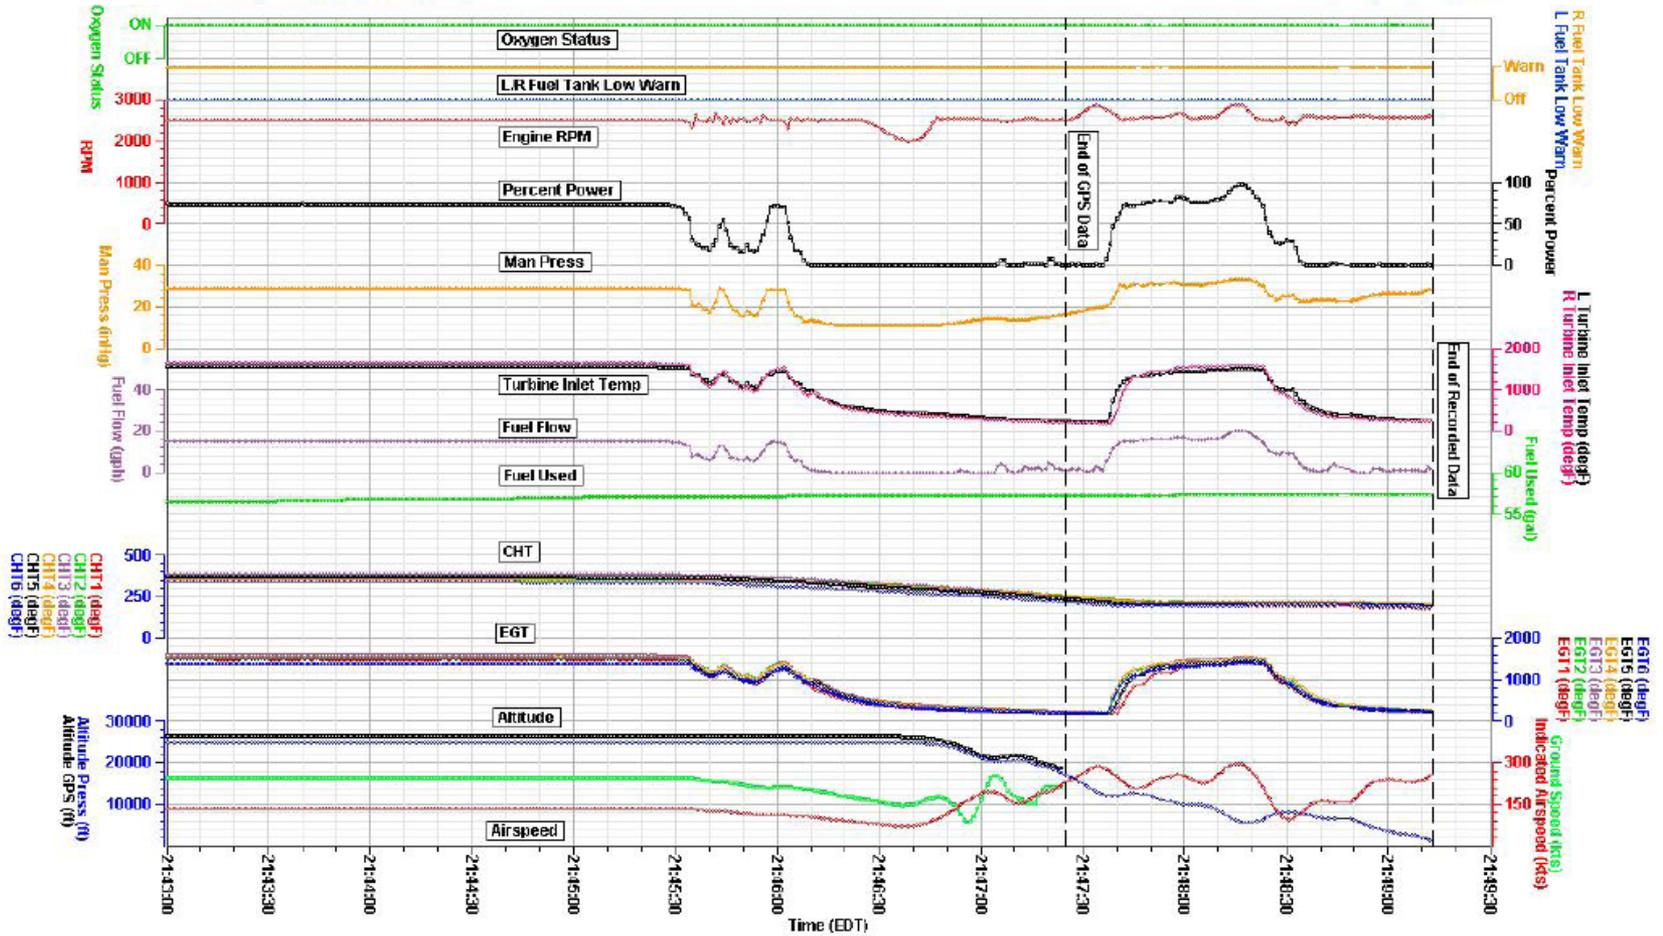
Figure 5

- 2051: overflew EYE at FL250
- Maintained altitude and heading
- 2146: loss of power

Engine parameters over end of accident flight

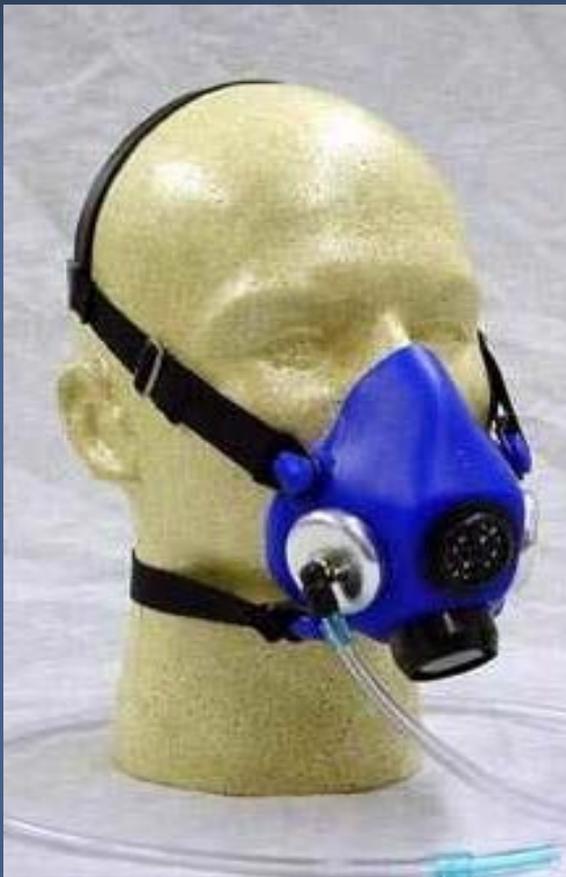
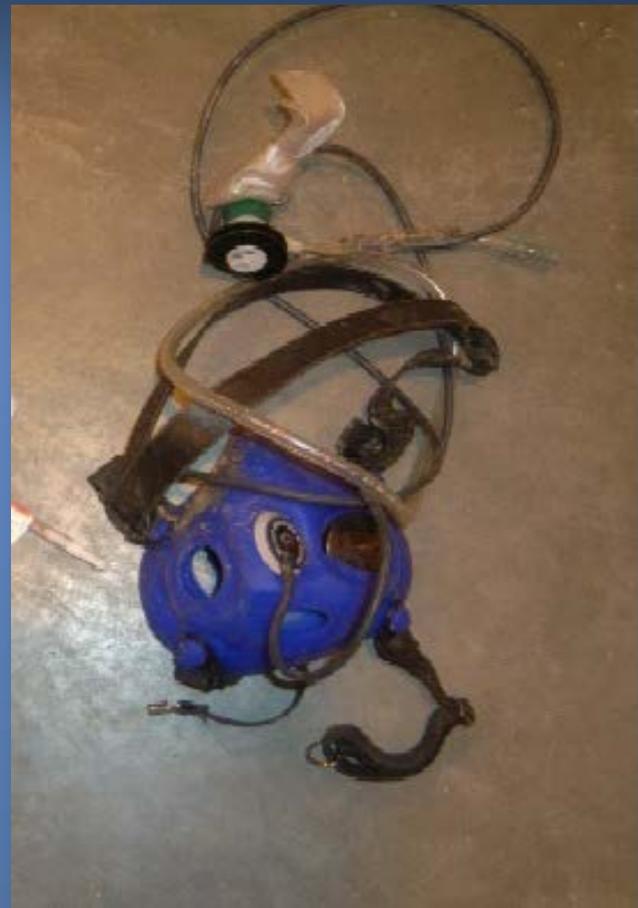
- Equipped with constant-flow O2 system from factory
- Pulse-demand system installed in March 2009 by pilot
- “Plug and play” – in-line regulator
- Pulse-demand masks not equipped with diluter bags

- Known issues with mask fit
- Used pulse oximeter “randomly”
- Attempt to retrofit diluter bag masks
