National Transportation Safety Board Aviation Incident Final Report

Location:	Chicago, IL	Incident Number:	OPS15IA011A
Date & Time:	02/17/2015, 2145 CST	Registration:	
Aircraft:	EMBRAER EMB 145LR	Aircraft Damage:	None
Defining Event:	Runway incursion veh/AC/person	Injuries:	53 None
Flight Conducted Under:

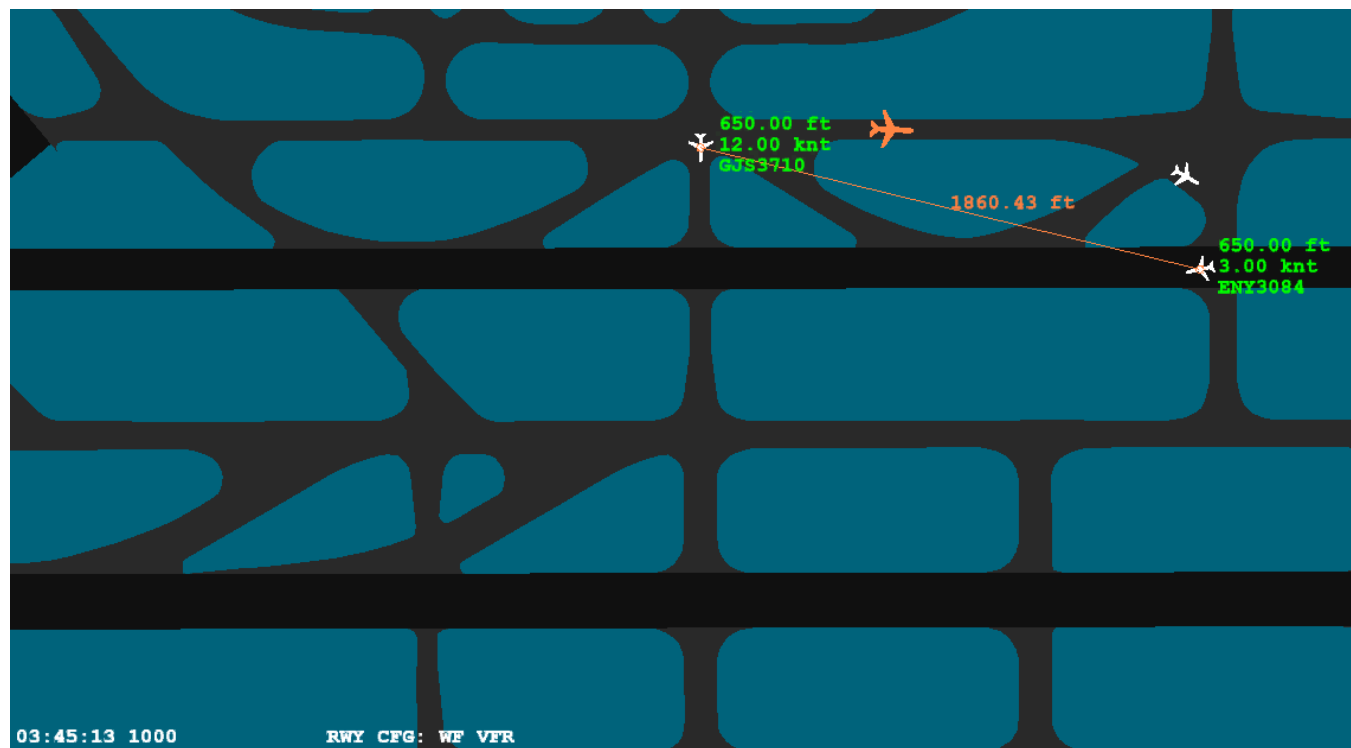
ASDE-X data for this investigation was obtained from the Federal Aviation Administration. Figure 1 shows the ASDE-X presentation just prior to ENY3084 starting takeoff roll. Figure 2 illustrates the ASDE-X presentation as GJS3710 is approaching runway 28 on taxiway F.

Figure 1 – ASDE-X presentation of ENY3084 and GJS3710 at 2145:13.
