# National Transportation Safety Board Aviation Accident Final Report

<b>Location:</b>	Juneau, AK	<b>Accident Number:</b>	ANC15FA049
<b>Date &amp; Time:</b>	07/17/2015, 1318 AKD	<b>Registration:</b>	N62AK
<b>Aircraft:</b>	CESSNA 207A	<b>Aircraft Damage:</b>	Substantial
<b>Defining Event:</b>	Controlled flight into terr/obj (CFIT)	<b>Injuries:</b>	1 Fatal, 4 Serious
<b>Flight Conducted Under:</b>	Part 135: Air Taxi & Commuter - Scheduled

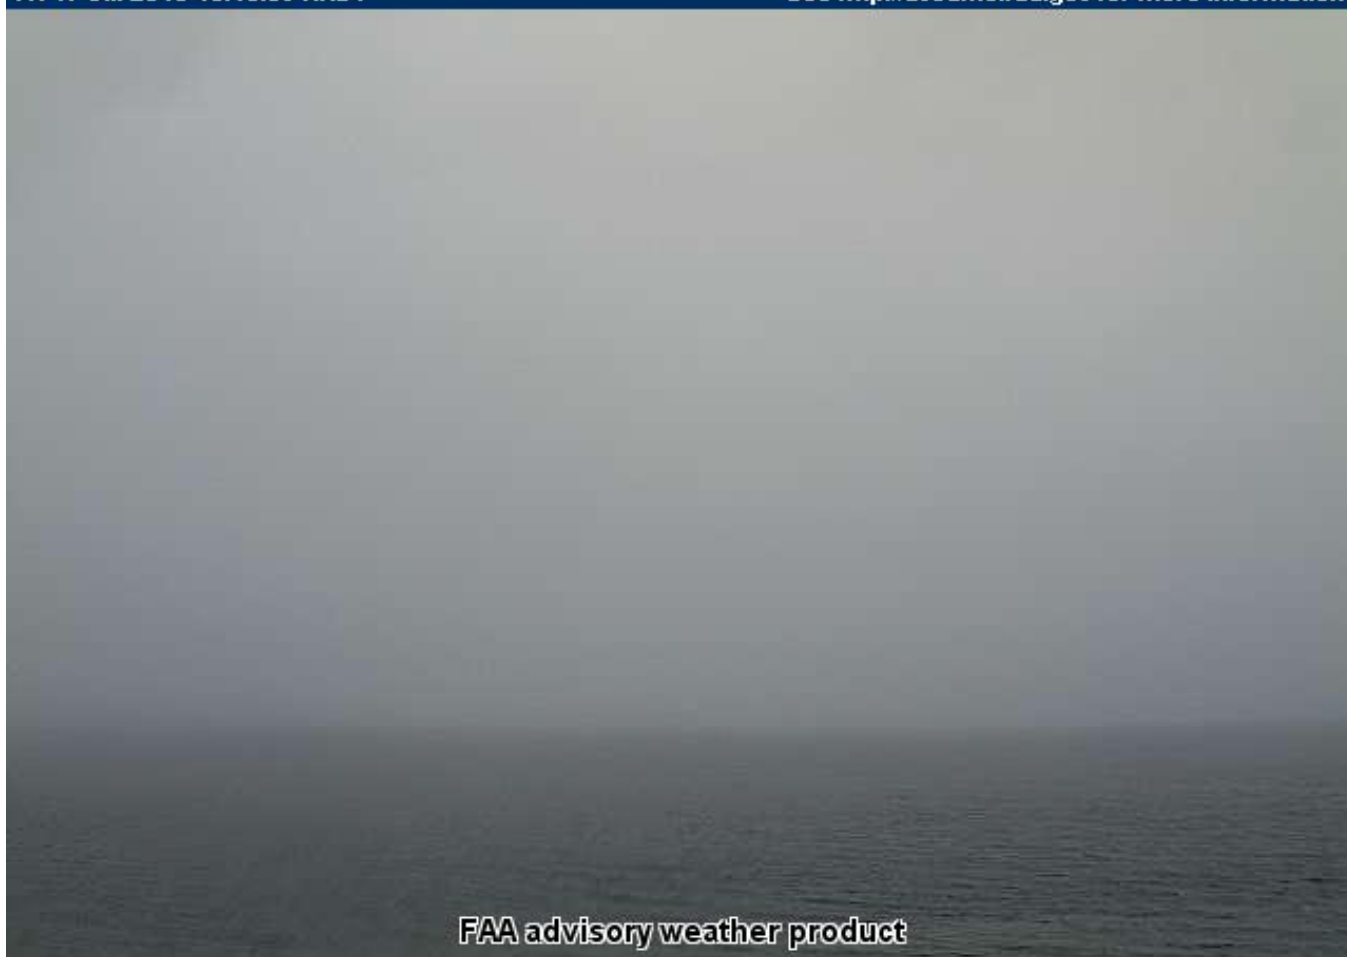
Numerous Federal Aviation Administration (FAA) weather cameras are located in the vicinity of the Juneau Airport. Images from several of the cameras closest to the pilot's flight route were obtained for the period from 1100 to 1600 on the day of the accident. Figure 1 shows an image that was taken about 5 minutes before the estimated accident time, facing the direction of the accident location. (Refer to the Meteorology Group Chairman's Factual Report in the public docket for further weather information and weather camera images.)

Figure. A video camera image showing visibility conditions at Juneau Airport about 5 minutes before the estimated accident time, facing the direction of the accident location.
