National Transportation Safety Board Aviation Accident Final Report

Location:	Juneau, AK	Accident Number:	ANC15FA049
Date & Time:	07/17/2015, 1318 AKD	Registration:	N62AK
Aircraft:	CESSNA 207A	Aircraft Damage:	Substantial
Defining Event:	Controlled flight into terr/obj (CFIT)	Injuries:	1 Fatal, 4 Serious
Flight Conducted Under:	Part 135: Air Taxi & Commuter - Scheduled

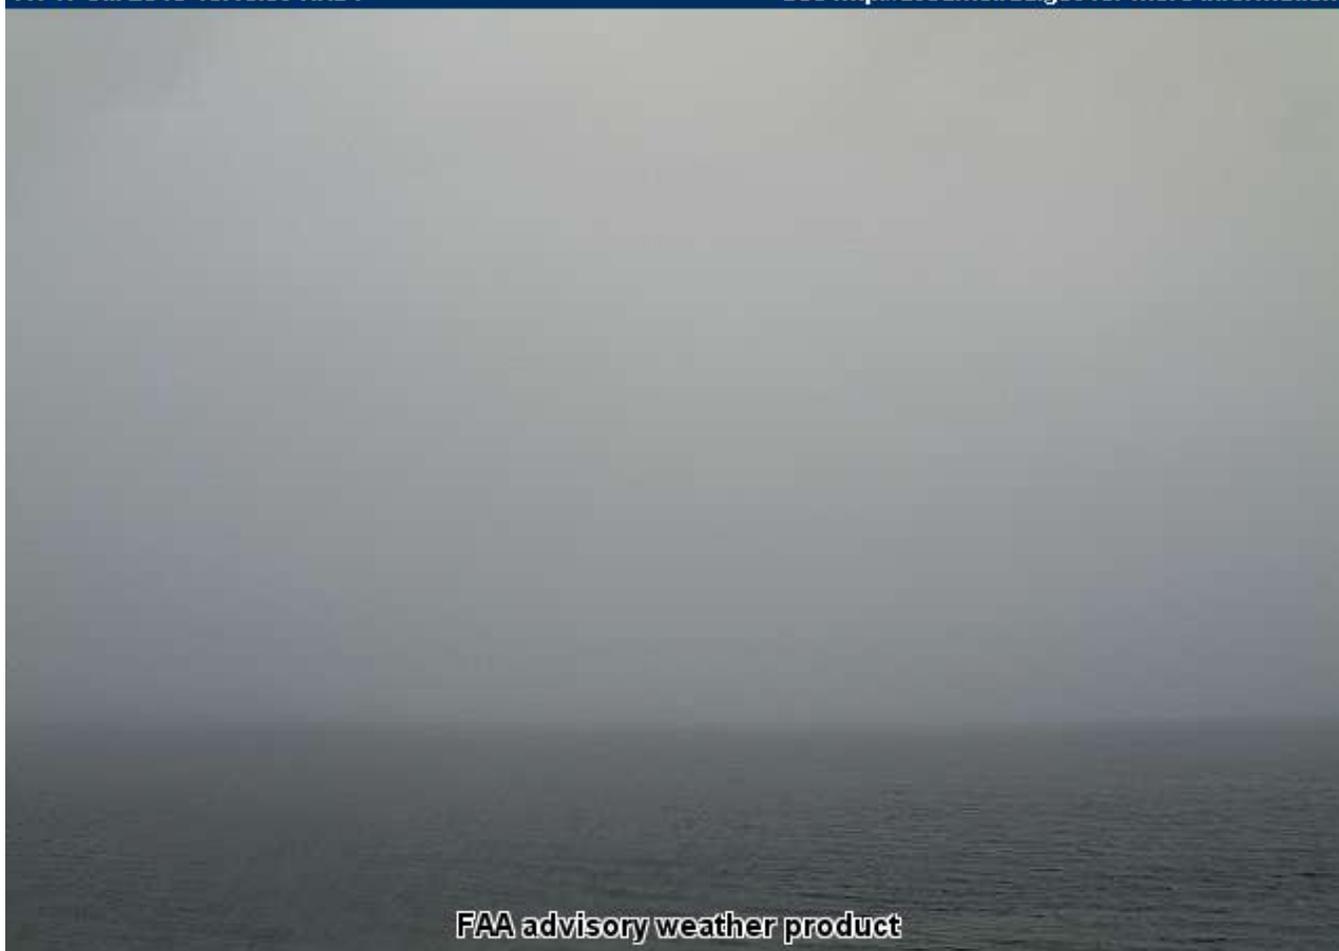
Numerous Federal Aviation Administration (FAA) weather cameras are located in the vicinity of the Juneau Airport. Images from several of the cameras closest to the pilot's flight route were obtained for the period from 1100 to 1600 on the day of the accident. Figure 1 shows an image that was taken about 5 minutes before the estimated accident time, facing the direction of the accident location. (Refer to the Meteorology Group Chairman's Factual Report in the public docket for further weather information and weather camera images.)

Figure. A video camera image showing visibility conditions at Juneau Airport about 5 minutes before the estimated accident time, facing the direction of the accident location.
