# National Transportation Safety Board Aviation Accident Final Report

<b>Location:</b>	Pascagoula, MS	<b>Accident Number:</b>	ERA16LA028
<b>Date &amp; Time:</b>	10/26/2015, 1237 CDT	<b>Registration:</b>	N817PR
<b>Aircraft:</b>	SCHUMACHER Lancair Super ES	<b>Aircraft Damage:</b>	Destroyed
<b>Defining Event:</b>	Windshear or thunderstorm	<b>Injuries:</b>	3 Fatal
<b>Flight Conducted Under:</b>	Part 91: General Aviation - Business

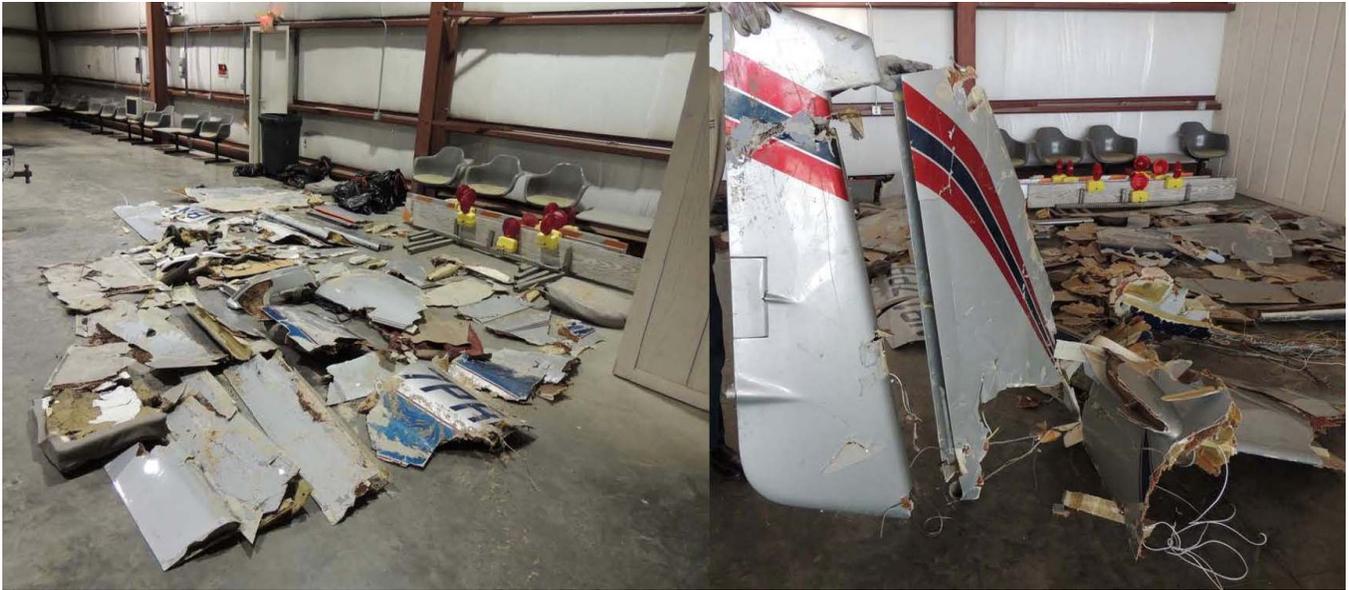
Figure 1. Airplane Wreckage in Hangar.

Fragmented debris from the airplane was subsequently recovered from the water and surrounding beaches. Given the limited amount of wreckage and its severely fragmented condition, no useful information pertaining to the preimpact mechanical condition of the airplane could be obtained from the recovered wreckage. However, the fragmentation of the wreckage is consistent with the airplane impacting the water in an uncontrolled descent, and, based on the flight track and weather data, it is likely that the pilot lost control of the airplane after encountering convective shower activity.

The recovered wreckage was severely fragmented, and significant portions of the airplane, including the engine and propeller were not recovered (see figure 1). The recovered debris was examined by an FAA inspector; however, given the limited wreckage and its condition, the inspector was not able to determine the preimpact mechanical condition of the airplane.

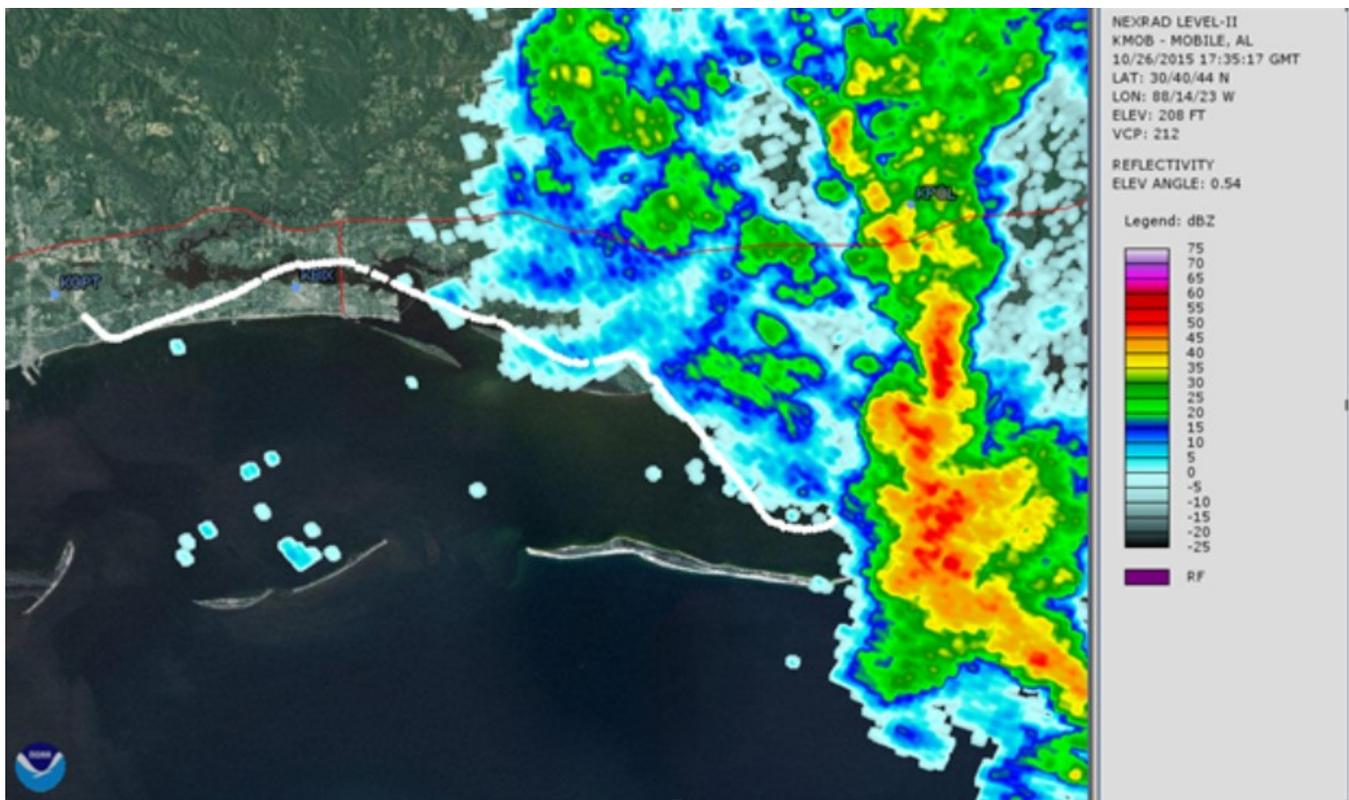
Figure 2. Weather Surveillance Radar with Radar Flight Track Overlay.

Overlaying the airplane's flight track on a photograph of the Mobile, Alabama, weather surveillance radar at 1235 (see figure 2) shows that the airplane flew along the leading edge of echoes of 5 to 15 dBZ (light intensity echoes) and was approaching an area of echoes from 40 to 50 dBZ (heavy intensity echoes) when radar contact was lost.
