National Transportation Safety Board Aviation Accident Final Report

Location:	Apple Valley, CA	Accident Number:	WPR16FA035
Date & Time:	12/06/2015, 1407 PST	Registration:	N39AY
Aircraft:	AERO VODOCHODY L 39C	Aircraft Damage:	Destroyed
Defining Event:	Loss of engine power (total)	Injuries:	2 Fatal
Flight Conducted Under:	Part 91: General Aviation - Personal

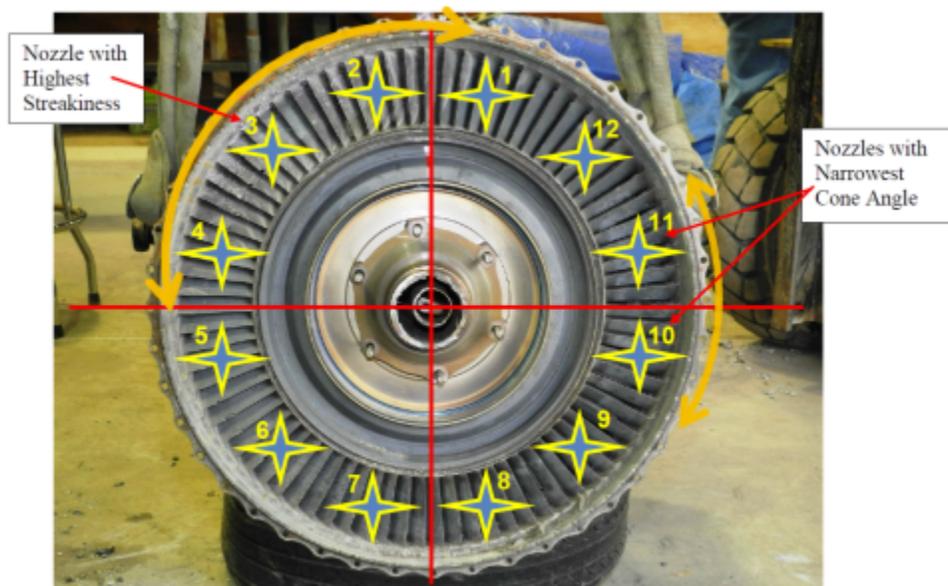
Figure 1 – Fuel Nozzle Locations Overlaid on Damaged 3rd Stage Turbine Nozzle Vanes

The 3rd stage turbine hub was intact, and all blades were present. Two non-consecutive blades were bent. Blade tip shrouds from the 2nd stage turbine and other metal debris were found between the blades and at the bottom of the housing. The 3rd stage turbine nozzle vanes displayed a circumferentially-varying heat distress pattern with the distress most prominent between the 9:00 and 12:30 o'clock positions and the 2:00 and 4:00 o'clock positions.

All of the fuel nozzles failed the factory functional test procedure and would have required overhaul in order to be returned to service. The fuel nozzles were all below allowable factory limits for flow rate and spray pattern. It was noted that fuel nozzle No. 3 had the highest spray pattern variance or streakiness (97%), which matched the location of the thermal distress between 9:00 and 12:30 o'clock on the 3rd stage turbine nozzle vanes. Additionally, fuel nozzles Nos. 10 and 11 had the narrowest spray cone angles (70° and 73°, respectively), which matched the location of the thermal distress between 2:00 and 4:00 o'clock on the 3rd stage turbine nozzle vanes. Figure 1 shows the fuel nozzle locations overlaid on the damaged 3rd stage turbine nozzle vanes. The two orange arcs in the figure highlight the areas of greatest thermal distress on the 3rd state nozzle vanes.

The damage noted on the 2nd and 3rd stage nozzles and turbines was consistent with an over-temperature condition caused by a disturbed combustion process in the combustor due to poor fuel atomization by the fuel nozzles.
