# National Transportation Safety Board Aviation Accident Final Report

<b>Location:</b>	Corinth, MS	<b>Accident Number:</b>	ERA16LA078
<b>Date &amp; Time:</b>	12/24/2015, 0840 CST	<b>Registration:</b>	N891CR
<b>Aircraft:</b>	PIPER AIRCRAFT INC PA-46	<b>Aircraft Damage:</b>	Substantial
<b>Defining Event:</b>	Loss of control in flight	<b>Injuries:</b>	2 Serious, 2 Minor
<b>Flight Conducted Under:</b>	Part 91: General Aviation - Personal

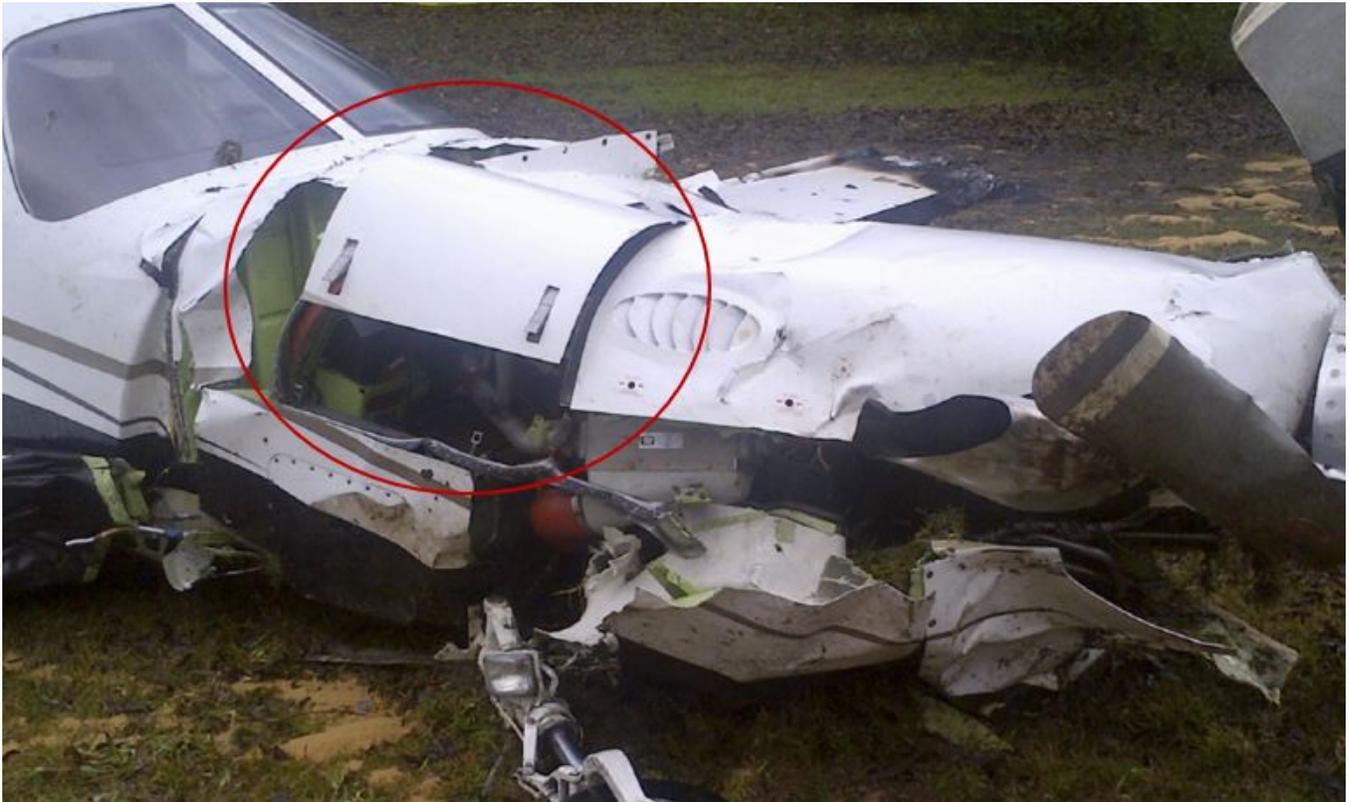
Figure 1 – Right Side Access Door

examination also revealed that the battery charging port cover which was inside the compartment that the right access door allowed access to, had not been placed and secured over the battery charging port, indicating that the preflight inspection had not been properly completed.

The airplane came to rest about 1,792 ft from the departure end of runway 18 on a 132° magnetic heading on the front lawn of a residence. Examination of photographs of the wreckage taken at the accident site revealed that the right cowl door was open (see Figure 1).

The right access door was found open and unlatched with minimal damage noted to the door. The right access door support rod was found lying on top of the battery bay, and the battery charging port cover was not installed over the charging port. A functional check of the right access door latches found them to be functional with no indication of overstress or deformation, and there was no deformation or indication of overstress to the clevis keepers.
