# National Transportation Safety Board Aviation Accident Final Report

<b>Location:</b>	San Pedro, CA	<b>Accident Number:</b>	WPR16FA065A
<b>Date &amp; Time:</b>	02/05/2016, 1500 PST	<b>Registration:</b>	N9872R
<b>Aircraft:</b>	BEECH M35	<b>Aircraft Damage:</b>	Substantial
<b>Defining Event:</b>	Midair collision	<b>Injuries:</b>	2 Fatal
<b>Flight Conducted Under:</b>	Part 91: General Aviation - Personal

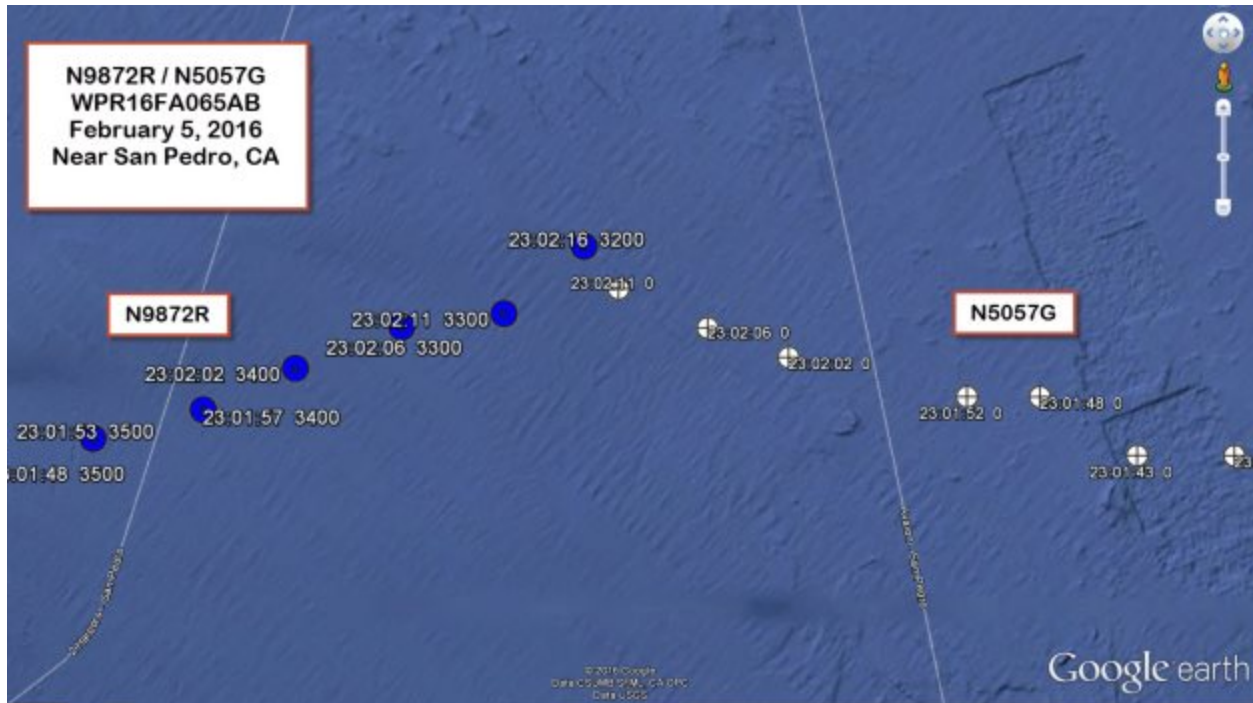
Radar data showed the tracks of both airplanes converge with the airplanes approaching each other nearly head-on. The last radar return from the Beechcraft, just before the collision, was at 3,300 ft. Following the collision, both airplanes descended, impacted the ocean, and sank.

The radar data showed that the Bellanca, departed from TOA on a VFR local area flight about 1430. The pilot flew south toward the coastline, and then generally flew over the ocean south of San Pedro. The airplane's transponder operated intermittently on a 1200 code and reported altitudes between 3,000 and 3,500 ft. Primary radar returns showed that the high-wing Bellanca was on a west-northwest heading at the time of the collision. The radar showed that the tracks of the two airplanes converged with the airplanes approaching each other at a shallow angle that was nearly head-on (see Figure 1.)

Figure 1. Radar tracks of Beechcraft (blue dots, transponder operating) and Bellanca (white dots, transponder not operating) approaching the collision.

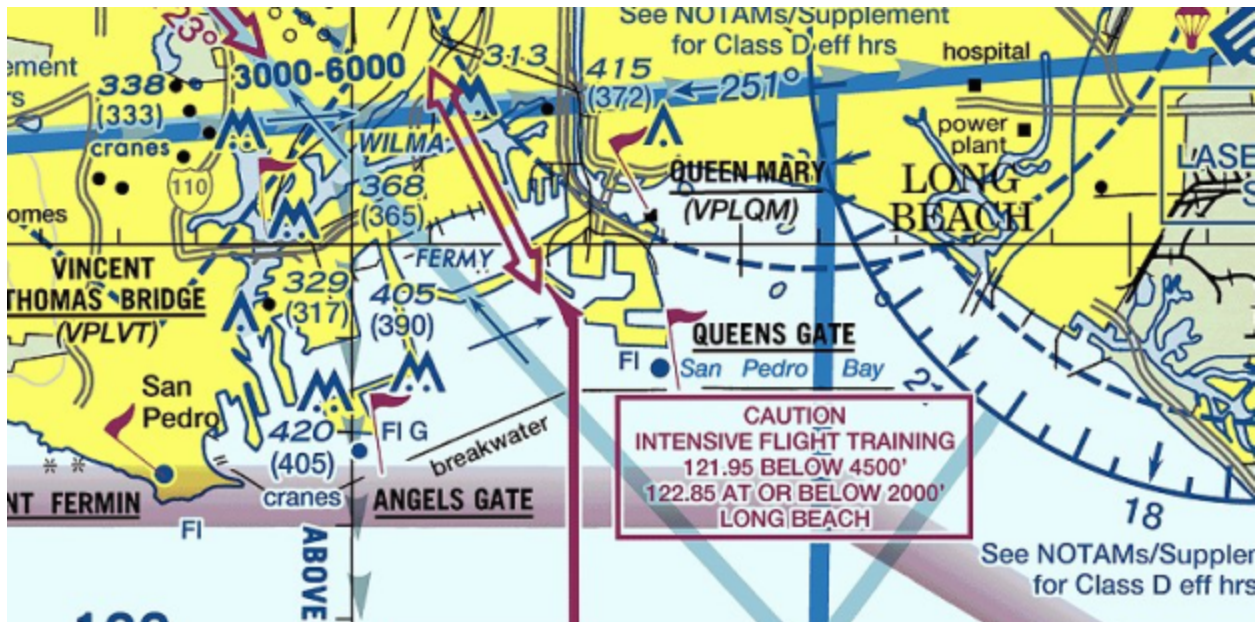
According to the FAA's VFR aeronautical sectional chart for the area that the accident occurred, there is an applicable note outlined in magenta for the area. It's a CAUTION note that identified the area as intensive flight training and indicated radio frequencies to be used by aircraft to establish two-radio communication before entering the class C airspace. The radio frequencies are a best practice for pilots training in those areas, as well as for en route pilots transitioning through the airspace. (See Figure 2)

Figure 2 – FAA Intensive Flight Training area identified and radio frequencies to monitor.
