National Transportation Safety Board Aviation Accident Final Report

Location:	San Pedro, CA	Accident Number:	WPR16FA065B
Date & Time:	02/05/2016, 1500 PST	Registration:	N5057G
Aircraft:	BELLANCA 8KCAB	Aircraft Damage:	Substantial
Defining Event:	Midair collision	Injuries:	1 Fatal
Flight Conducted Under:	Part 91: General Aviation - Personal

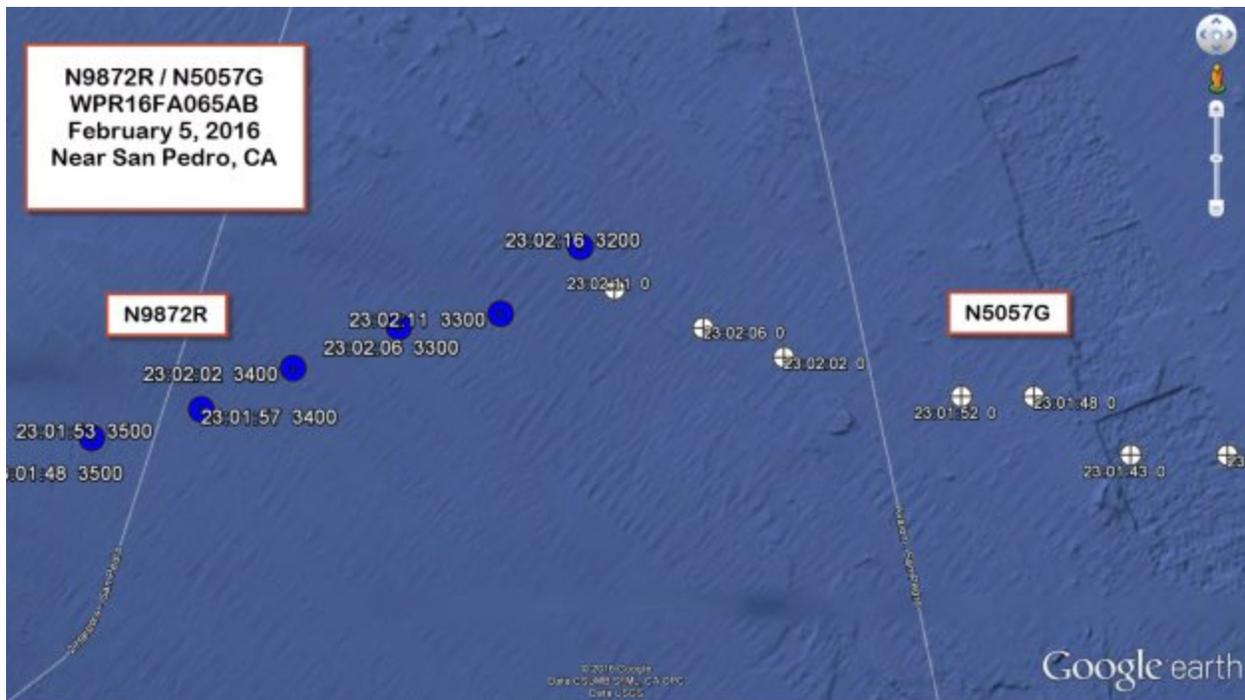
Radar data showed the tracks of both airplanes converge with the airplanes approaching each other nearly head-on. The last radar return from the Beechcraft, just before the collision, was at 3,300 ft. Following the collision, both airplanes descended, impacted the ocean, and sank.

The radar data showed that the Bellanca, departed from TOA on a VFR local area flight about 1430. The pilot flew south toward the coastline, and then generally flew over the ocean south of San Pedro. The airplane's transponder operated intermittently on a 1200 code and reported altitudes between 3,000 and 3,500 ft. Primary radar returns showed that the high-wing Bellanca was on a west-northwest heading at the time of the collision. The radar showed that the tracks of the two airplanes converged with the airplanes approaching each other at a shallow angle that was nearly head-on (see Figure 1.)

Figure 1. Radar tracks of Beechcraft (blue dots, transponder operating) and Bellanca (white dots, transponder not operating) approaching the collision.

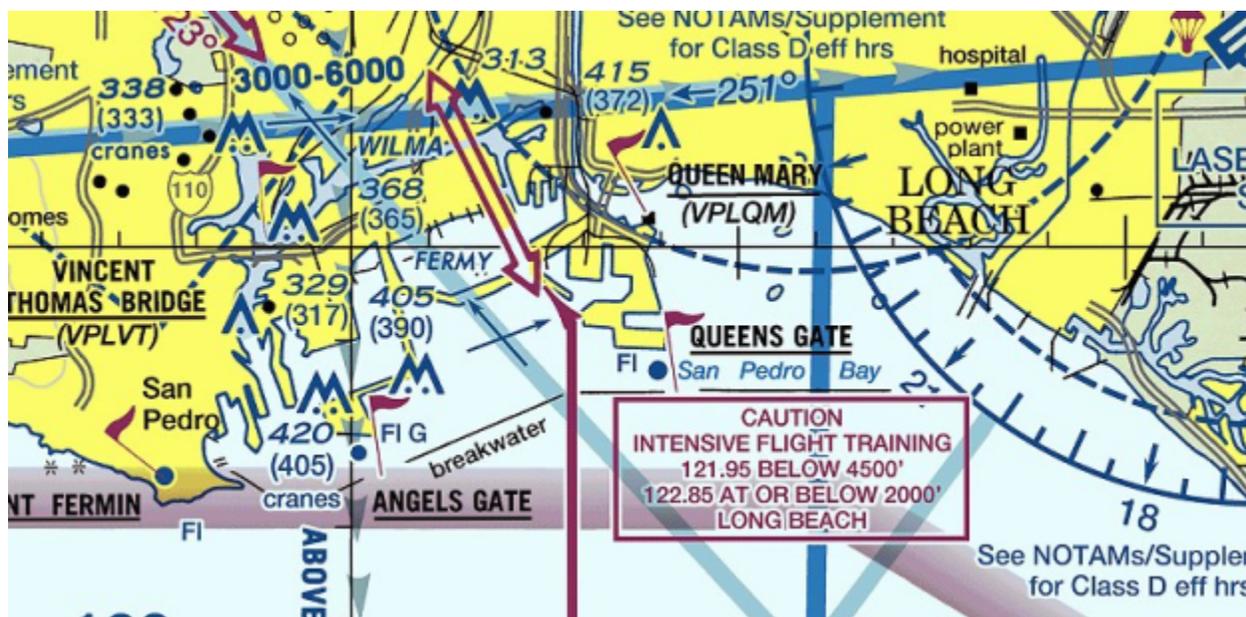
According to the FAA's VFR aeronautical sectional chart for the area that the accident occurred, there is an applicable note outlined in magenta for the area. It's a CAUTION note that identified the area as intensive flight training and indicated radio frequencies to be used by aircraft to establish two-radio communication before entering the class C airspace. The radio frequencies are a best practice for pilots training in those areas, as well as for en route pilots transitioning through the airspace. (See Figure 2)

Figure 2 – FAA Intensive Flight Training area identified and radio frequencies to monitor.
