## National Transportation Safety Board Aviation Accident Factual Report

<b>Location:</b>	Van Nuys, CA	<b>Accident Number:</b>	WPR16FA157
<b>Date &amp; Time:</b>	08/02/2016, 1322 PDT	<b>Registration:</b>	N341AL
<b>Aircraft:</b>	ARION AIRCRAFT LLC LIGHTNING LS-1	<b>Aircraft Damage:</b>	Substantial
<b>Defining Event:</b>	Aerodynamic stall/spin	<b>Injuries:</b>	1 Fatal
<b>Flight Conducted Under:</b>	Part 91: General Aviation - Personal

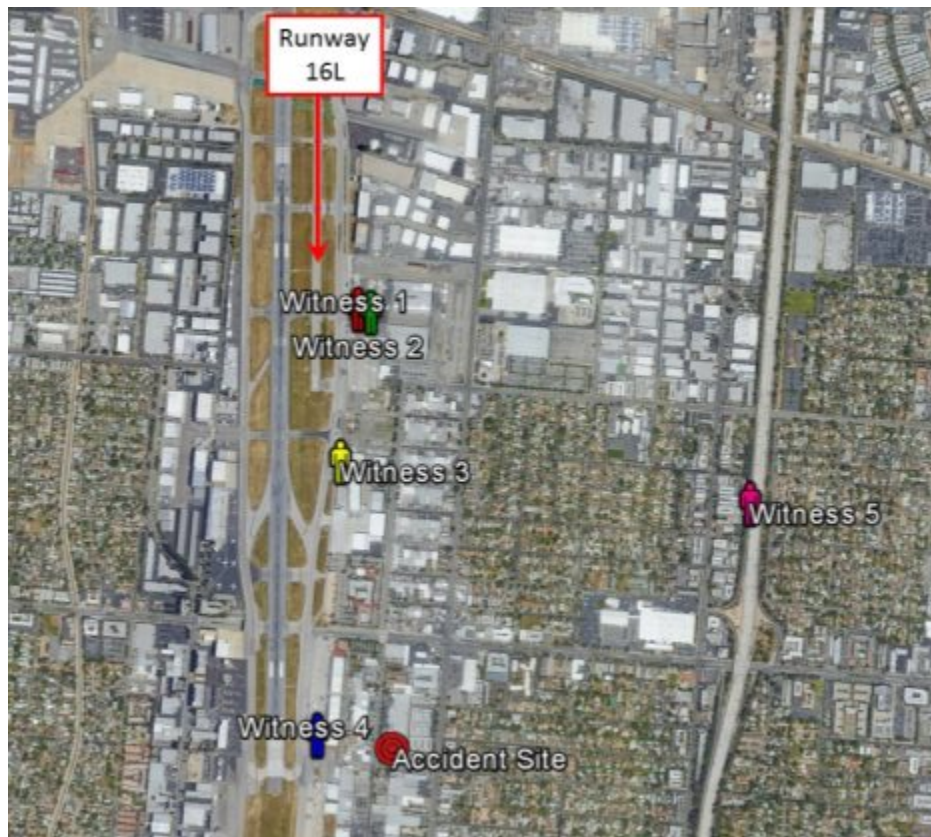
Figure 1 – Witness Locations

Several witnesses observed the airplane during its departure from VNY. One witness (Witness 3 in Figure 1) observed a piece of the left main landing gear hanging from the airplane as it climbed from runway 16L. The airplane then began a left turn from the departure end of the runway that initially looked normal, but then the airplane decelerated. At this time, two

witnesses who had listened to the exchange between the pilot and the controller (Witnesses 1 & 2), reported that, seconds after the pilot's final communication, they observed the airplane enter a hard left turn. One witness described the turn as a "knife edge." The airplane's nose yawed left to a nose-down attitude and the airplane rapidly descended toward the ground. Witness 5, who was a passenger in a helicopter at the time of the accident, reported that the airplane entered the descent from an altitude about 350 ft above ground level and impacted an industrial park below. Witness 4 reported hearing a sputtering engine about 7 seconds before the airplane impacted the ground.
