## National Transportation Safety Board Aviation Accident Factual Report

| <b>Location:</b> | Wickenburg, AZ | <b>Accident Number:</b> | WPR16FA176 |
| <b>Aircraft:</b> | CESSNA 310N | <b>Aircraft Damage:</b> | Substantial |
| <b>Defining Event:</b> | Fuel starvation | <b>Injuries:</b> | 4 Serious |

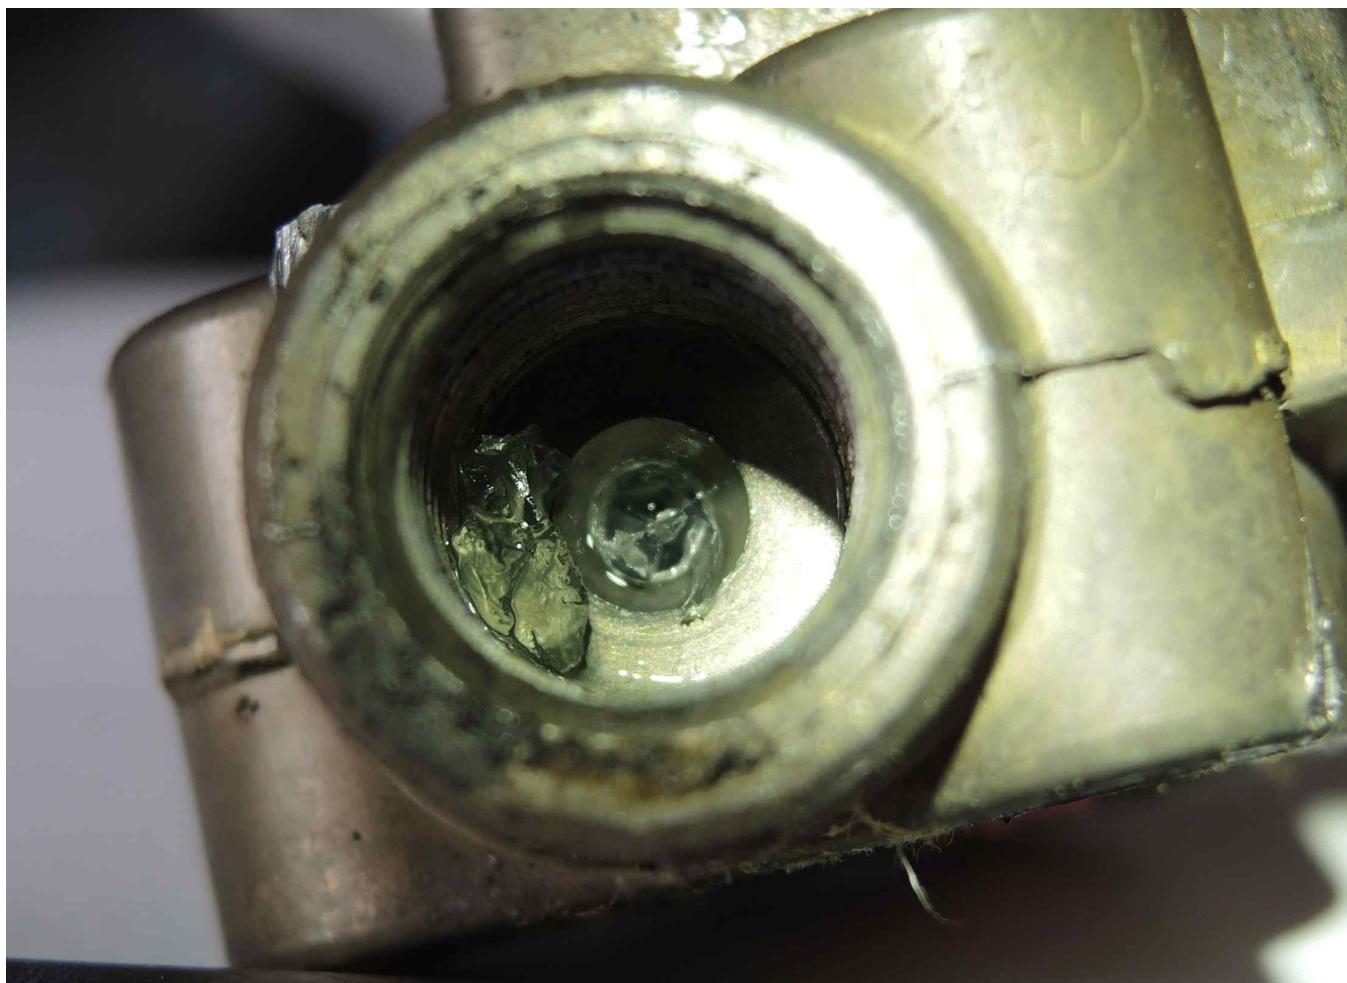
Photo 1 - Fuel Flow Transducer Inlet Port

Disassembly of the fuel lines revealed that a clear gelatinous substance had completely blocked the fuel flow transducer inlet port (metering orifice) (Photo 1). The material was removed, and had a slimy wet texture. After one hour of exposure to air, the material had hardened and took on a texture similar to room-temperature-vulcanization (RTV) silicone. Six fragments were recovered, which, after drying for 24 hours, ranged in size from 1 to 3 mm. Further examination of the fuel manifold valve revealed a similar fragment of the material within the manifold cavity on the pre-filtered side of its screen.

The rubber-like material was sent to the NTSB Materials Laboratory Division for analysis using a Fourier Transform Infrared spectrometer. The results revealed spectral peaks, which when evaluated, were a strong match to polydimethylsiloxane, also known as silicone.
