# National Transportation Safety Board Aviation Accident Final Report

<b>Location:</b>	Wickenburg, AZ	<b>Accident Number:</b>	WPR16FA176
<b>Date &amp; Time:</b>	09/09/2016, 0700 MST	<b>Registration:</b>	N126P
<b>Aircraft:</b>	CESSNA 310N	<b>Aircraft Damage:</b>	Substantial
<b>Defining Event:</b>	Fuel starvation	<b>Injuries:</b>	4 Serious
<b>Flight Conducted Under:</b>	Part 91: General Aviation - Personal

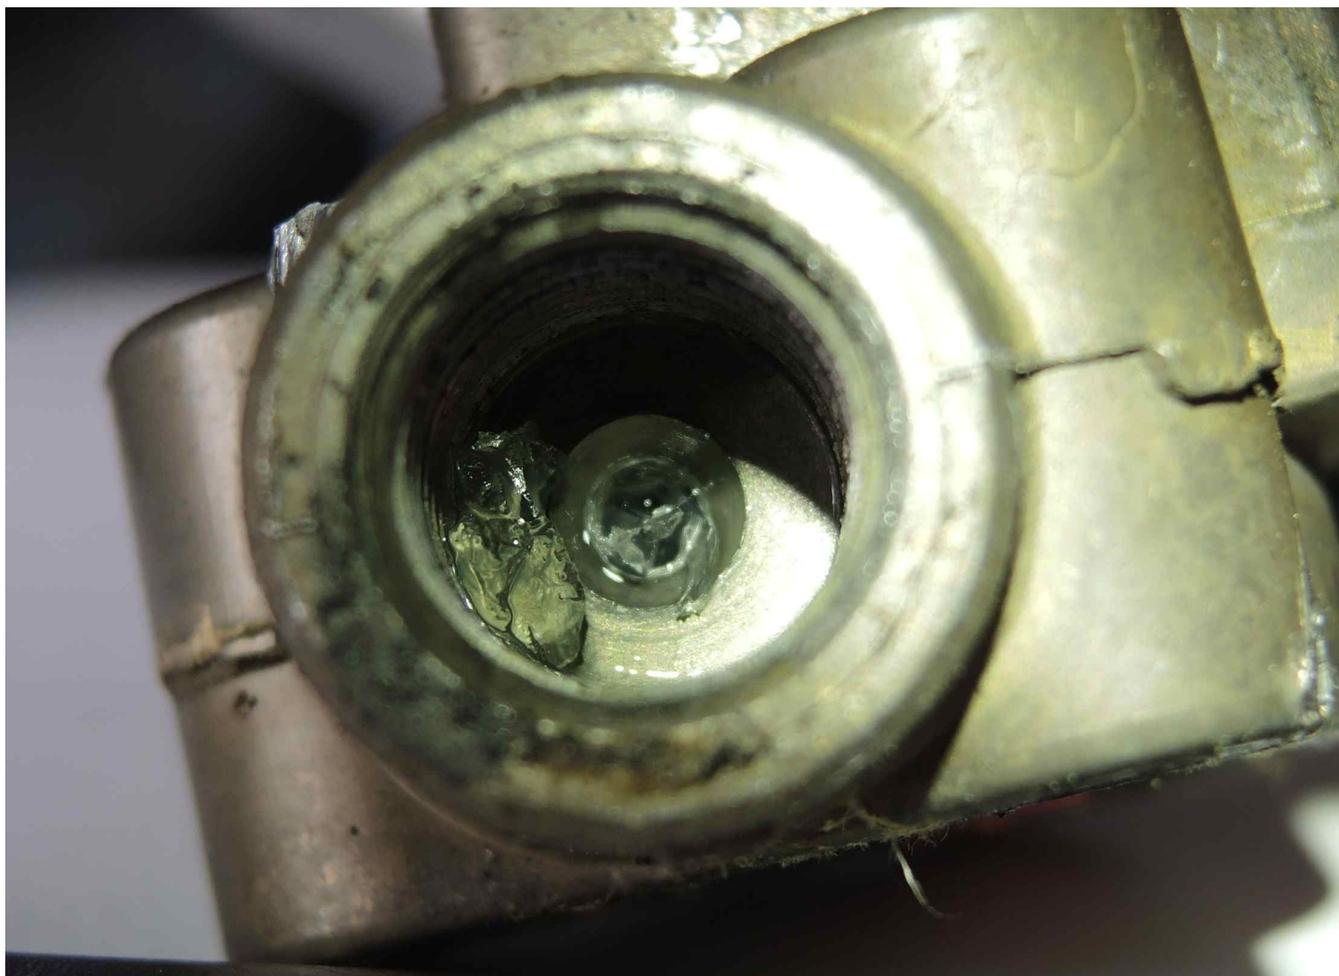
Examination of the right engine revealed that a clear, gelatinous substance had blocked the inlet port of the fuel flow transducer, leading to fuel starvation. The substance was determined to be silicone, most likely room-temperature-vulcanization silicone sealant. There were no indications that this material had been used anywhere within the fuel system, nor were there any signs of recent maintenance that could have resulted in the introduction of this contaminant. To get to the fuel flow transducer, the silicone would have had to pass through multiple fine mesh filters, which was unlikely based on the material's size when dry. However, silicone becomes semi-soluble once in contact with aviation gasoline, and it is possible that it was extruded through the filters in this state, and eventually coalesced in the flow divider inlet port. Smaller fragments of the silicone were found in the fuel manifold valve, beyond the flow divider, and a fuel injector valve port was partially occluded, possibly with the same material.

Total loss of power to the right engine during takeoff due to a fuel contaminant, which blocked the fuel flow transducer and resulted in fuel starvation to the engine.

Disassembly of the fuel lines revealed that a clear gelatinous substance had completely blocked the fuel flow transducer inlet port (metering orifice) (Photo 1). The material was removed, and had a slimy wet texture. After one hour of exposure to air, the material had hardened and took on a texture similar to room-temperature-vulcanization (RTV) silicone. Six fragments were recovered, which, after drying for 24 hours, ranged in size from 1 to 3 mm. Further examination of the fuel manifold valve revealed a similar fragment of the material within the manifold cavity on the pre-filtered side of its screen.

Photo 1 - Fuel Flow Transducer Inlet Port

The rubber-like material was sent to the NTSB Materials Laboratory Division for analysis using a Fourier Transform Infrared spectrometer. The results revealed spectral peaks, which when evaluated, were a strong match to polydimethylsiloxane, also known as silicone.
