National Transportation Safety Board Aviation Accident Final Report

Location:	Reno, NV	Accident Number:	WPR16LA185A
Date & Time:	09/18/2016, 1118 PDT	Registration:	N616DH
Aircraft:	HOOVER DAVID ARNOLD AR 6	Aircraft Damage:	Substantial
Defining Event:	Collision during takeoff/land	Injuries:	1 None
Flight Conducted Under:	Part 91: General Aviation - Air Race/Show

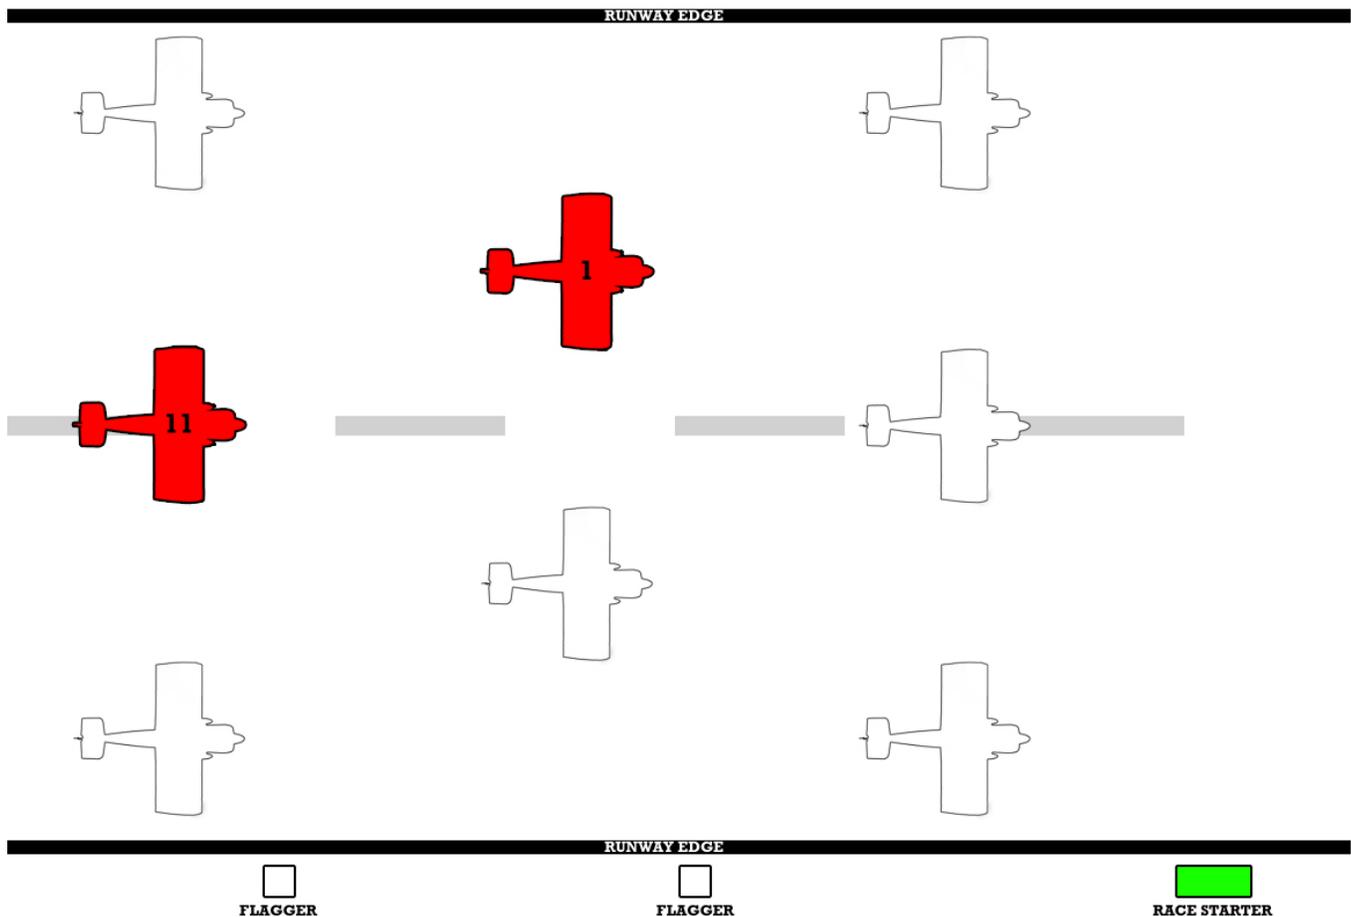
Figure 1: Formula One Staggered Race Start Diagram with Race 1 and 11 and Flagger Locations Depicted

The race heat consisted of 8 airplanes, each positioned in a staggered formation on the runway. Figure 1 depicts the position of each airplane prior to the race start. Flaggers were located to the right of each row on the runway edge. Additionally, a race start flagger was located on the right side of the runway, in front of the first row of airplanes. Prior to the race start, all of the airplanes are at takeoff power, waiting for the race start signal. The race start is signaled by the race start flagger raising and subsequently dropping a green flag along with flaggers on the second and third row raising and dropping white flags.

The flagger, who was positioned on the second row as depicted in figure 1, reported that everything seemed to appear normal leading up to the race start. He observed the second row "Red Flagger" hold up one finger indicating the one-minute time hack and then getting a firm thumbs up from each of the two pilots positioned in the second row. The flagger stated that his attention then turned to the Reno Starter Position, who was located past the front row of aircraft and that he observed the green flag being raised and the red flag being lowered; he followed by raising his green flag. Seconds later, the Reno Starter dropped the green flag and he followed by dropping his green flag drop in sequence with the Reno Starter and proceeded to run several yards back to clear himself away from the runway. The flagger stated that when he turned around to view the runway, he saw Race 1 stationary on the runway and Race 11 directly behind his position. A second later, the collision occurred.
