National Transportation Safety Board Aviation Accident Final Report

Location:	Reno, NV	Accident Number:	WPR16LA185B
Date & Time:	09/18/2016, 1118 PDT	Registration:	N913FT
Aircraft:	REBERRY BRIAN 3M1C1R	Aircraft Damage:	Substantial
Defining Event:	Collision during takeoff/land	Injuries:	1 Minor
Flight Conducted Under:	Part 91: General Aviation - Air Race/Show

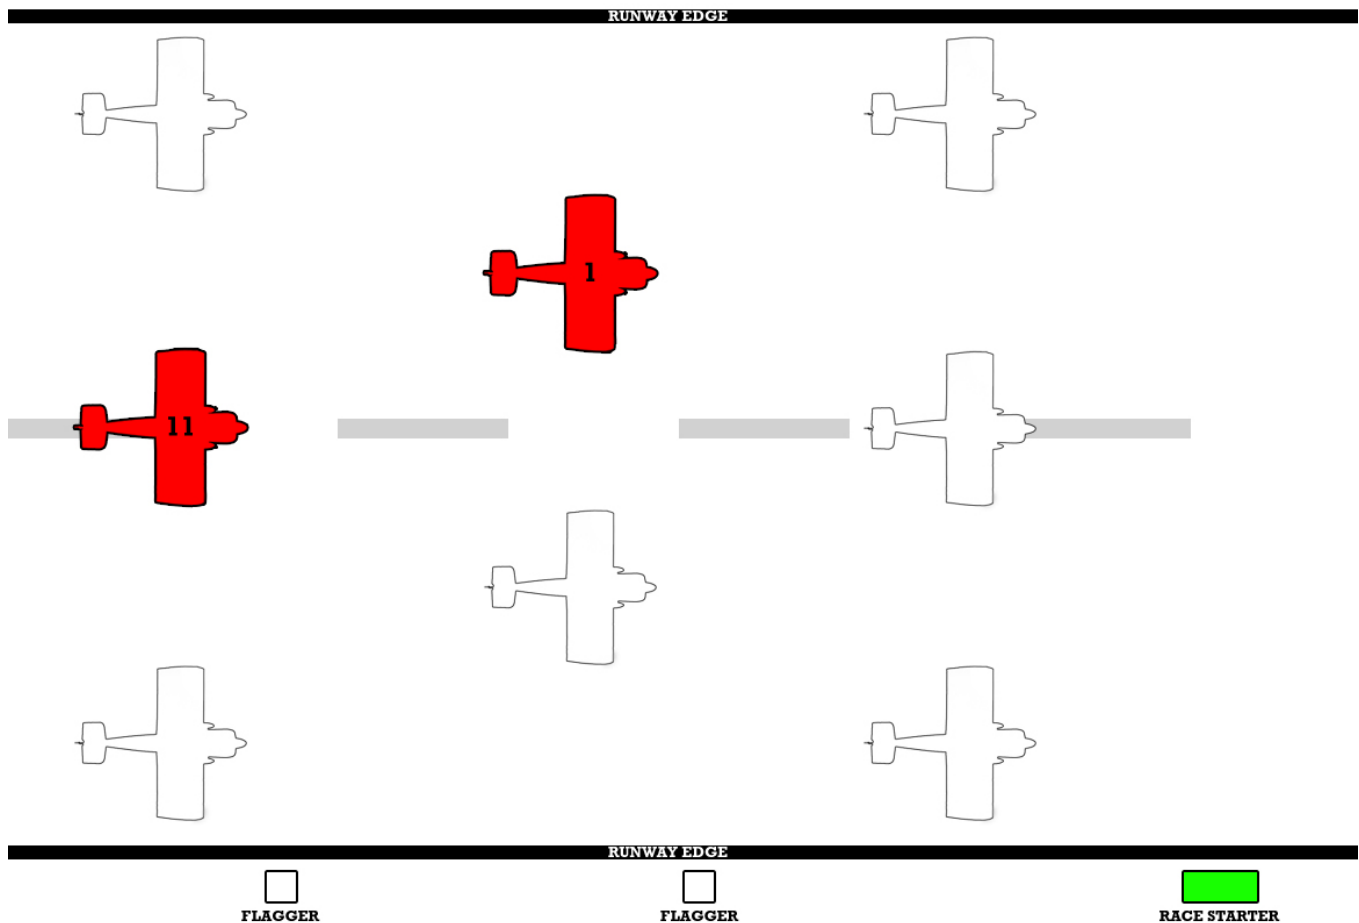
Figure 1: Formula One Staggered Race Start Diagram with Race 1 and 11 and Flagger Locations Depicted

The race heat consisted of 8 airplanes, each positioned in a staggered formation on the runway. Figure 1 depicts the position of each airplane prior to the race start. Flaggers were located to the right of each row on the runway edge. Additionally, a race start flagger was located on the right side of the runway, in front of the first row of airplanes. Prior to the race start, all of the airplanes are at takeoff power, waiting for the race start signal. The race start is signaled by the race start flagger raising and subsequently dropping a green flag along with flaggers on the second and third row raising and dropping white flags.

The flagger, who was positioned on the second row as depicted in figure 1, reported that everything seemed to appear normal leading up to the race start. He observed the second row "Red Flagger" hold up one finger indicating the one-minute time hack and then getting a firm thumbs up from each of the two pilots positioned in the second row. The flagger stated that his attention then turned to the Reno Starter Position, who was located past the front row of aircraft and that he observed the green flag being raised and the red flag being lowered; he followed by raising his green flag. Seconds later, the Reno Starter dropped the green flag and he followed by dropping his green flag drop in sequence with the Reno Starter and proceeded to run several yards back to clear himself away from the runway. The flagger stated that when he turned around to view the runway, he saw Race 1 stationary on the runway and Race 11 directly behind his position. A second later, the collision occurred.
