National Transportation Safety Board Aviation Accident Final Report

Location:	Austin, PA	Accident Number:	ERA17FA017
Date & Time:	10/16/2016, 1957 EDT	Registration:	C-GYSN
Aircraft:	PIPER PA28	Aircraft Damage:	Destroyed
Defining Event:	Abrupt maneuver	Injuries:	3 Fatal
Flight Conducted Under:	Part 91: General Aviation - Personal

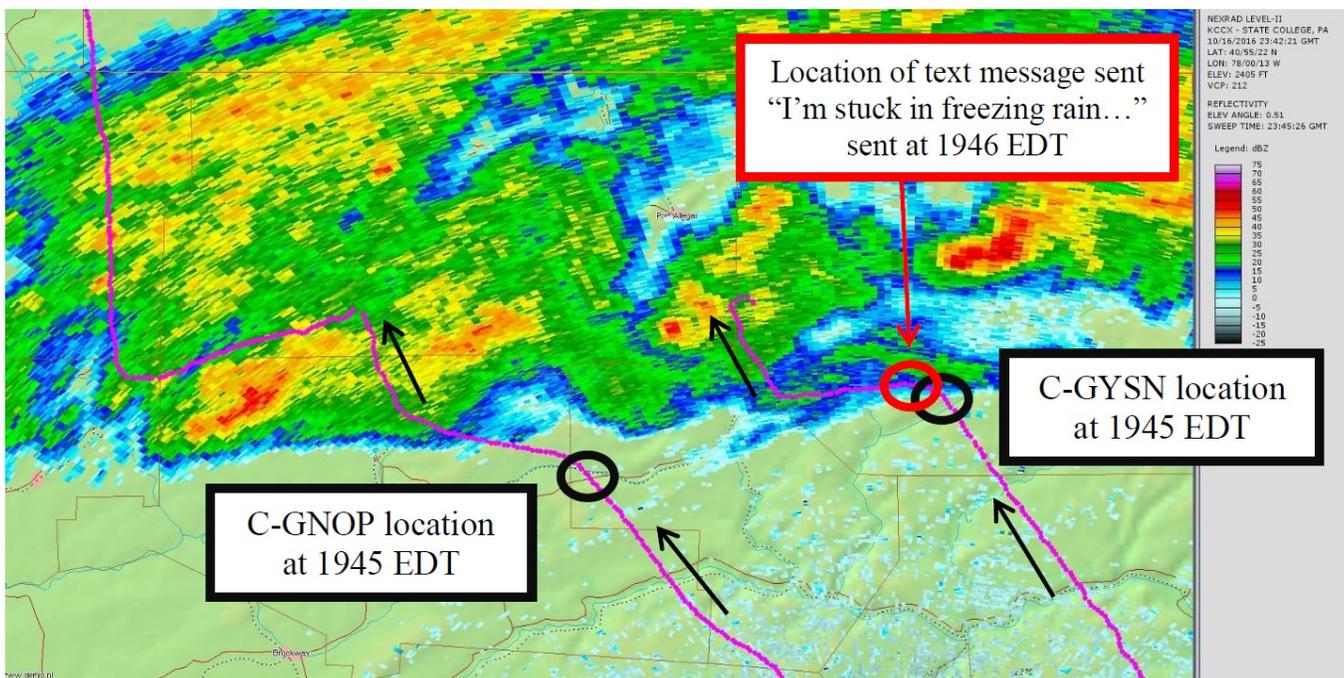
Figure 1: Locations and Flight Path of the Accident Airplane and other Flying Club Airplane (C-GNOP)

About 1946, while flying about 6,000 ft mean sea level (msl) in clouds at the southern edge of a frontal system, the rear seat passenger sent a text message to a friend that the airplane was "...stuck in freezing rain...." The flight continued west, and at 1951:02, the controller advised the accident pilot that the other flying club airplane, located about 20 miles ahead of his location at 6,000 ft msl, reported light rain and smooth ride conditions (see figure 1). About 1952, the accident airplane conducted a right standard rate turn (about 3° per second) onto a north-northwesterly heading while maintaining about 6,000 ft msl, and remained on that heading until about 1956:15.

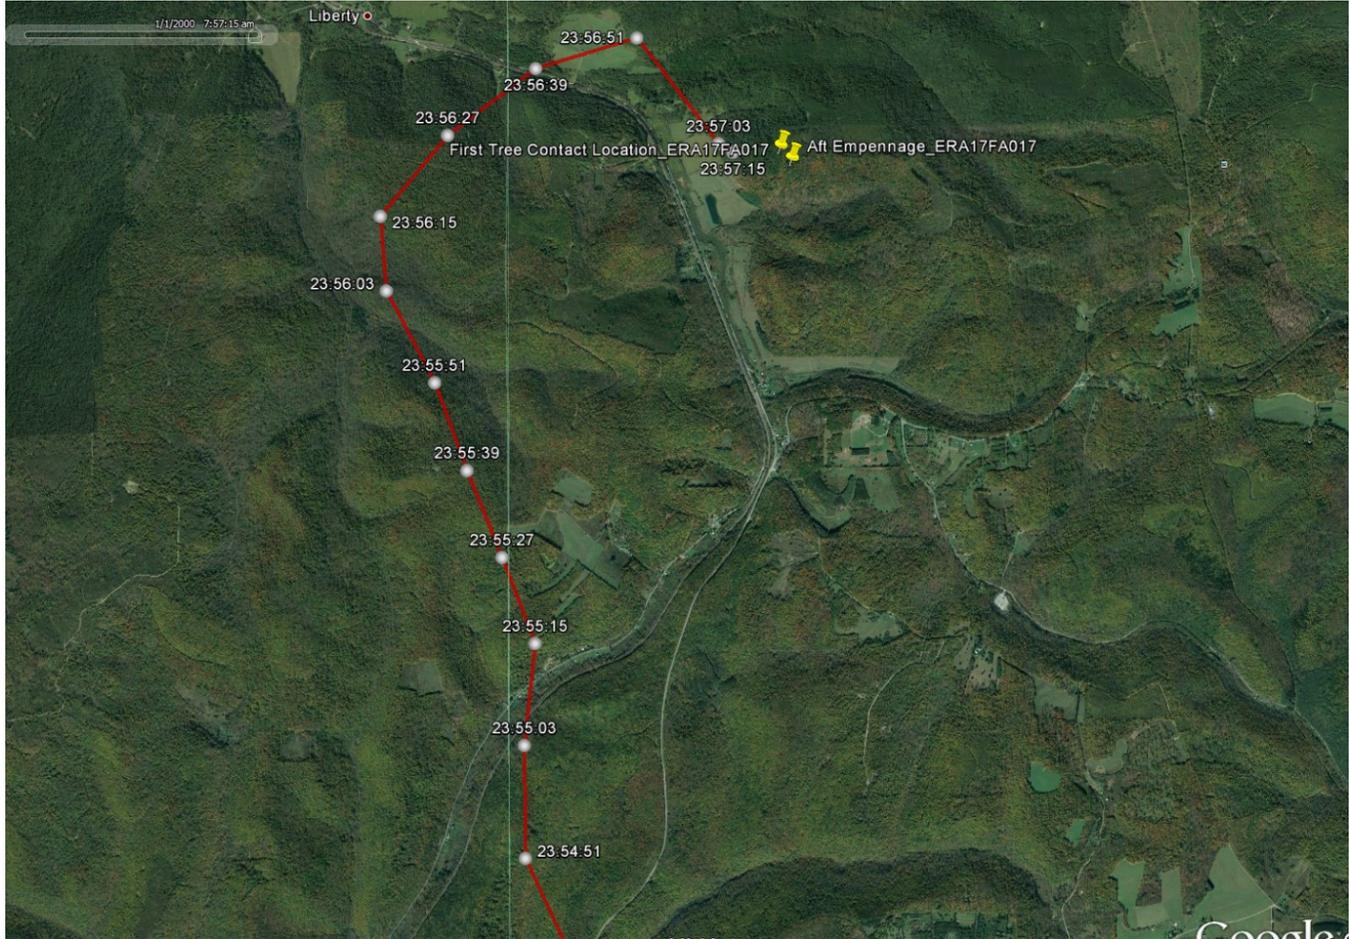
Figure 2: Radar Track Depicting the End of the Flight.

About 1956:15, the accident airplane conducted a right turn to a northeasterly direction at its cruise altitude and remained on that general heading until 1956:51, when it began another right turn. The last radar targets with recorded altitude indicated a heading change from 074° to 142°, and descent from 6,000 to 5,500 ft msl, which correlated to an average descent rate of 2,500 ft per minute, and a 5.6°-per-second rate of turn (see figure 2). The controller attempted to contact the airplane at 1957:11; there was no reply. Following the loss of radar and radio contact, air traffic control personnel alerted local authorities who initiated a search for the airplane. The wreckage was located by a Pennsylvania State Police helicopter during an aerial search the following day.
