National Transportation Safety Board Aviation Accident Factual Report

Location:	Port Orange, FL	Accident Number:	ERA17FA074
Date & Time:	12/27/2016, 1756 EST	Registration:	N669WR
Aircraft:	INDEPENDENT TECHNOLOGIES INC EPIC LT	Aircraft Damage:	Substantial
Defining Event:	Loss of control in flight	Injuries:	2 Fatal
Flight Conducted Under:	Part 91: General Aviation - Personal

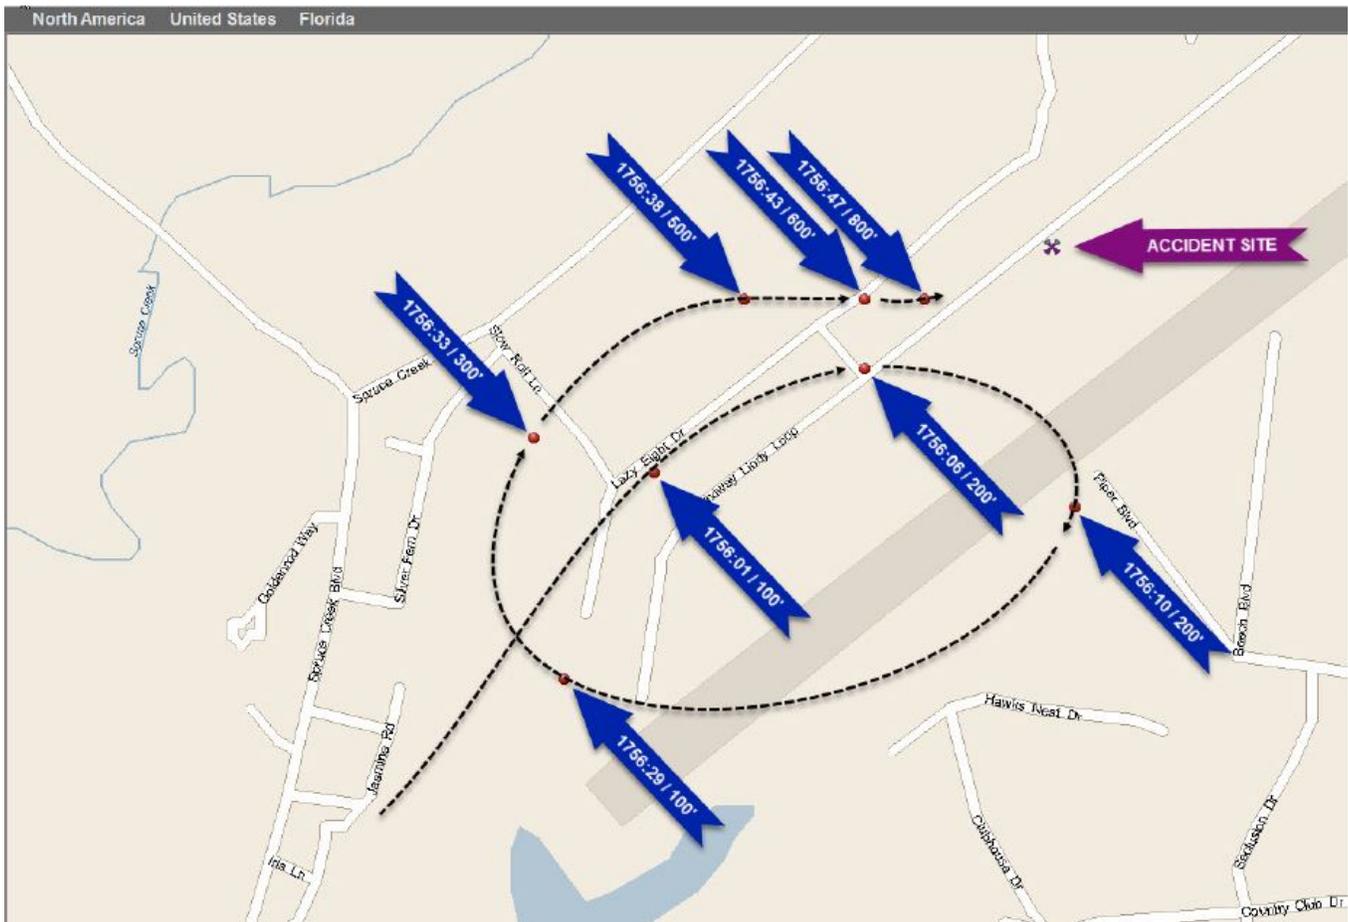
A review of radar data revealed that, during the final 46 seconds of flight, the airplane approached the airport on a northeasterly heading just north of the final approach course. At 1756:01, the airplane was abeam the runway numbers at an altitude of 100 ft mean sea level (msl) (76 ft above ground level) before it initiated a climbing right turn. During the turn, the airplane initially climbed to 200 ft msl then descended to 100 ft msl before climbing up to 300 ft. After completing a 360° turn, the airplane began to climb on a northeasterly heading. Over the next 14 seconds, the airplane climbed to 800 ft, while making a shallow turn to the right followed by a turn to the left before the data ended at 1756:47. The last radar return was near-coincident with the location of the accident site (See figure 1).

Figure 1. Radar Flight Track of Attempted Landing at 7FL6.
