# National Transportation Safety Board Aviation Accident Final Report

<b>Location:</b>	Chauvin, LA	<b>Accident Number:</b>	CEN17FA112
<b>Date &amp; Time:</b>	02/27/2017, 1033 CST	<b>Registration:</b>	N1371
<b>Aircraft:</b>	BELL 407	<b>Aircraft Damage:</b>	Destroyed
<b>Defining Event:</b>	Controlled flight into terr/obj (CFIT)	<b>Injuries:</b>	1 Fatal
<b>Flight Conducted Under:</b>	Part 91: General Aviation - Positioning

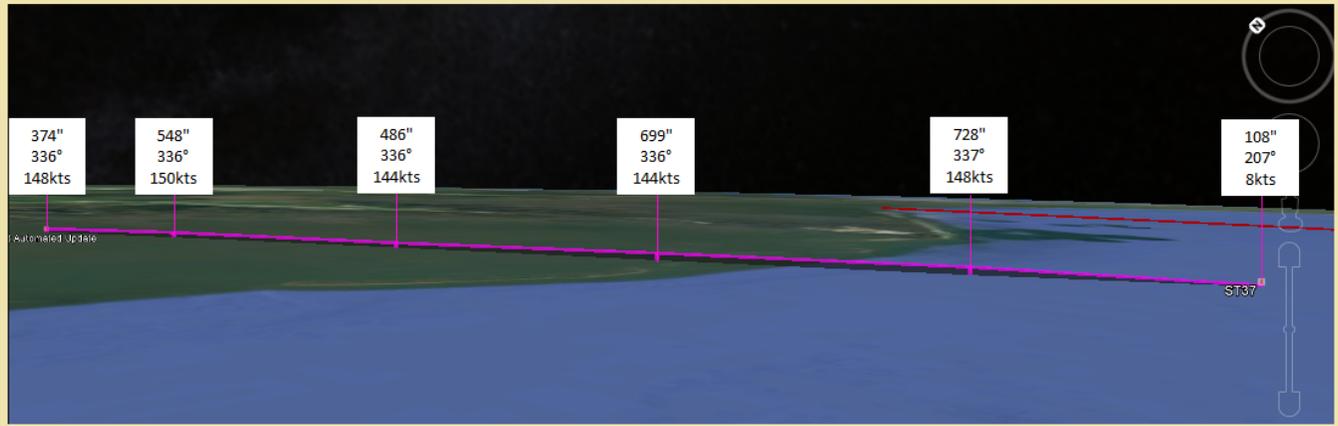
Figure. Sky Connect Flight Path

The helicopter was equipped with an on-board flight tracking system (Sky Connect). After takeoff from ST37, six flight path data points were recorded at 2-minute intervals and showed the helicopter on a northwest heading. Sky Connect data showed the flight path of the helicopter flying direct toward HUM on a northwest heading. Sky Connect Flight Path Data Points:

- 1 Heading 207 degrees, altitude 108 feet, ground speed 8 knots (ST37 Departure)
- 2 Heading 337 degrees, altitude 728 feet, ground speed 148 knots
- 3 Heading 336 degrees, altitude 699 feet, ground speed 144 knots
- 4 Heading 336 degree, altitude 486 feet, ground speed 144 knots
- 5 Heading 336 degrees, altitude 548 feet, ground speed 150 knots
- 6 Heading 336 degrees, altitude 374 feet, ground speed 148 knots (Last Recorded Point)

The figure shows the helicopter's altitude, heading, and ground speed; ST37 is located at the right of the figure. The last Sky Connect data point was at 1024, indicating an altitude of 374 ft and ground speed of 148 knots. Sky Connect issued an "Overdue" alarm at 1033. At 1103, company flight monitoring personnel dispatched a search helicopter, and the wreckage was found at 1135 about 15 miles south-southeast of HUM.
