National Transportation Safety Board Aviation Accident Final Report

Location:	Hayden, AL	Accident Number:	ERA17FA136
Date & Time:	03/25/2017, 1433 CDT	Registration:	N6563D
Aircraft:	CESSNA T210	Aircraft Damage:	Destroyed
Defining Event:	Loss of control in flight	Injuries:	4 Fatal
Flight Conducted Under:	Part 91: General Aviation - Personal

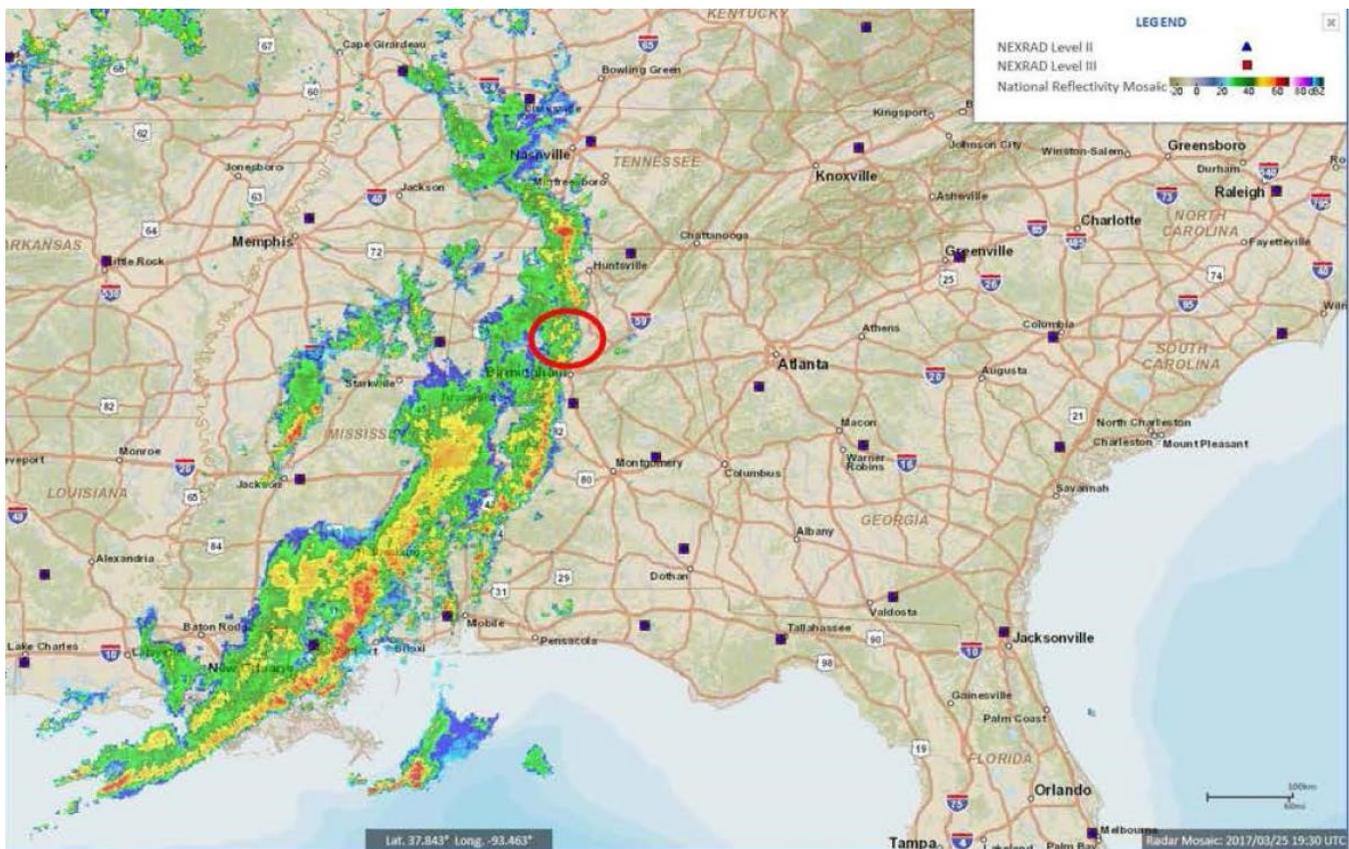
Figure 1: National Radar Mosaic

Weather radar depicted a line of echoes in the immediate vicinity of the accident site, which is enclosed in the red circle (see figure 1), the echoes were immediately west of Birmingham, Alabama at the time. A second more defined line of intense echoes associated with the squall line extended behind the first line from southeast Mississippi, to southeastern Louisiana, and into the Gulf of Mexico. A third area was located behind the two lines west through north of Jackson, Mississippi with an area of intense echoes.

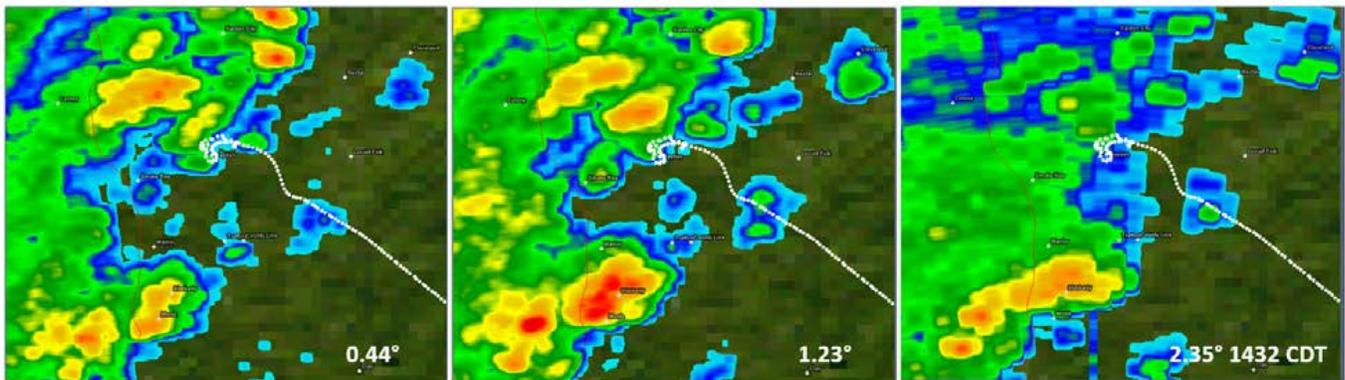
Figure 2: Birmingham WSR-88D Base Reflectivity Images

Figure 2 depicts the airplane's flight track overlaid on the Birmingham WSR-88D base reflectivity image for 1432 with reflectively elevation angle scans at 0.44°, 1.23° and 2.35°; respectively. Echoes of 5 to 35 dBZ or light to moderate intensity echoes along the flight track were present at all elevation scans with echoes of 45dBZ or heavy intensity echoes present within 5 miles northwest of the flight track. A strong intensity echo with reflectivity of 55dBZ or extreme intensity echoes south-southwest of the accident site was beginning to develop or surge upwards and move to the north-northeast.
