National Transportation Safety Board Aviation Accident Final Report

Location:	Micanopy, FL	Accident Number:	ERA17FA145
Date & Time:	04/04/2017, 0908 EDT	Registration:	N155CL
Aircraft:	Pipistrel Virus SW	Aircraft Damage:	Destroyed
Defining Event:	Windshear or thunderstorm	Injuries:	1 Fatal
Flight Conducted Under:	Part 91: General Aviation - Personal

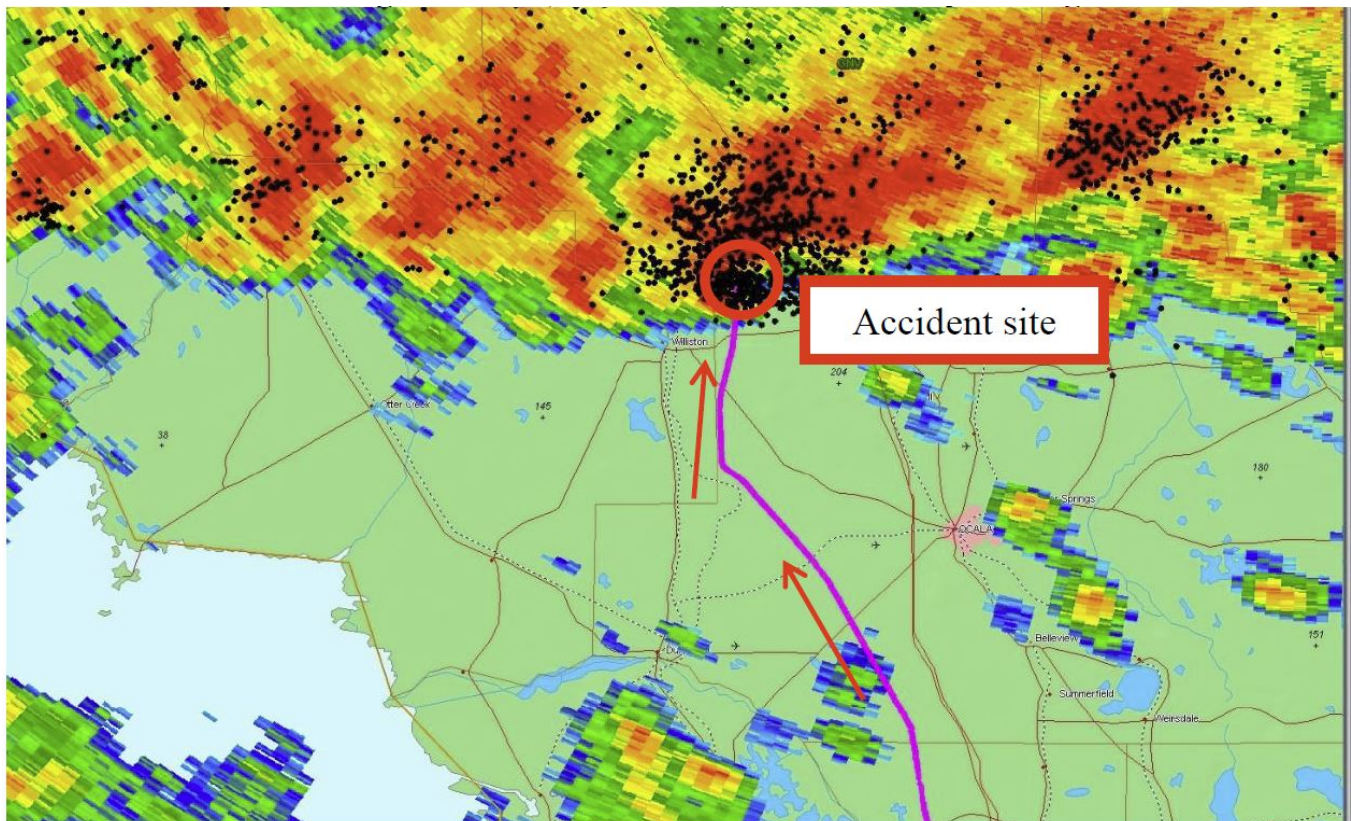
Figure 1 - KJAX WSR-88D reflectivity for the 0.5° elevation scan initiated at 0911 EDT

Radar returns from the motorglider ended at the edge of an east-west oriented line of severe thunderstorms, rain showers, and lightning that extended about 100 nautical miles to either side of the motorglider's radar flight track, according to National Weather Service (NWS) weather radar data. (See figure 1.)

the accident location with convective cells and lightning. The echoes were consistent with the possibility of hail, extreme turbulence, and strong surface wind gusts. Radar velocity data indicated winds conducive to rotation above the accident site at the time of the accident, with the potential for tornadic activity at the surface. The area of heavy to extreme precipitation stretched across the entire width of northern Florida between 0845 and 0915.
