National Transportation Safety Board Aviation Accident Factual Report

Location:	Spanaway, WA	Accident Number:	WPR17LA087
Date & Time:	04/13/2017, 0940 PDT	Registration:	N5131H
Aircraft:	TITAN TORNADO I	Aircraft Damage:	Substantial
Defining Event:	Flight control sys malf/fail	Injuries:	1 Serious
Flight Conducted Under:	Part 91: General Aviation - Personal

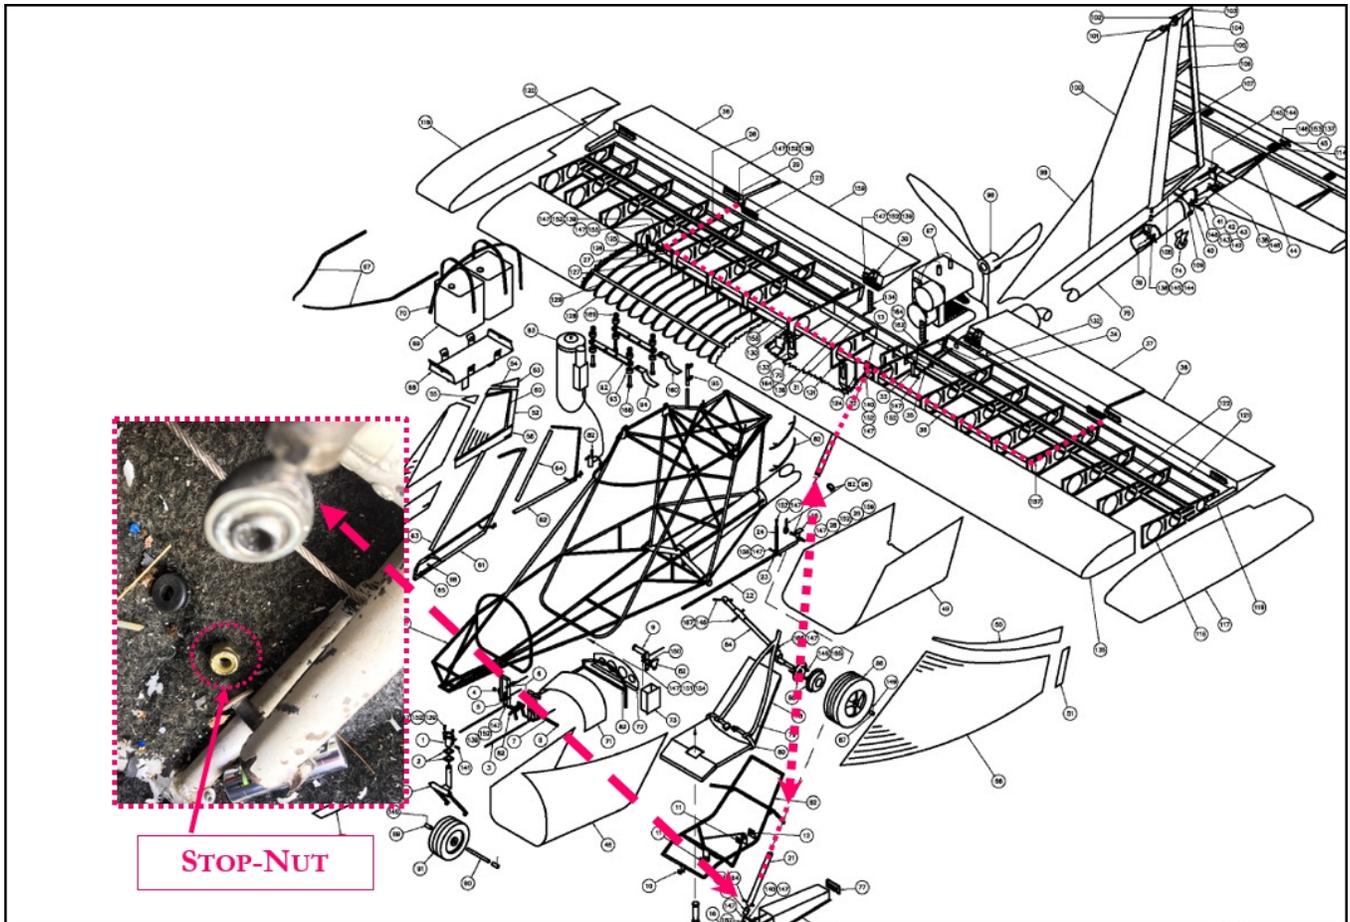
Picture 1: Aileron System

During the post-accident examination, control continuity for the rudder and elevator systems was established. An examination of the aileron system revealed that there was control continuity from the aileron control surfaces to the control tube in the cockpit. The upper attach point of the control tube (near wings) remained intact and the lower end (in cockpit) was found disconnected from the control mixer weldment. The stop-nut that normally is affixed to the bolt connecting the aileron control tube to the control yoke tube was found on the cabin floor about 5 inches from the ball joint (see picture 1). The bolt end had a hole for a cotter pin, but no cotter pin was located. There were no markings on the nylon insert of the stop nut consistent with it not being adequately tightened during the last maintenance.

The pilot reported that at the last condition inspection on 12/15/2016, the airframe and powerplant mechanic had adjusted the aileron control mixer. The airplane accumulated about 24 flight hours since the inspection.
