National Transportation Safety Board Aviation Accident Final Report

Location:	Bowling Green, OH	Accident Number:	CEN17FA207
Date & Time:	06/01/2017, 1159 EDT	Registration:	N4635V
Aircraft:	VARGA AIRCRAFT CORP. 2150A	Aircraft Damage:	Substantial
Defining Event:	Powerplant sys/comp malf/fail	Injuries:	1 Fatal
Flight Conducted Under:	Part 91: General Aviation - Personal

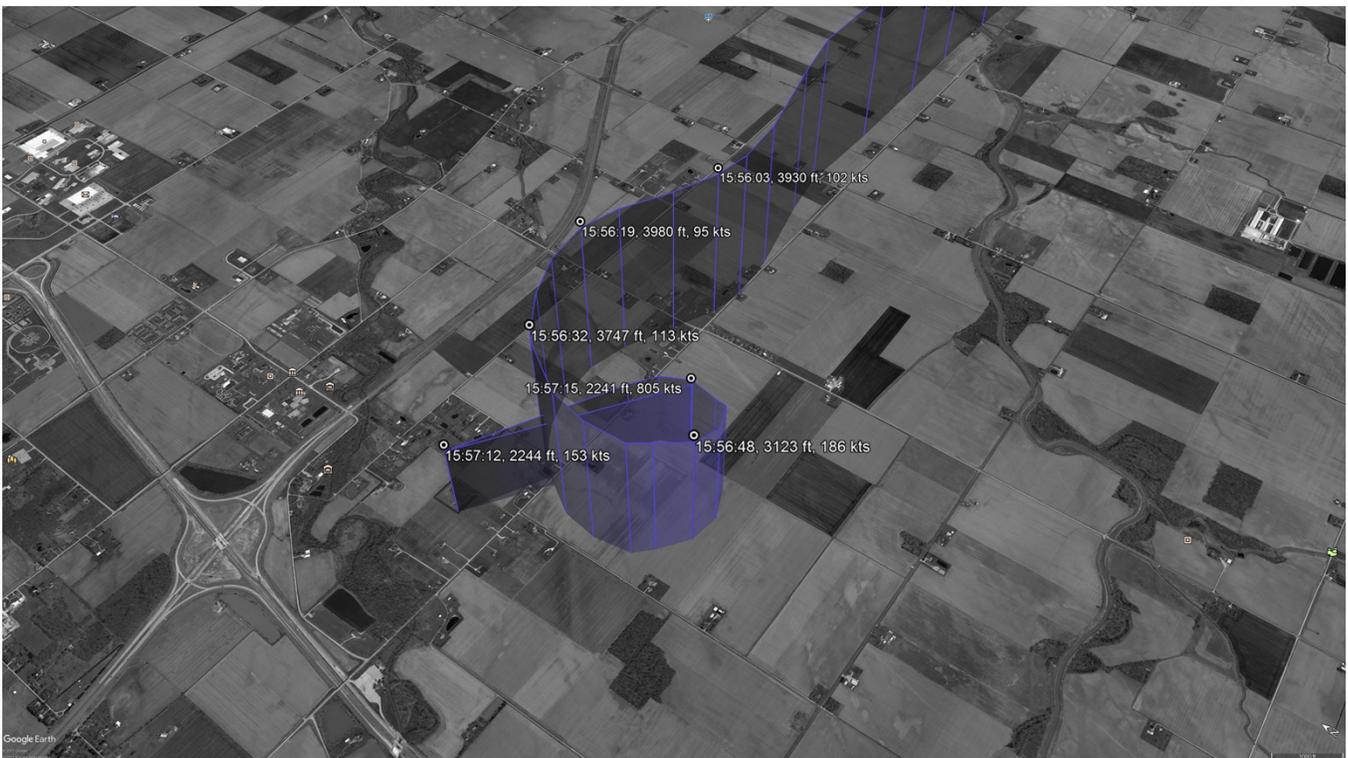
The pilot had recently purchased the airplane and was relocating it to a private airstrip near his home. GPS data recovered from an onboard device showed that the airplane departed 3G6 about 1034 and flew northwest toward OI92. The airplane maintained consistent groundspeeds and headings until 1156, when it entered a left-turning spiral descent. (See figure.)

Figure: Final GPS Data (oriented Northeast up, times are depicted in UTC)
