National Transportation Safety Board Aviation Accident Final Report

Location:	Green Township, NJ	Accident Number:	ERA17FA265
Date & Time:	08/06/2017, 1025 EDT	Registration:	N2854L
Aircraft:	NORTH WING FREEDOM	Aircraft Damage:	Substantial
Defining Event:	Aircraft structural failure	Injuries:	1 Fatal
Flight Conducted Under:	Part 91: General Aviation - Personal

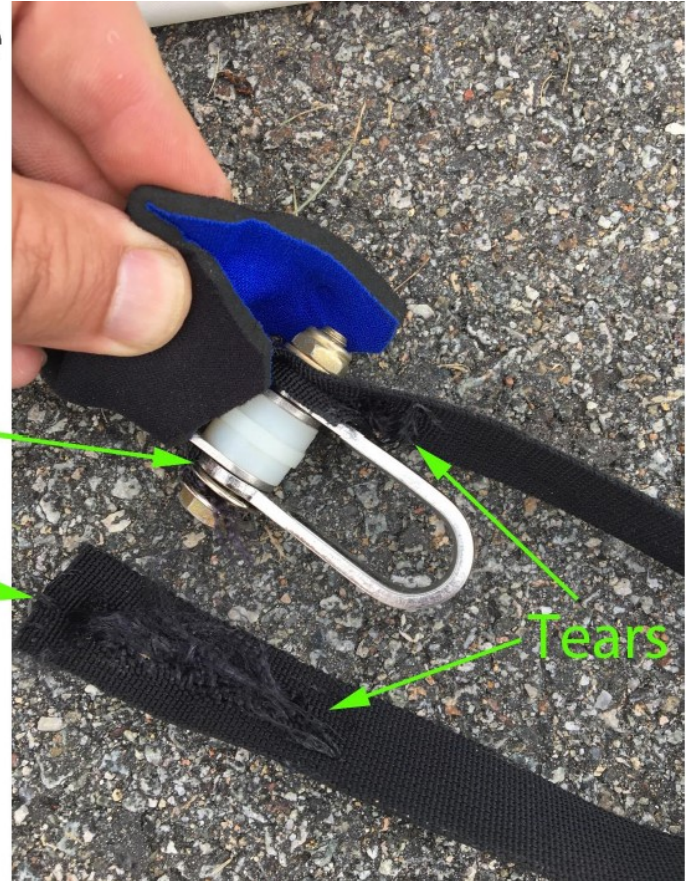
A postaccident examination of the wing revealed that the cross-bar restraint cable, which held the wing in its open position, was not attached at its shackle and hook fitting at the rear of the wing keel tube. Additionally, the nylon webbing strap, which was attached to the steel cable shackle and designed to be used as a handle to pull the cable in place, was torn and separated from one mounting point and torn but still attached to the other mounting point. The shackle likely did not disengage from the hook during flight because the locking mechanism on the hook remained intact, was undamaged, and functioned normally. Given the witness report of the pilot's difficulty pulling the crossbar restraint cable into place, as well as the damage to the nylon webbing handle used to pull the cable, it is likely that the pilot inadvertently placed the nylon handle in the attachment hook instead of the steel shackle. Shortly after takeoff, the nylon handle likely tore from its mount, which caused the wing to partially fold, precluding the aircraft's continued flight.

The pilot's improper preflight setup of the aircraft's foldable wing, during which he incorrectly attached a nylon strap loop pull handle, instead of the steel cable shackle at the end of the

strap, to its mounting hook. The nylon strap failed in flight, resulting in a partial collapse of the wing and the aircraft's descent and impact with terrain.

The crossbar restraint cable remained intact and attached to its forward mounting location. The aft end of the cable, to which a "U"-shaped steel shackle was attached, was free and not attached to the hook (referred to as the baily block hook) located at the rear of the wing keel tube. The hook was equipped with a spring lock to keep the shackle engaged in the hook; the spring lock was found intact, and it functioned normally. A strip of nylon fabric webbing, which was attached to the shackle as a loop, had separated from one of its two mounting points. The loop served as a handle to pull the cable into place and allows the shackle to engage with the hook. A 2-inch-long tear was present in the center of the webbing, about 1/2 inch from its loose end, as shown in figure 1. The other end of the webbing remained attached to the shackle at its mounting point with short tears in the center of the strap on both sides of the mount.

Figure 1. Cable shackle and pull handle. Note tears in nylon webbing.
