National Transportation Safety Board Aviation Incident Final Report

Location:	Hoffman Island, NY	Incident Number:	DCA17IA202A
Date & Time:	09/21/2017, 1920 EDT	Registration:	None
Aircraft:	DJI Phantom	Aircraft Damage:	Destroyed
Defining Event:	Midair collision	Injuries:	1 None
Flight Conducted Under:	Part 107: Small UAS

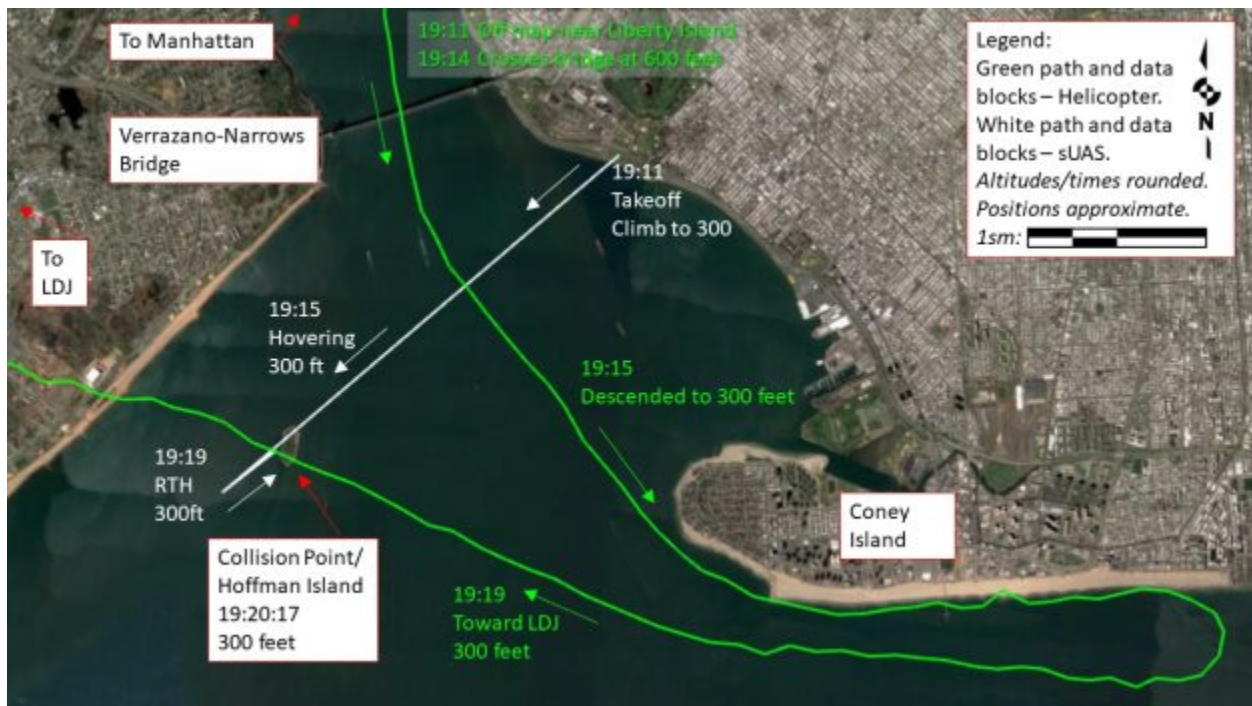
At 1914:30, ATC radar indicated the flight of helicopters was travelling south-southeasterly from the Verrazano-Narrows Bridge toward Coney Island at 400 ft (Figure 1). The helicopters passed the sUAS pilot's position from his right to left about 1 mile from his location. The sUAS was about 1 1/2 miles from the sUAS pilot at that time and along a common line of sight. Shortly afterward, at 1915:30, data logs indicated the sUAS paused and hovered northeast of Hoffman Island for about 2 minutes before resuming a southwesterly track toward the island. During this time, the helicopters were flying east along the Coney Island shoreline about 300 ft msl.

Figure 1: Approximate route of flight of the UH-60 and sUAS
