# National Transportation Safety Board Aviation Accident Final Report

<b>Location:</b>	Umatilla, FL	<b>Accident Number:</b>	ERA17FA339
<b>Date &amp; Time:</b>	09/28/2017, 1122 EDT	<b>Registration:</b>	N152AH
<b>Aircraft:</b>	HICKOX ANDY ANDYS GYROPLANE	<b>Aircraft Damage:</b>	Destroyed
<b>Defining Event:</b>	Abrupt maneuver	<b>Injuries:</b>	1 Fatal
<b>Flight Conducted Under:</b>	Part 91: General Aviation - Personal

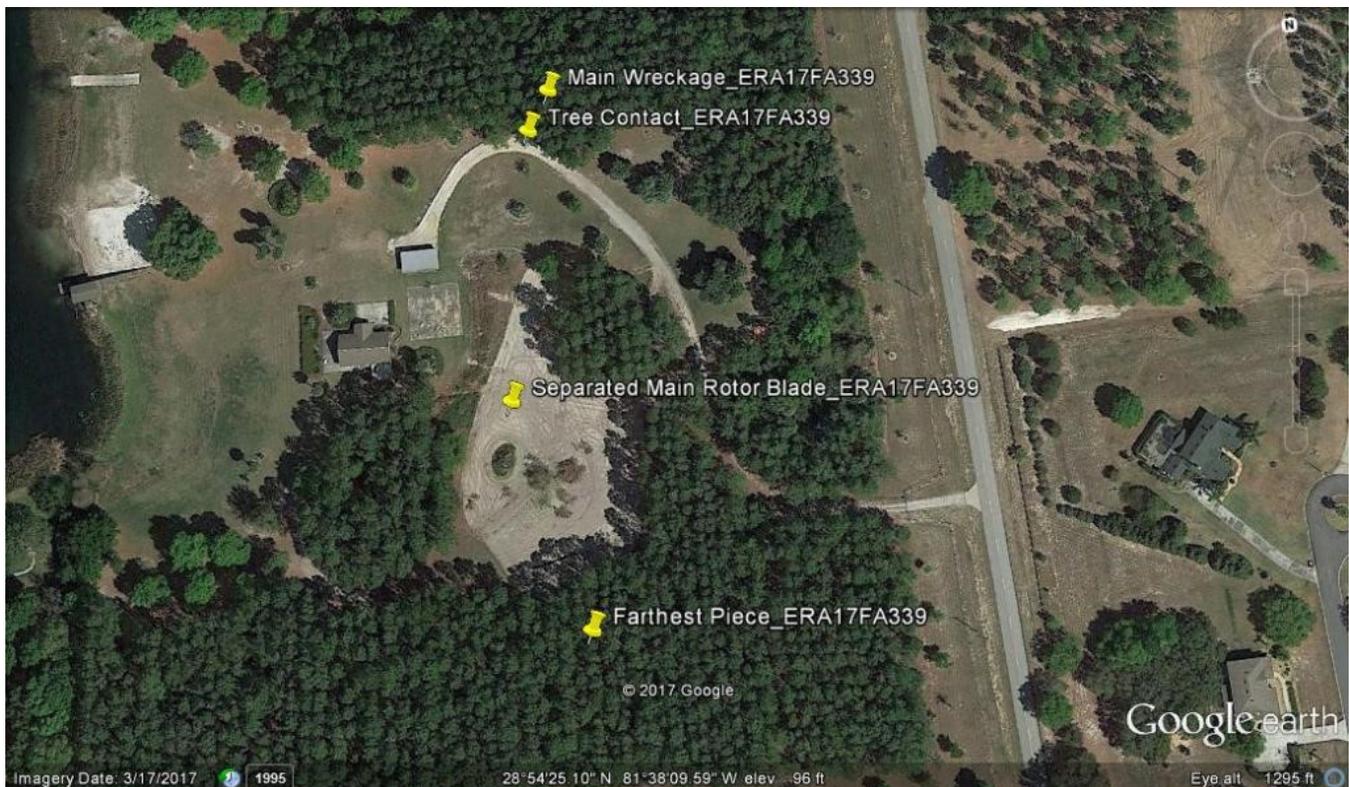
The gyroplane crashed into a wooded area on private property. Components of the gyroplane consisting of pieces of the propeller blades, foam, fiberglass, and components of the vertical stabilizer and rudder were located on the ground along the direction of flight, south of the resting position of the main wreckage. A section of main rotor blade measuring about 12 ft long was located along the direction of flight south of the main wreckage (see Figure of Google Earth plot depicting key position of components).

Figure: Google Earth Plot Depicting Key Position of Components.
