National Transportation Safety Board Aviation Accident Final Report

Location:	Bowie, AZ	Accident Number:	WPR18FA011
Date & Time:	10/19/2017, 0834 MST	Registration:	N259L
Aircraft:	Peterson Lancair Legacy	Aircraft Damage:	Substantial
Defining Event:	Birdstrike	Injuries:	1 Fatal
Flight Conducted Under:	Part 91: General Aviation - Personal

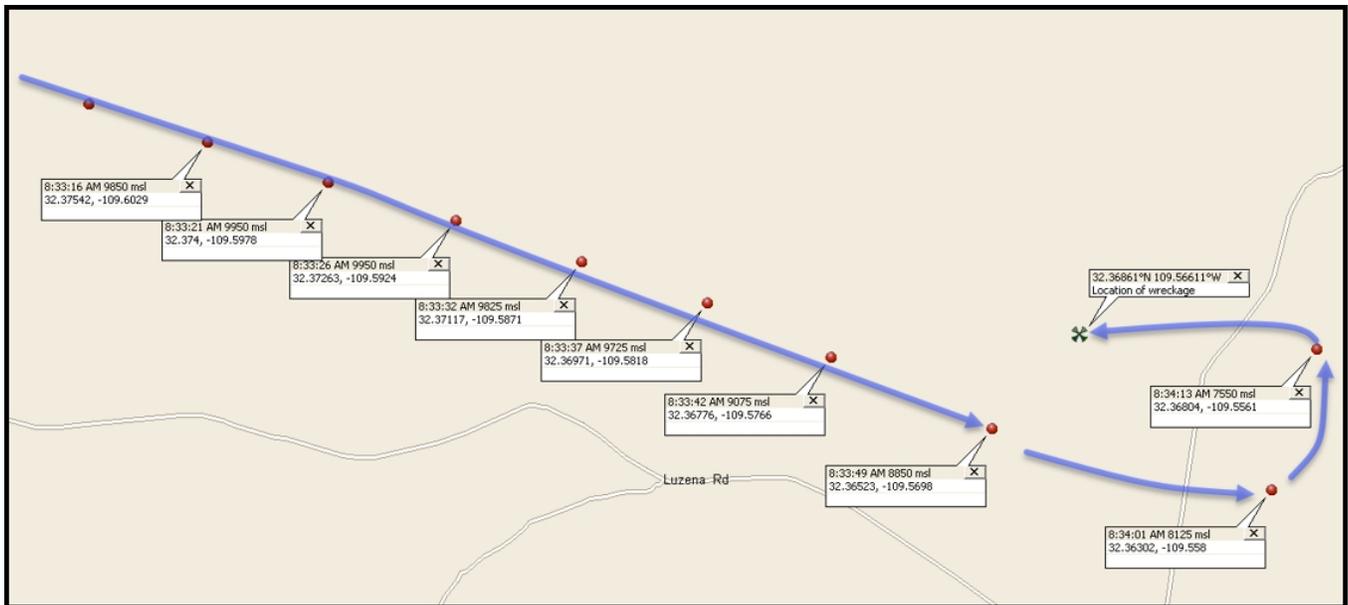
Federal Aviation Administration (FAA) radar data revealed that the airplane flew southeast at a cruising altitude of about 10,000 ft mean sea level (msl). The last nine radar returns occurred between 0833:16 to 0834:13. During that time, the airplane's altitude decreased from 9,850 to 7,550 ft msl. The last radar return was located about 100 ft east of the accident location (see figure 1). The airplane wreckage was located about 17 nm northwest of the San Simon VORTAC.

Figure 1. Last radar returns for the accident flight.
