# National Transportation Safety Board Aviation Accident Final Report

<b>Location:</b>	Elko, NV	<b>Accident Number:</b>	WPR18FA073
<b>Date &amp; Time:</b>	01/11/2018, 1802 PST	<b>Registration:</b>	N54857
<b>Aircraft:</b>	PIPER PA 23-250	<b>Aircraft Damage:</b>	Destroyed
<b>Defining Event:</b>	Turbulence encounter	<b>Injuries:</b>	1 Fatal
<b>Flight Conducted Under:</b>	Part 91: General Aviation - Positioning

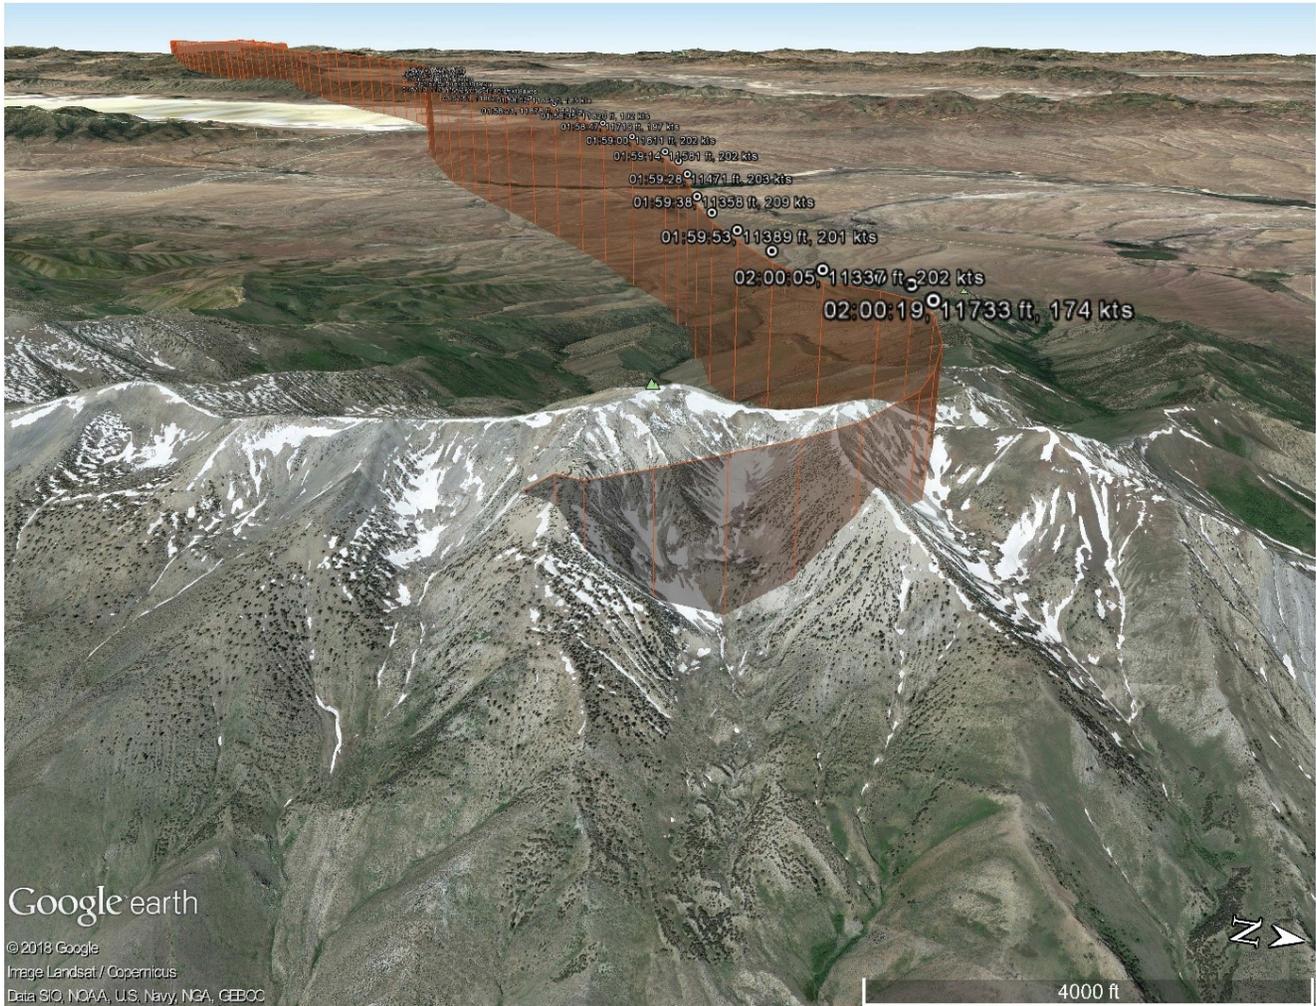
Figure 1. GPS flight track, west view

Review of radar and onboard GPS data revealed that the airplane was flying east at an altitude of about 11,500 ft mean sea level (msl) and approaching 11,084-ft-tall Pearl Peak when the pilot reported to air traffic control that he was encountering clouds and was going to turn around to avoid entering icing conditions. The controller then asked if he would like information on nearby airports. The pilot asked for information about the nearest airport and indicated that he would "head over there." The controller provided information for Elko Regional Airport (EKO), Elko, Nevada, about 40 miles north of the airplane's position, and the pilot replied, "Alright, I'm getting super turbulent over here I'm going to head over there." Communication and radar contact with the airplane were lost shortly thereafter. Radar data showed the airplane cross the ridgeline north of Pearl Peak at an altitude of 11,635 ft at a ground speed of 176 knots; the airplane then turned southeast of Pearl Peak as it descended and its ground speed decreased before the track ended.

After an initial search for the airplane at local airports was unsuccessful, the Federal Aviation Administration (FAA) issued an Alert Notice (ALNOT) and the wreckage was located by air on January 19, 2018. The accident site was found near the end of the radar track, on the east side of Pearl Peak, at an elevation of 10,090 ft msl. (see figure 1).

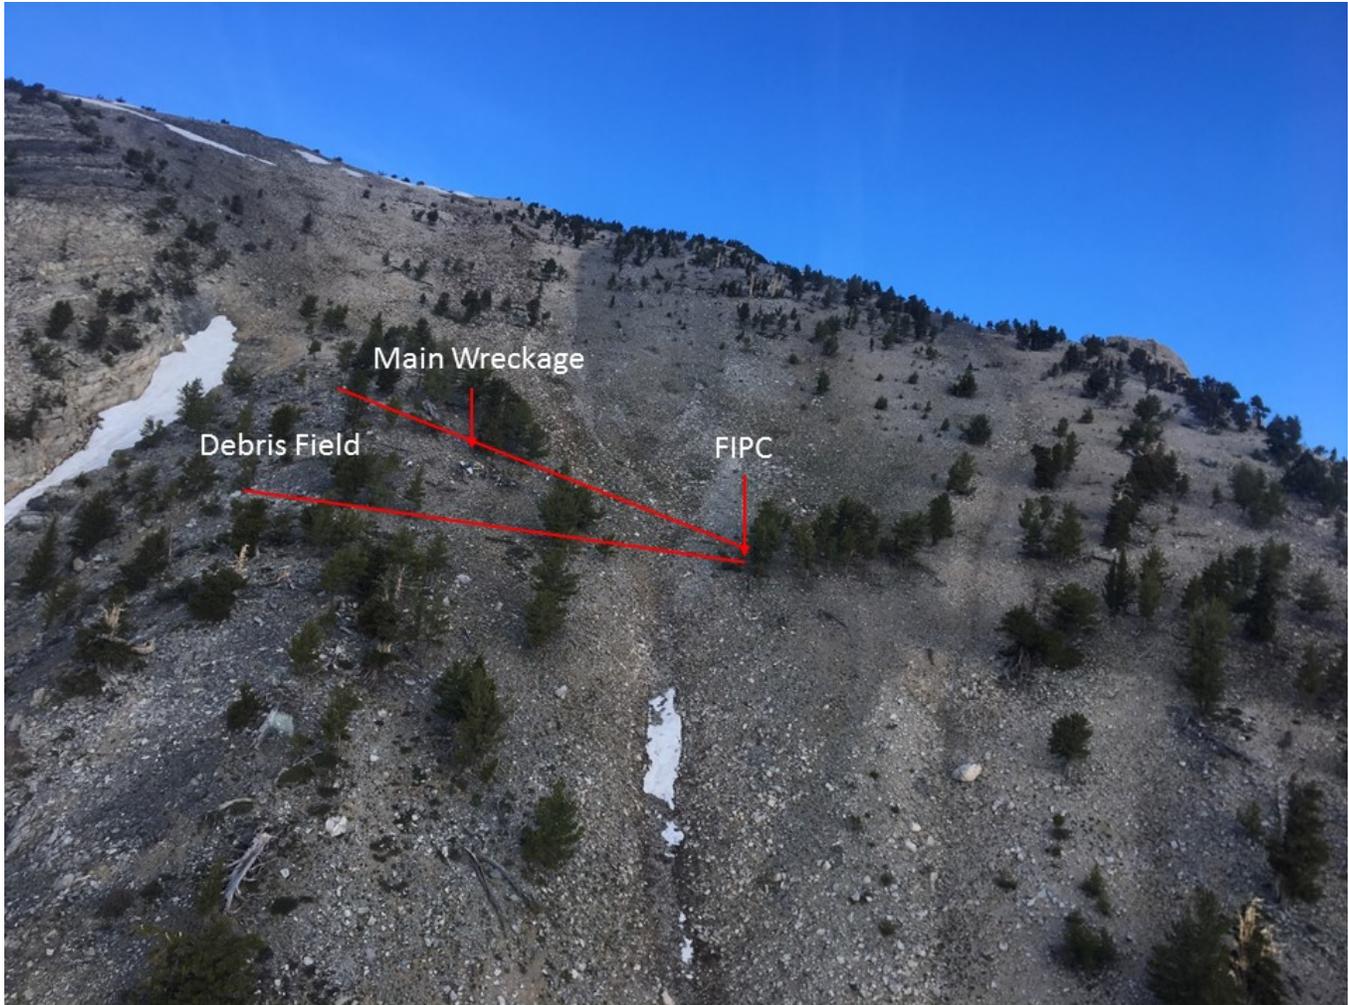
Figure 2-Aerial View of the Accident Site

On June 15, 2018, examination of the accident site revealed that the airplane came to rest on steep, sparsely wooded terrain and was destroyed by impact forces. The wreckage, including all major structural airplane components and primary flight controls, was contained within a debris field about 325 ft long and oriented on a magnetic heading of about 213°. (see figure 2)
