National Transportation Safety Board Aviation Accident Final Report

Location:	Atlantic Ocean, AO	Accident Number:	ERA18LA119
Date & Time:	03/31/2018, 1117 EDT	Registration:	N4ZQ
Aircraft:	AMES ANGIER M LNC2	Aircraft Damage:	Substantial
Defining Event:	Loss of control in flight	Injuries:	2 Fatal
Flight Conducted Under:	Part 91: General Aviation - Personal

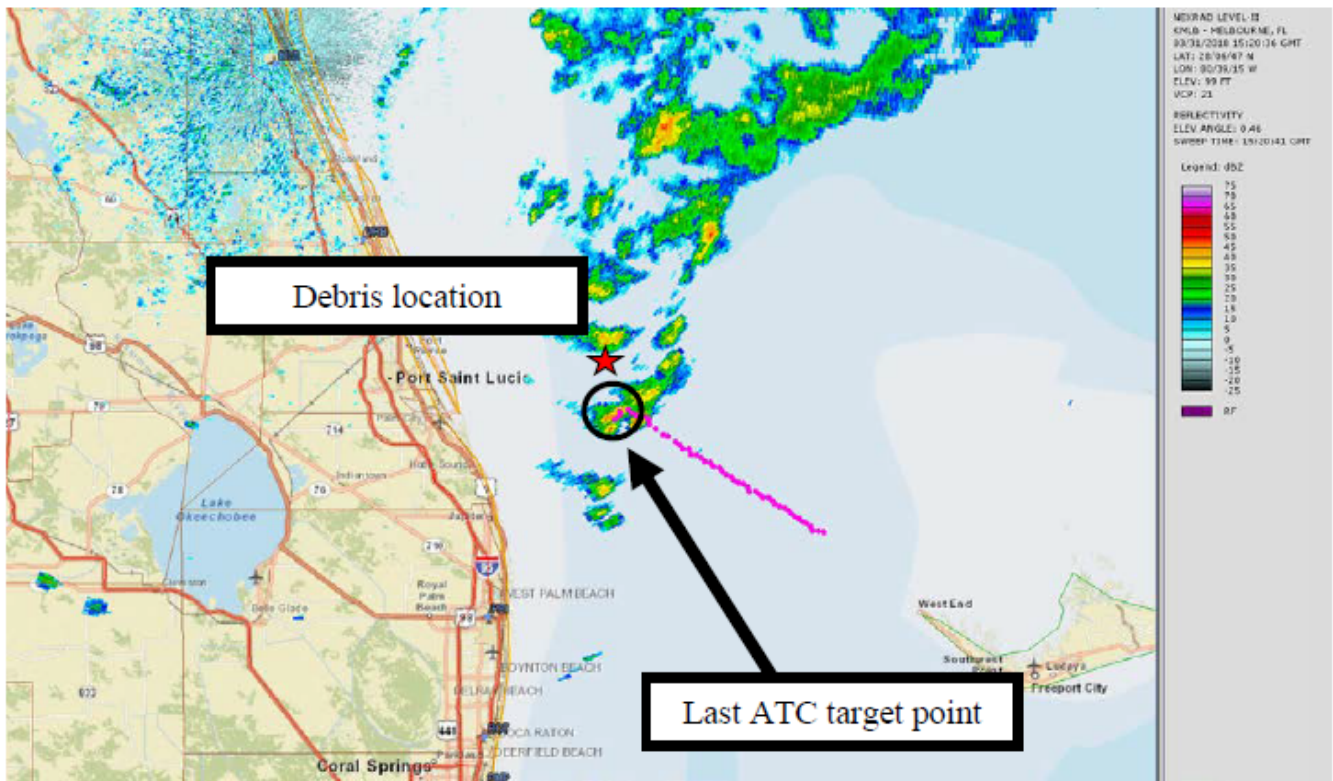
The closest National Weather Service Weather Surveillance Radar–1988, Doppler (WSR-88D) to the accident site was the Melbourne, Florida, radar, which was 65 miles north-northwest of the accident site and 72 miles north-northwest of the last radar target. Reflectivity values between 30 and 45 dBZ were located in the area of the airplane's last radar observed position, between 1115 and 1121; these values corresponded to moderate-to-heavy precipitation (see figure 1). The reflectivity bands were moving from northeast to southwest between 1100 and 1135. There were no lightning strikes near the accident location about the time of the accident.

Figure 1 - Melbourne, Florida, WSR-88D composite reflectivity image at 1121 with the airplane's ATC radar-derived flight track points in pink, the last ATC target point marked with black circle, and the debris location indicated with a red star.
