National Transportation Safety Board Aviation Accident Final Report

Location:	Cascade, ID	Accident Number:	WPR18FA141
Date & Time:	05/13/2018, 1230 MDT	Registration:	N2377R
Aircraft:	CESSNA 182G	Aircraft Damage:	Destroyed
Defining Event:	Controlled flight into terr/obj (CFIT)	Injuries:	1 Fatal
Flight Conducted Under:	Part 91: General Aviation - Personal

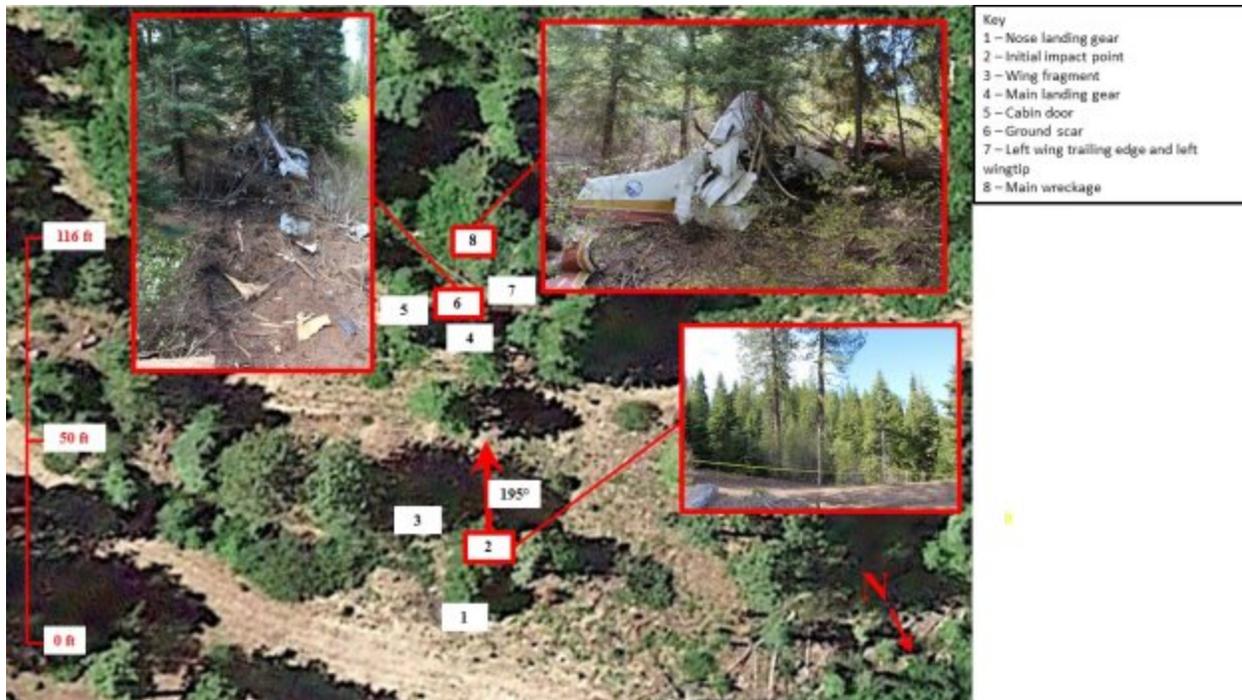
Figure 1: Wreckage Diagram

The airplane debris path was located in a wooded area about 41 nm north of BOI and was oriented on a 195° magnetic heading. All major structures of the airplane were accounted for at the accident site, as shown in figure 1. The initial impact point (IIP) was identified by two scars located about halfway up a 70-ft tree. The terrain elevation of the IIP was about 5,800 ft msl. The nose landing gear was located at the base of the tree, and wing fragments were distributed along the wreckage path. A large ground scar was located about 50 ft forward of the IIP in the debris path. The main wreckage comprised the empennage, right wing, main cabin, and engine and was located about 110 ft forward of the IIP. The empennage was vertically oriented and at rest against the right wing, which was beneath a portion of the cabin and instrument panel. The left wing was found in the debris path.
