# National Transportation Safety Board Aviation Accident Final Report

<b>Location:</b>	Ferdinand, IN	<b>Accident Number:</b>	CEN18TA233
<b>Date &amp; Time:</b>	06/18/2018, 2245 EDT	<b>Registration:</b>	N3002X
<b>Aircraft:</b>	CESSNA 150F	<b>Aircraft Damage:</b>	Substantial
<b>Defining Event:</b>	Loss of engine power (total)	<b>Injuries:</b>	1 Serious, 1 Minor
<b>Flight Conducted Under:</b>	Part 91: General Aviation - Personal

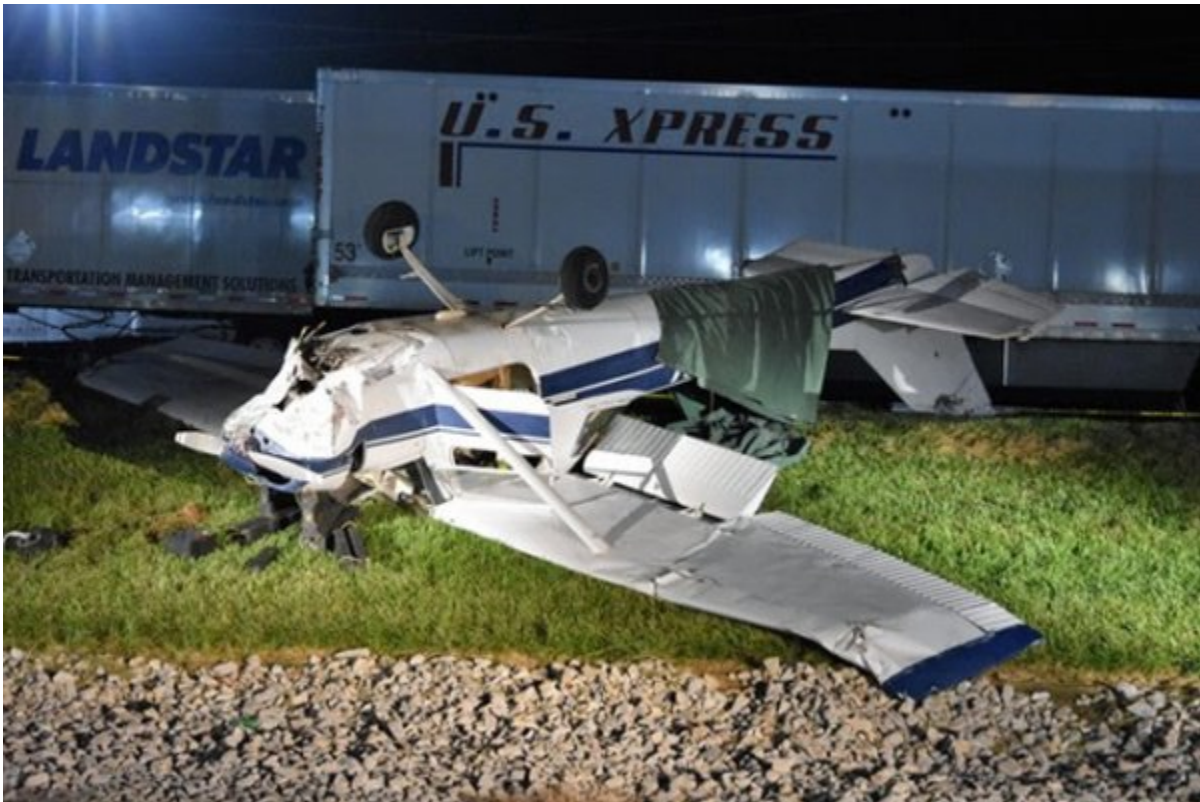
Figure 1 – Accident Site (photo courtesy of the Indiana State Police)

On June 18, 2018, about 2245 eastern daylight time, a Cessna 150F airplane, N3002X, made a forced landing in a parking lot then nosed over in an embankment. The private rated pilot sustained serious injuries and the passenger sustained minor injuries. The airplane sustained substantial damage. The airplane was registered to Gas Publishing LLC and operated by the pilot under the provisions of Title 14 *Code of Federal Regulations* Part 91 as a personal flight. Night visual meteorological conditions prevailed at the time of the accident and no flight plan had been filed. The flight departed Central Wisconsin Airport (CWA), Mosinee, Wisconsin, about 1700 central daylight time and was en route to Perry County Municipal Airport (TEL), Tell City, Indiana.

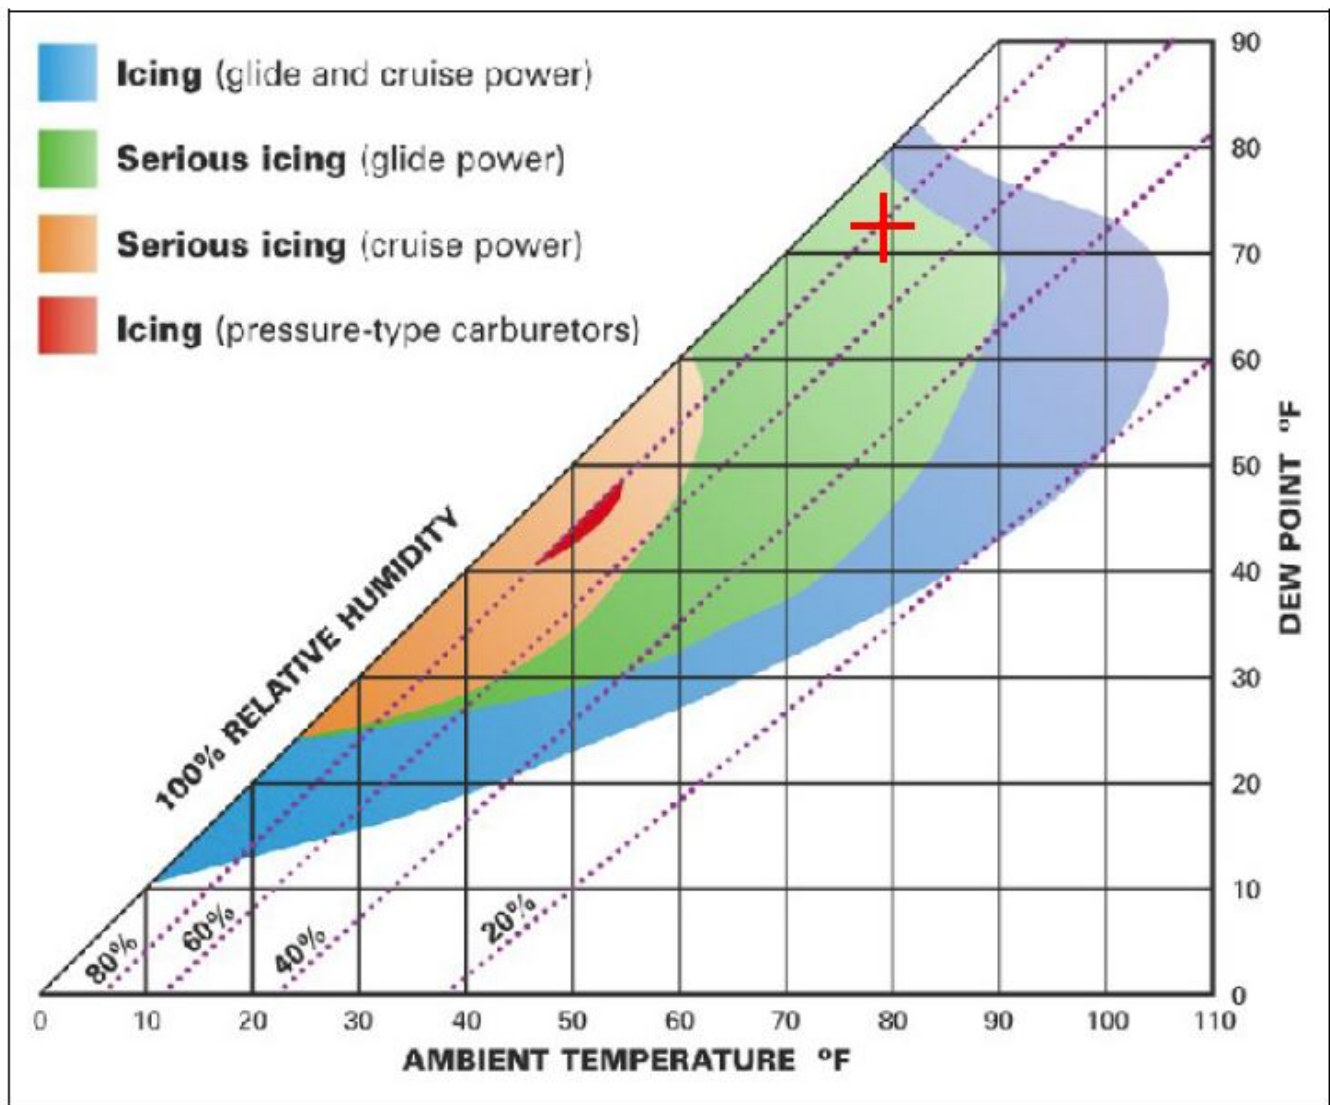
Figure 2 – Carburetor icing probability chart

The pilot's failure to apply carburetor heat in conditions conducive to the accumulation of carburetor icing, which resulted in a total loss of engine power.

The carburetor icing probability chart included in Federal Aviation Administration Special Airworthiness Information Bulletin No. CE-09-35, Carburetor Icing Prevention, indicated that the airplane was operating in an area that was associated with a serious risk of carburetor ice accumulation at glide power settings (figure 2).
