National Transportation Safety Board Aviation Accident Final Report

| Location: | Covington, TN | Accident Number: | ERA18FA240 |
| Date & Time: | 09/01/2018, 1720 CDT | Registration: | N815EY |
| Aircraft: | LANCE M HOOLEY JETEZ | Aircraft Damage: | Destroyed |

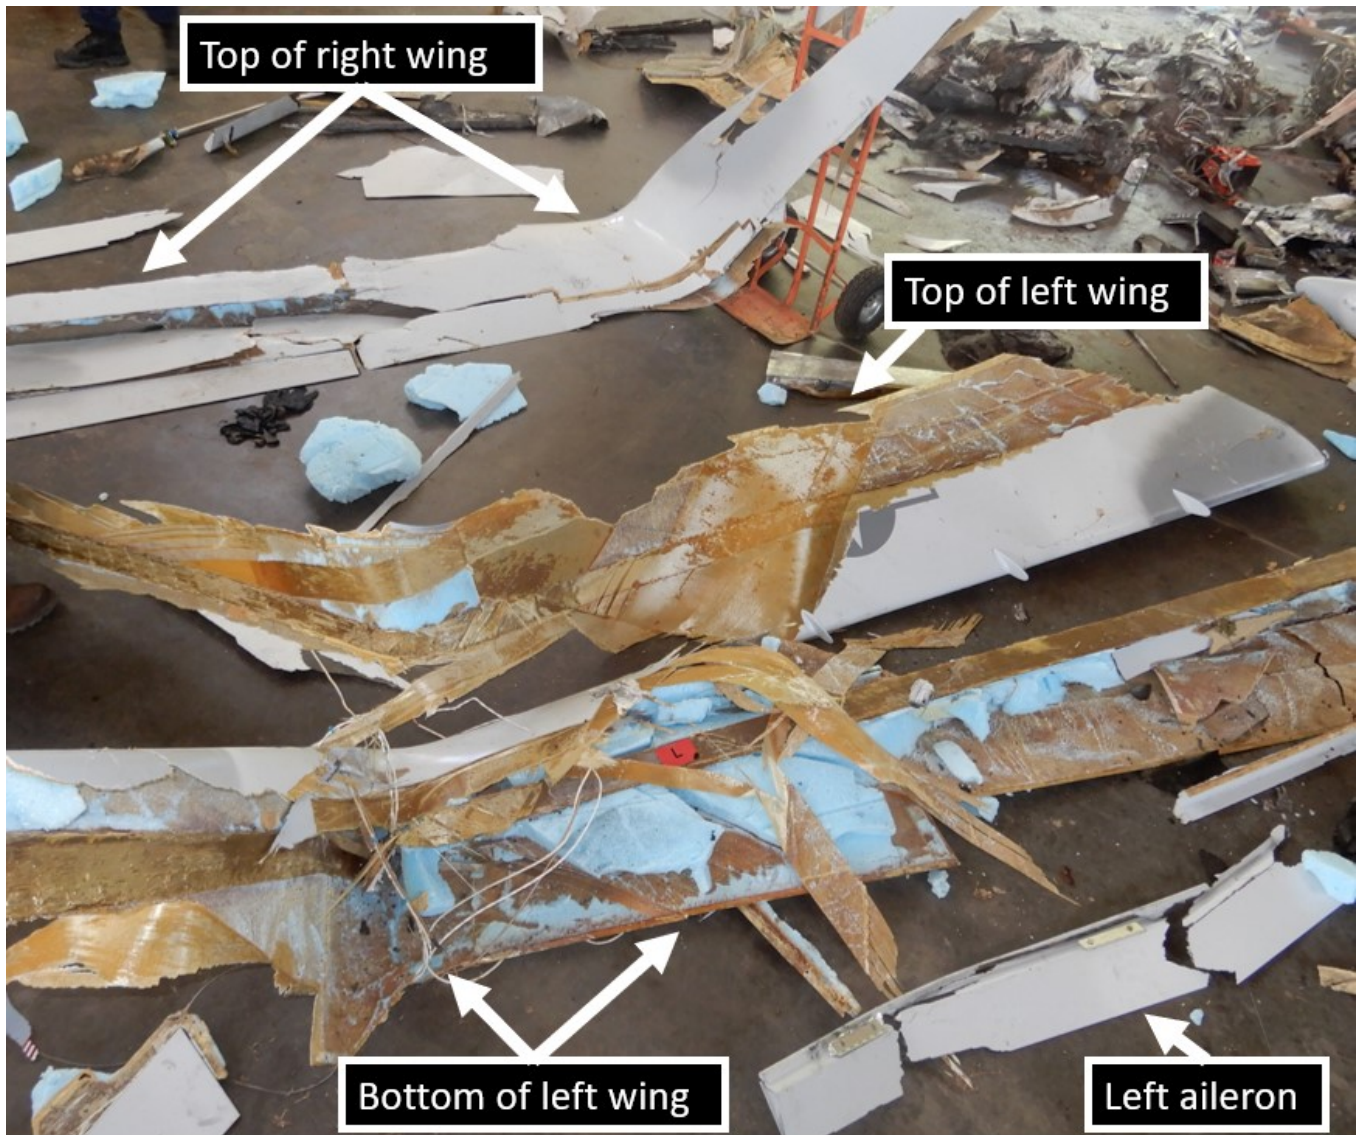
Portions of the left wing upper skin plies displayed evidence of fiber material transfer from the lower wing skin. Portions of the left wing upper spar cap and upper skin had a glossy appearance with no apparent evidence of fiber material transfer. The left winglet skin panels showed evidence of fiber material transfer between the winglet skin and the winglet spar caps. After examination, the left and right wing components were laid out. Figure 2 shows the top and bottom portions of the left wing and left aileron.

Figure 2. Left and right wing fragments.

Further examination of portions from the internal left wing structure was performed by the NTSB Materials Laboratory in Washington, DC. This examination showed that the upper wing surfaces and the upper spar cap sections had areas that were consistent with a resin-starved or dry laminate. These areas were also consistent with an adhesive disbond between the respective faying surfaces. This adhesive disbond was consistent with a lack of impregnation and interfacial interaction of the resin into and with the glass fiber fabric, resulting in a lack of strong adhesion between the wing skin and the spar cap. These issues were consistent with a fabrication problem during manufacturing of the layup rather than wear over time or an environmental degradation failure. Reference the Materials Laboratory Factual Report in the public docket for additional details and photographs.
