National Transportation Safety Board Aviation Accident Factual Report

Location:	Pflugerville, TX	Accident Number:	CEN19LA076
Date & Time:	01/27/2019, 1514 CST	Registration:	N39650
Aircraft:	Piper PA32RT	Aircraft Damage:	Substantial
Defining Event:	Fuel starvation	Injuries:	1 Minor
Flight Conducted Under:	Part 91: General Aviation - Personal

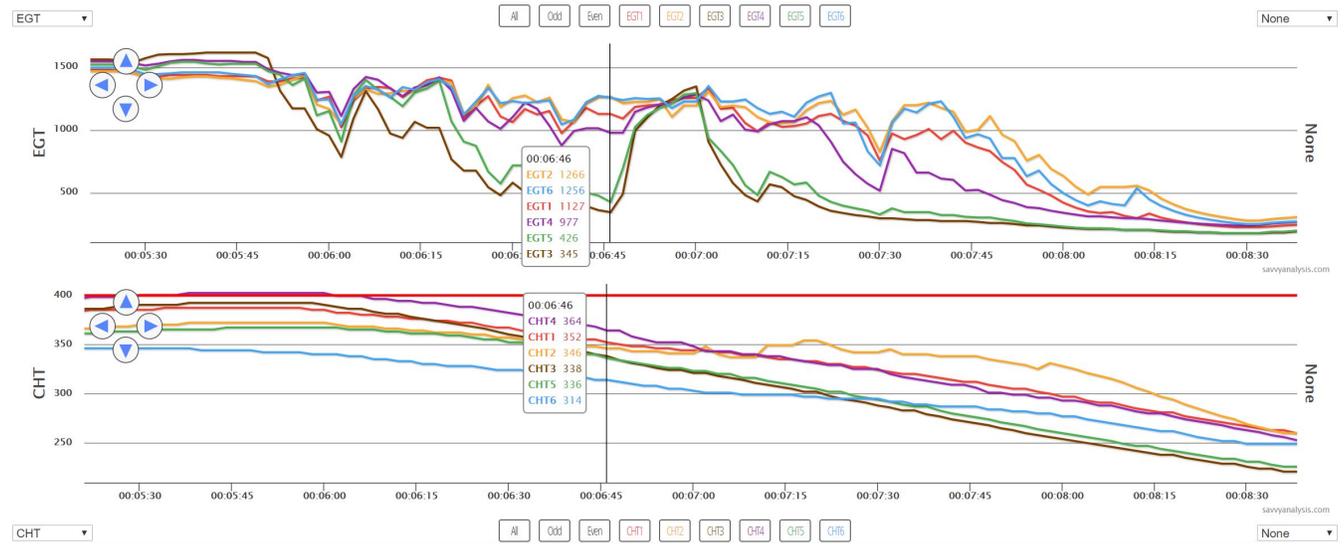
Figure 1 – Final Minutes of Accident Flight JPI Data

Data associated with the accident flight showed a consistent decrease in CHTs during the final 3 minutes of flight. EGT data showed a series of decreases and increases in temperatures during the same period. (Figure 1)

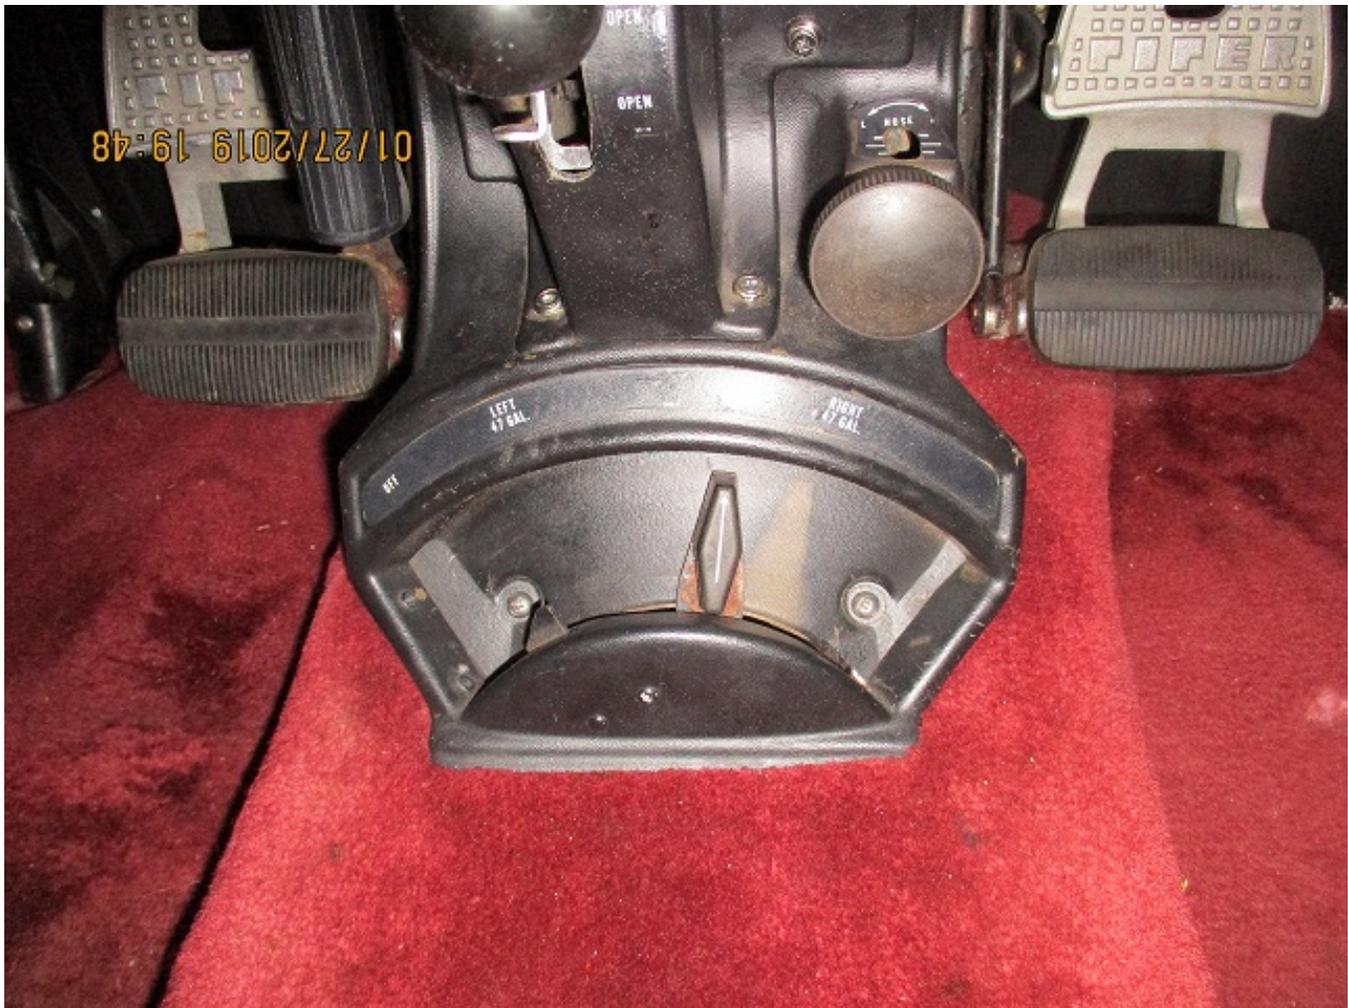
Figure 2 - Fuel Selector Position

The wreckage was initially moved to EDC, where it was stored outdoors with the left wing attached. It was later relocated to a secure storage facility in Lancaster, Texas. Recovery personnel retrieved 9 gallons of liquid consistent with aviation fuel from the left wing prior to removing it from the fuselage for transportation. The right wing tank did not contain any fuel and the right fuel cap was secure on the wing when viewed at the accident scene by Federal Aviation Administration (FAA) inspectors. The right tank fuel lines were compromised where the wing separated from the fuselage during the accident. Little evidence of fuel leakage from the right wing tank was evident at the accident scene and no fuel was found in the tank by recovery personnel. FAA inspectors documented the fuel selector handle in a position about 1 to 2 inches past center towards the right tank position (see figure 2).

FUEL SELECTOR VALVE OPERATION. When the fuel selector handle is not in a positive selector detent position, more than one fuel port will be open at the same time. It should be ascertained the fuel selector is positioned in a detent, which can be easily felt when moving the handle through its various positions.
