# National Transportation Safety Board Aviation Accident Preliminary Report

<b>Location:</b>	Farmington, NM	<b>Accident Number:</b>	WPR19FA103
<b>Date &amp; Time:</b>	03/31/2019, 1439 MDT	<b>Registration:</b>	N173CT
<b>Aircraft:</b>	Cirrus SR22	<b>Injuries:</b>	1 Fatal
<b>Flight Conducted Under:</b>	Part 91: General Aviation - Personal

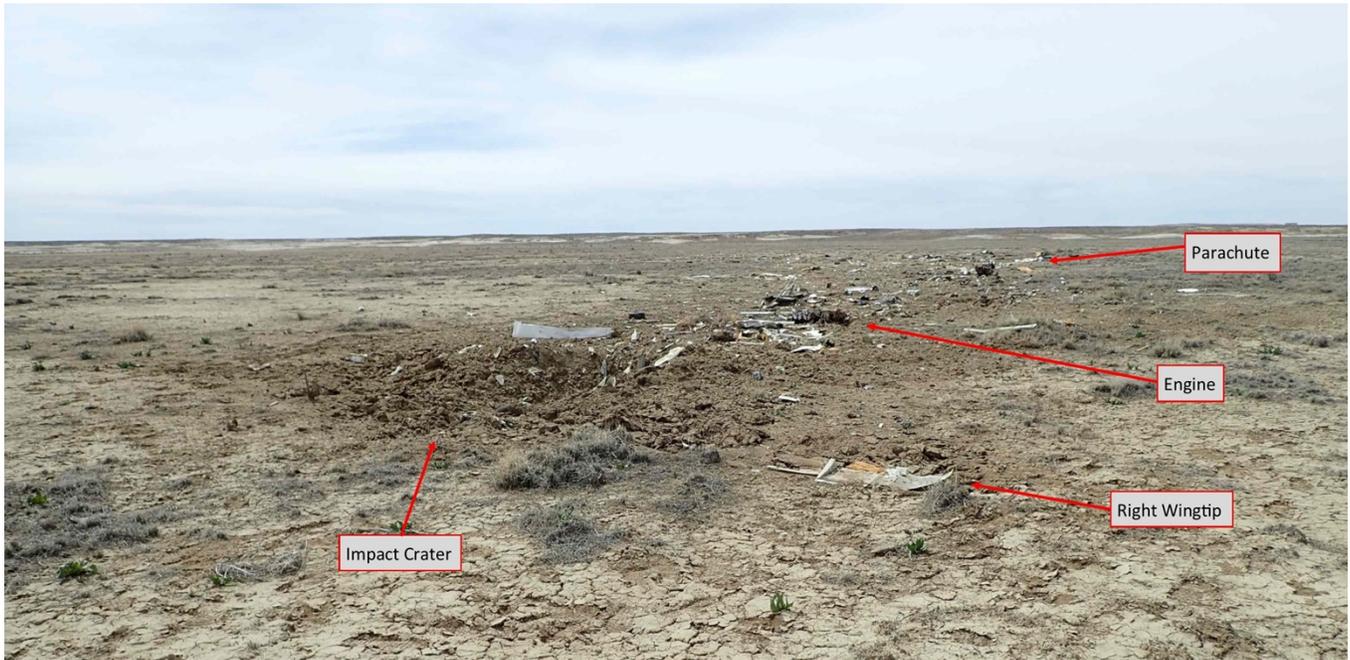
The debris field was 450 ft long, on a heading of about 210° true (See Figure 1). The engine came to rest about 30 ft beyond the crater, and the remainder of the debris was composed of fragmented pieces of composite main cabin and wing structure, fanned out to a width of about 100 ft. The aluminum ailerons, elevators, and flaps were crushed and distributed throughout the debris field, and the farthest components were the left forward seat and a wing fuel cap.

Figure 1 – Accident Site Viewed to the West
