National Transportation Safety Board Aviation Accident Preliminary Report

Location:	Fullerton, CA	Accident Number:	WPR19FA115
Date & Time:	04/18/2019, 1953 PDT	Registration:	N65MY
Aircraft:	Beech 60	Injuries:	1 Fatal
Flight Conducted Under:	Part 91: General Aviation - Personal

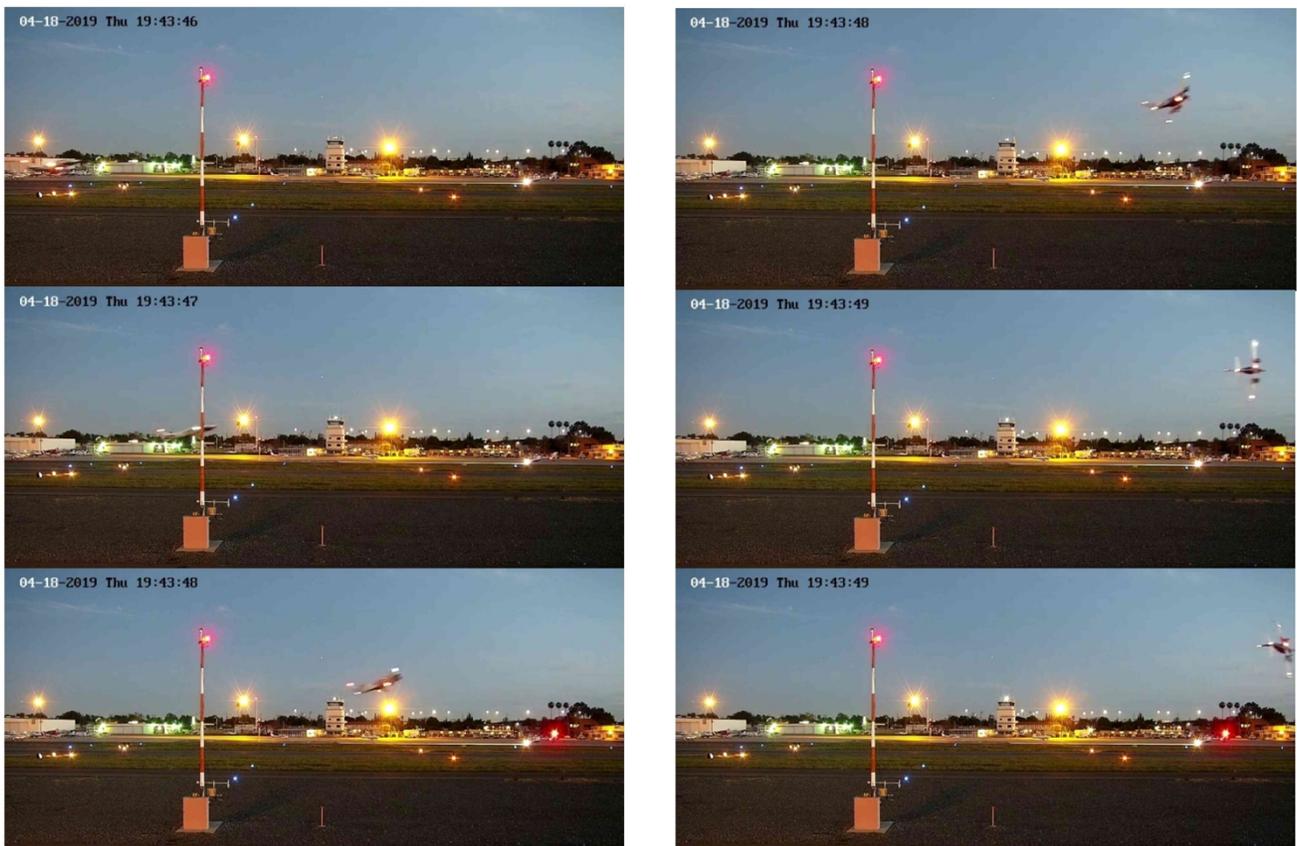
The accident sequence was captured by a series of surveillance video cameras located at multiple vantage points within the airport. Preliminary review of the video data revealed that the pilot boarded the airplane at his hangar at 1930. He started the engines, and taxied to the runway 24 runup where the airplane remained for the next 11 1/2 minutes. During that time, he was provided his IFR clearance by the tower controller. The airplane then taxied to the hold short line on taxiway A at the approach end of runway 24, and after the pilot was given the takeoff clearance, the airplane began the takeoff roll. The airplane was airborne after traveling about 1,300 ft down the runway, and about 2 seconds after rotation it began to roll to the left. Three seconds later, the airplane had reached an altitude of about 80 ft above ground level (agl), and was in a 90° left bank. The nose then dropped as the airplane rolled inverted, and struck taxiway E in a right-wing-low, nose down attitude. (See Figure 1).

Figure 1 – Accident Sequence Viewed Midfield to the South (timestamp inaccurate)
