National Transportation Safety Board Aviation Accident Factual Report

Location:	Cleburne, TX	Accident Number:	CEN19LA159
Date & Time:	05/30/2019, 1100 CDT	Registration:	N2514F
Aircraft:	Lancair LC41	Aircraft Damage:	Substantial
Defining Event:	Powerplant sys/comp malf/fail	Injuries:	1 None
Flight Conducted Under:	Part 91: General Aviation - Business

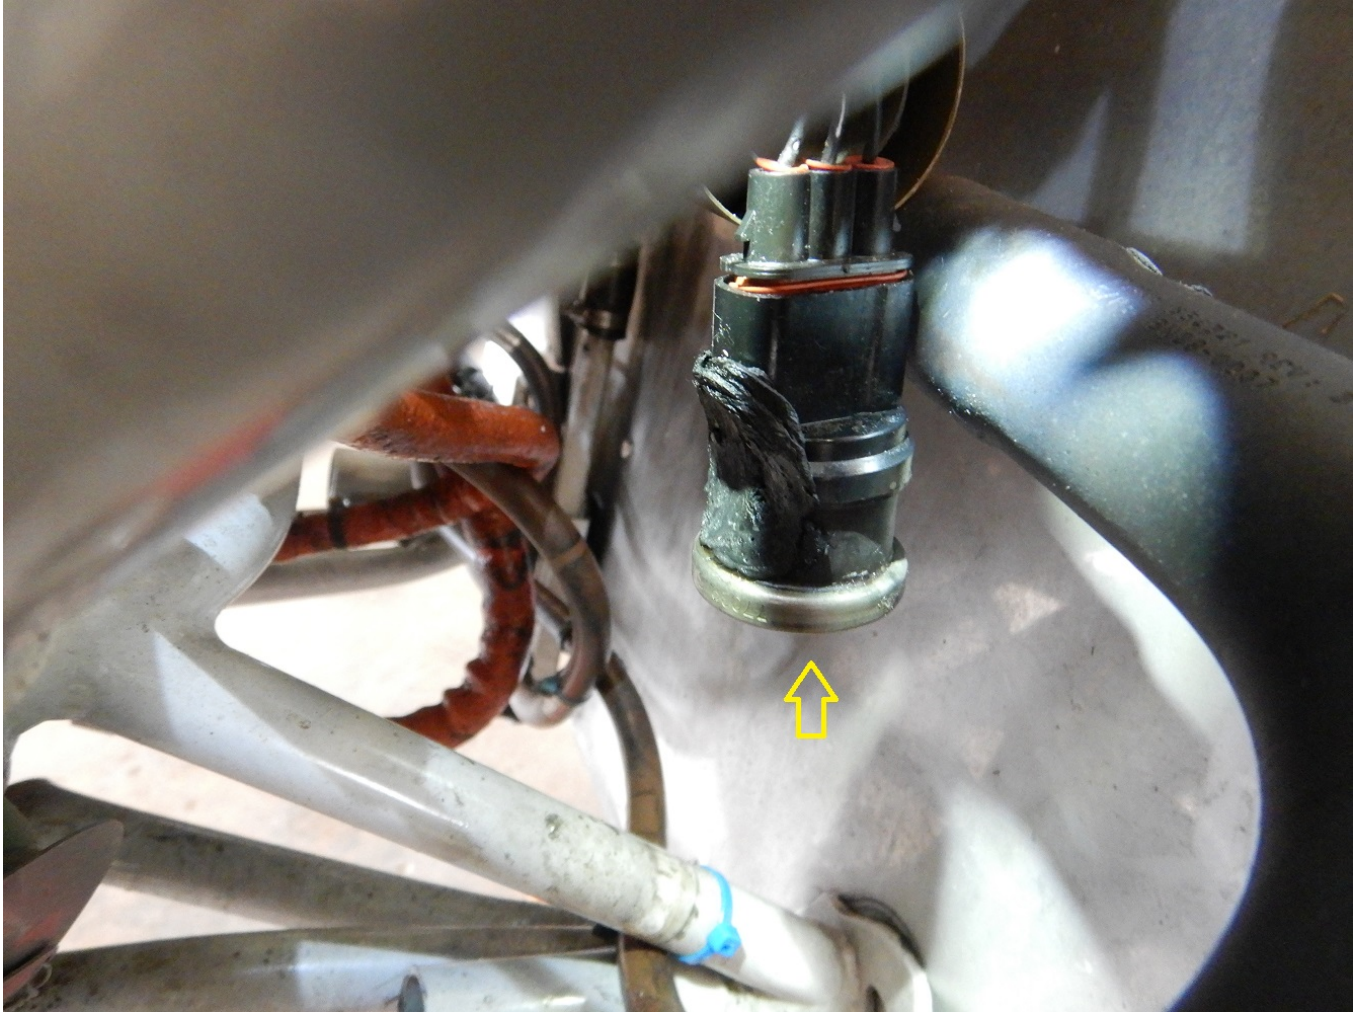
Figure 1: Oil Pressure Switch Photo Continental

The airplane was recovered to a secure facility for further examination. The examination was conducted by the NTSB Investigator-in-Charge, a representative from Van Bortel Aircraft, and technical representatives from the engine and airframe manufacturers. The examination noted the engine case had a hole above the No. 4 cylinder, and when the propeller was rotated by hand, the engine had limited rotation and internal binding was noted. A light, oil film was noted on the bottom of the airplane. The exam also found an oil pressure switch separated in two pieces. The threaded section remained to its mating joint; the other section rested on an exhaust tube and attached by its wire connector as seen in Figure 1.

A visual inspection of the switch noted that the switch had separated at a manufacturing joint between the body and threaded section.

The switch was removed and sent to Textron Aviation, Inc, Materials Laboratory for a detailed examination of the switch. Textron's examination noted the switch failed at the swaged joint between the threaded section and the base cap section of the switch. The examination was not able to determine how the joint failed, since there were no physical indications as to how the swaged joint failed.
