National Transportation Safety Board Aviation Accident Factual Report

Location:	Moose Pass, AK	Accident Number:	ANC19FA029
Date & Time:	06/28/2019, 1608 AKD	Registration:	N56512
Aircraft:	Maule M6	Aircraft Damage:	Substantial
Defining Event:	Abrupt maneuver	Injuries:	3 Fatal, 1 Serious
Flight Conducted Under:	Part 91: General Aviation - Personal

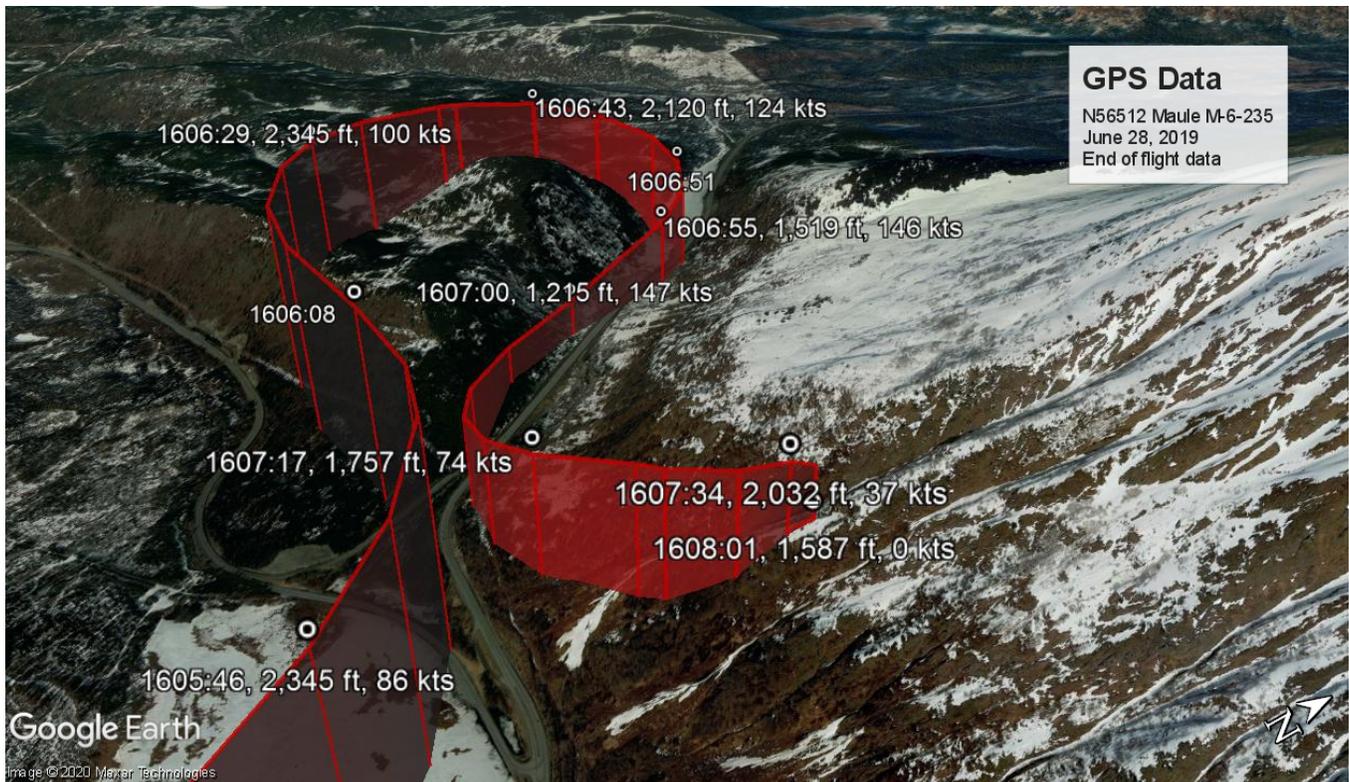
The GPS data logs for the day of the accident revealed that, about 1602, the airplane crossed Moose Pass at a GPS altitude of about 2,000 ft. The airplane continued northwest along Sterling Highway at GPS altitudes that varied between 1,700 and 2,400 ft. About 1606, after passing the intersection of Sterling and Seward Highways, the airplane began a right 180° turn to the southeast; shortly thereafter, the airplane began a descent to a GPS altitude of 1,215 ft. At 1607:00, the airplane began a left turn toward a northerly heading and initiated a climb. At 1607:34, the airplane was on a track of 354° at a GPS altitude of 2,032 ft, and at a groundspeed of 37 knots. The last fully recorded in-flight data point was at 1608:01, when the airplane was at a GPS altitude of 1,587 ft and a 0-knot groundspeed and on a track of 282°. (See figure 1.)

Figure 1. Last minutes of flight ground track.

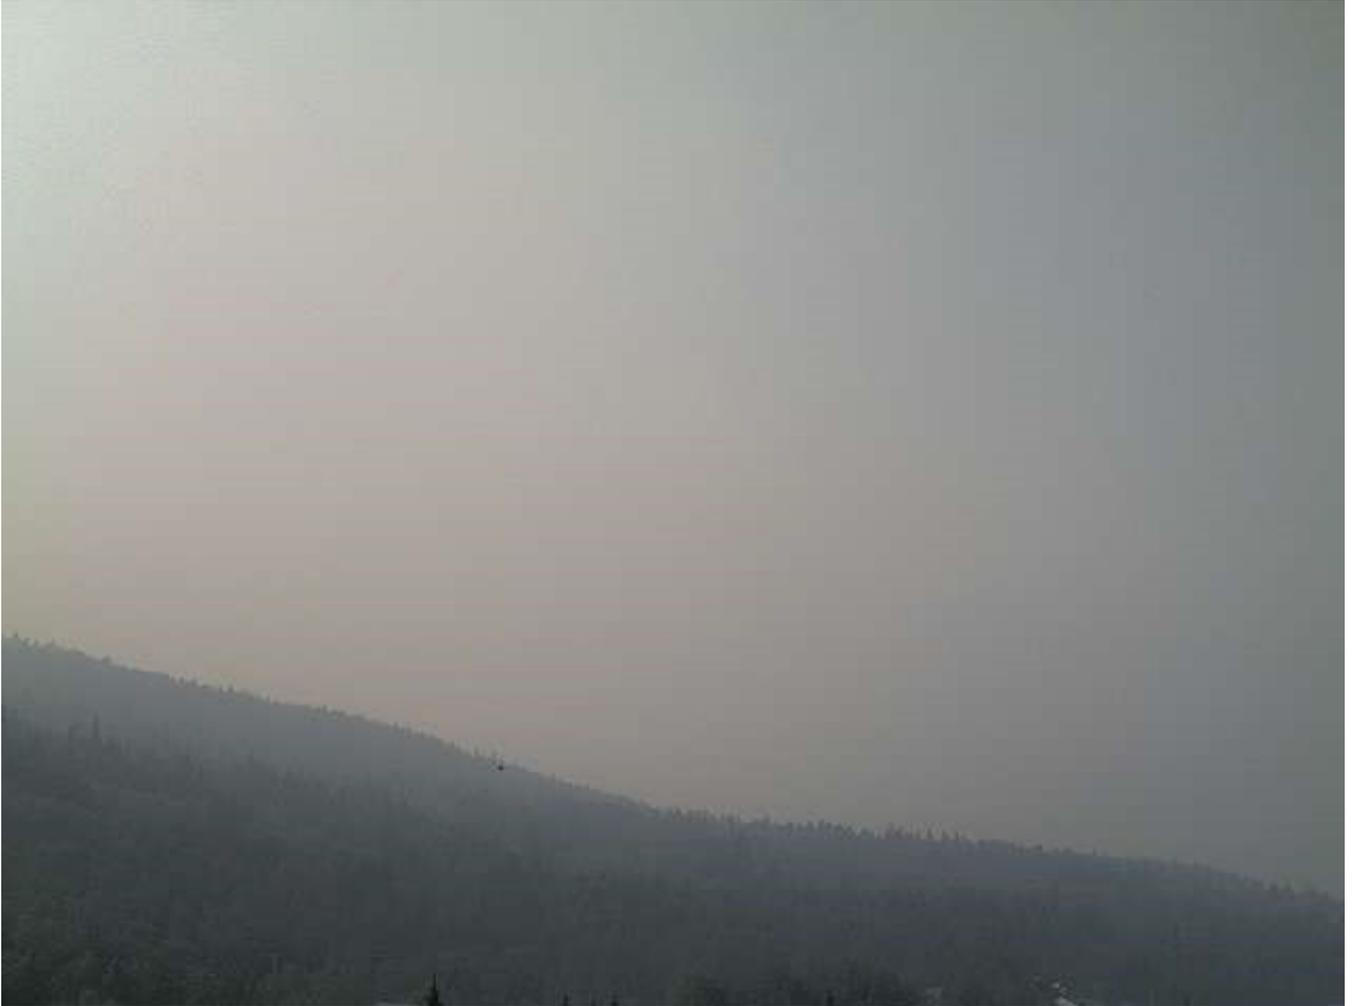
A review of Federal Aviation Administration (FAA) weather camera images recorded from Moose Pass (52Z), about 7 miles southeast of the accident site, revealed reduced visibilities in all directions about the time of the accident as a result of smoke and/or haze in the area. Figure 2 shows the visibility in the direction of the accident site about the time of the crash; Figure 3 shows the visibility on a clear day.

Figure 2. Reduced visibility conditions in the direction of the accident location at 1610 on the day of the accident.

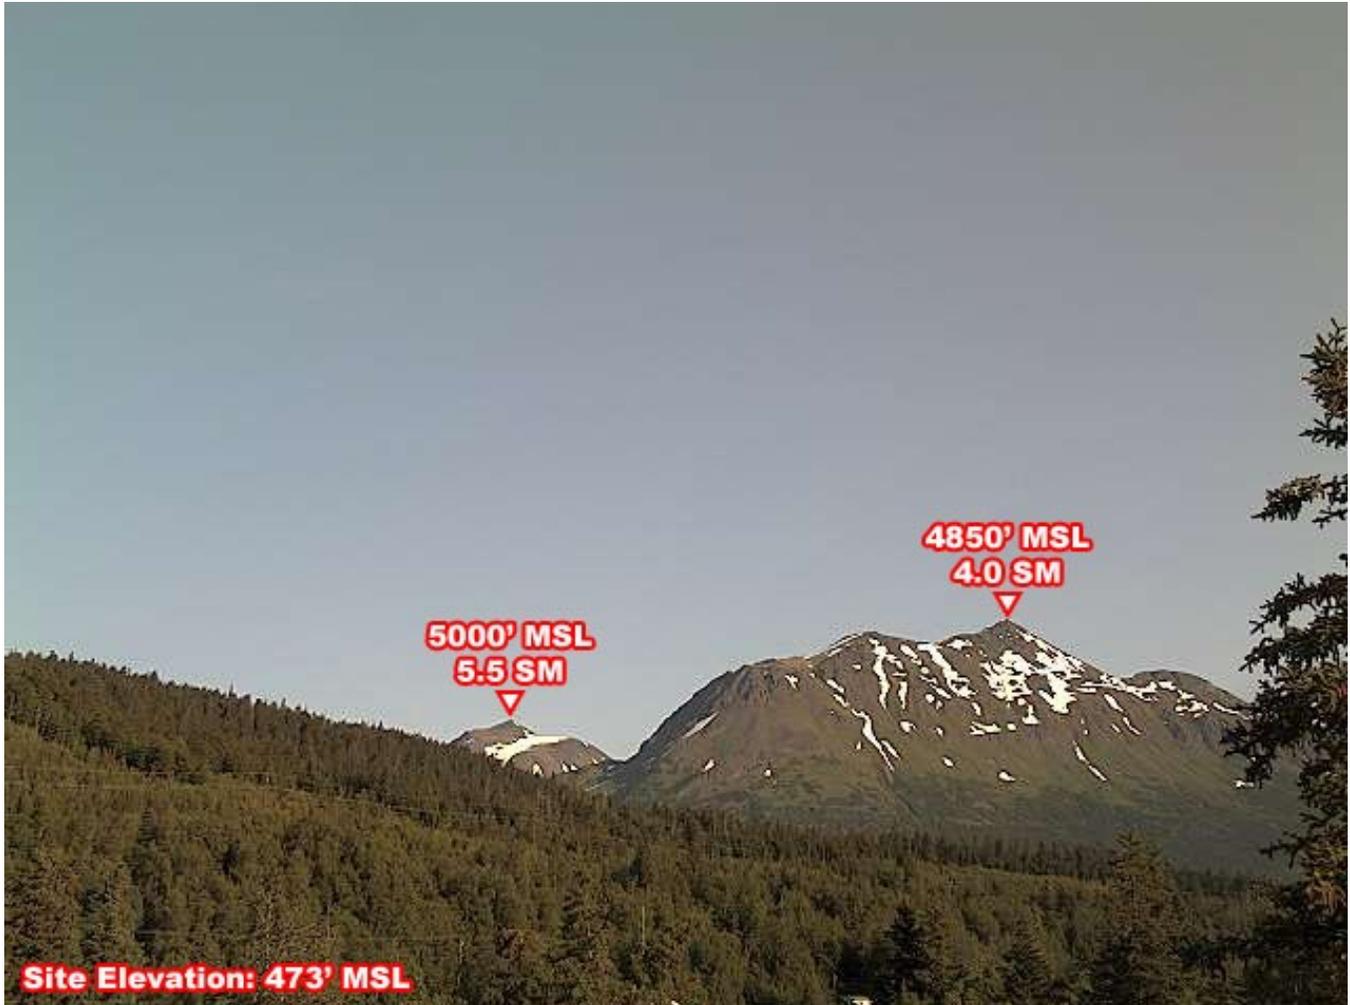
Figure 3. Visibilities in the direction of the accident location on a clear day.
