National Transportation Safety Board Aviation Accident Preliminary Report

Location:	Bethel, AK	Accident Number:	ANC19LA031
Date & Time:	07/08/2019, 1505 AKD	Registration:	N9448B
Aircraft:	Cessna 208	Injuries:	6 Minor
Flight Conducted Under:	Part 135: Air Taxi & Commuter - Scheduled

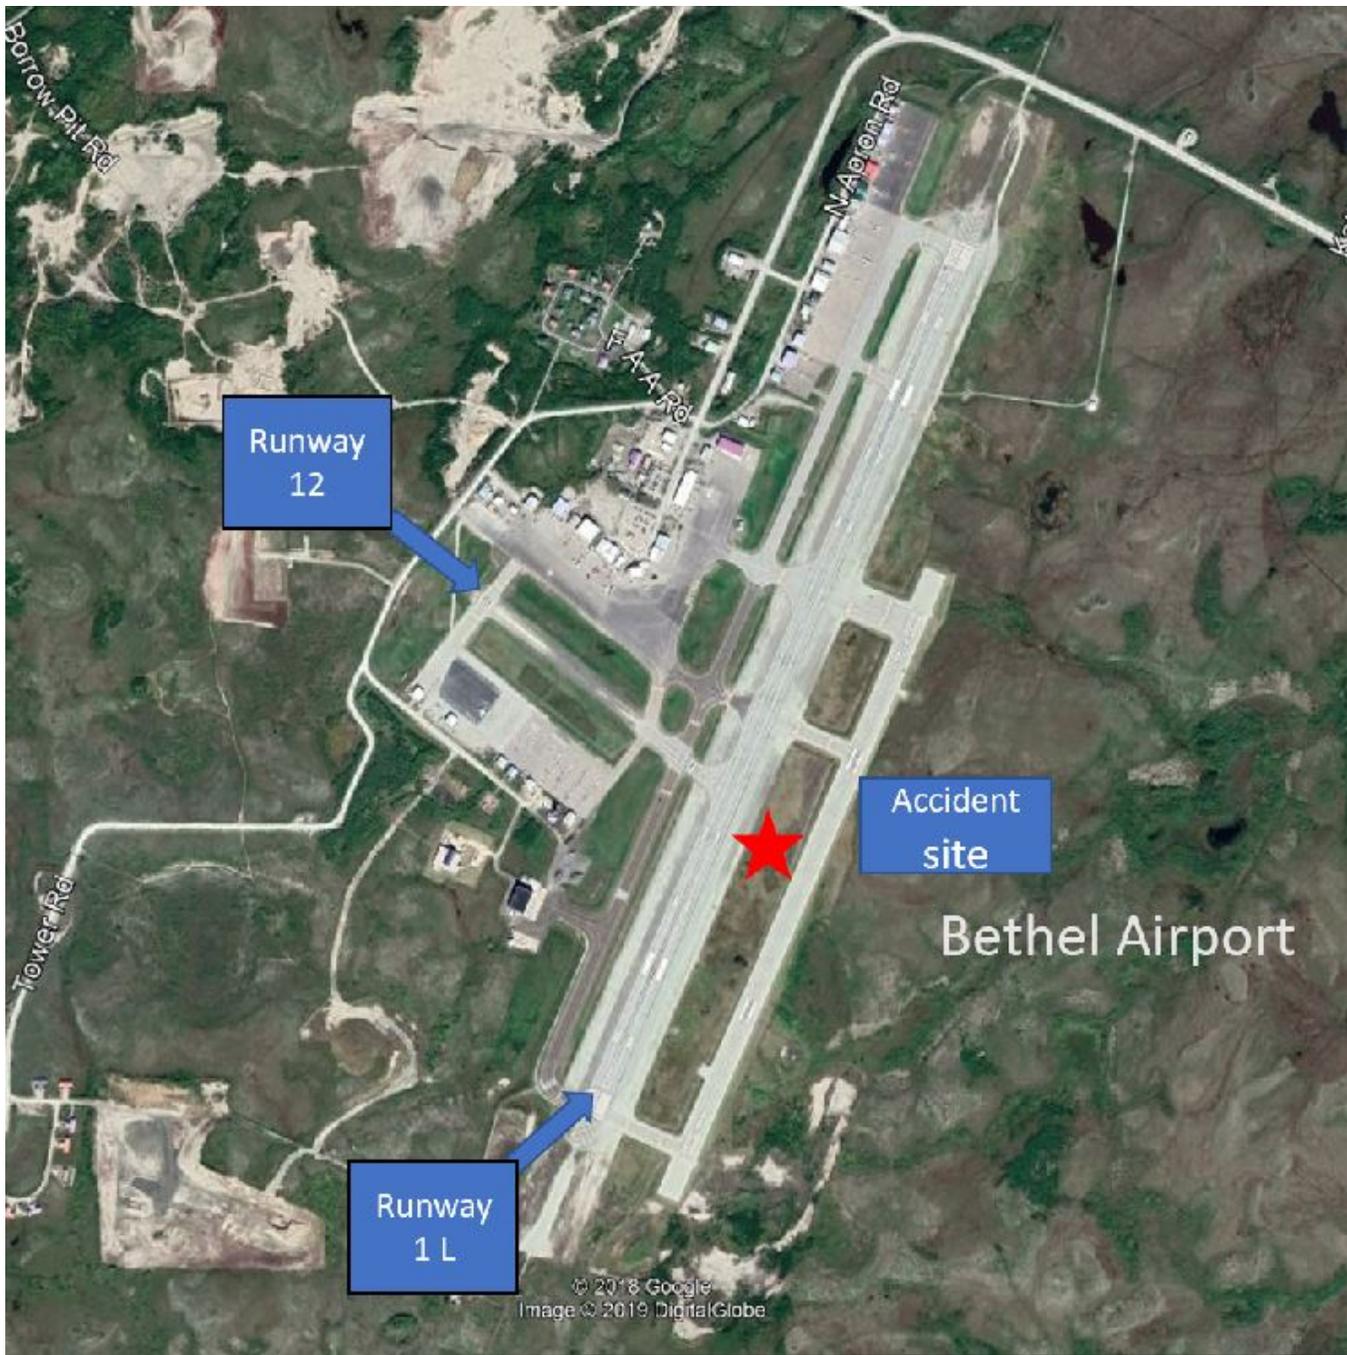
Figure 1. Bethel Airport runways and accident site

The airplane came to rest on its right side in the grass covered drainage ditch between runways 1L and 1R. The pilot stated that he saw fire through the right window, and immediately went to the back of the airplane to help with the evacuation of the two children and three adult passengers through the left cargo door before the airplane was consumed by fire. Witnesses,

Runway 12 at BET is a 1,858 ft long asphalt and gravel runway which does not intersect with runway 1L or 1R. Refer to figure 1.
