National Transportation Safety Board Aviation Accident Factual Report

Location:	Kaneville, IL	Accident Number:	CEN19LA216
Date & Time:	07/08/2019, 1600 CDT	Registration:	N112EZ
Aircraft:	Rutan VARIEZE	Aircraft Damage:	Substantial
Defining Event:	Fuel related	Injuries:	1 Minor
Flight Conducted Under:	Part 91: General Aviation - Personal

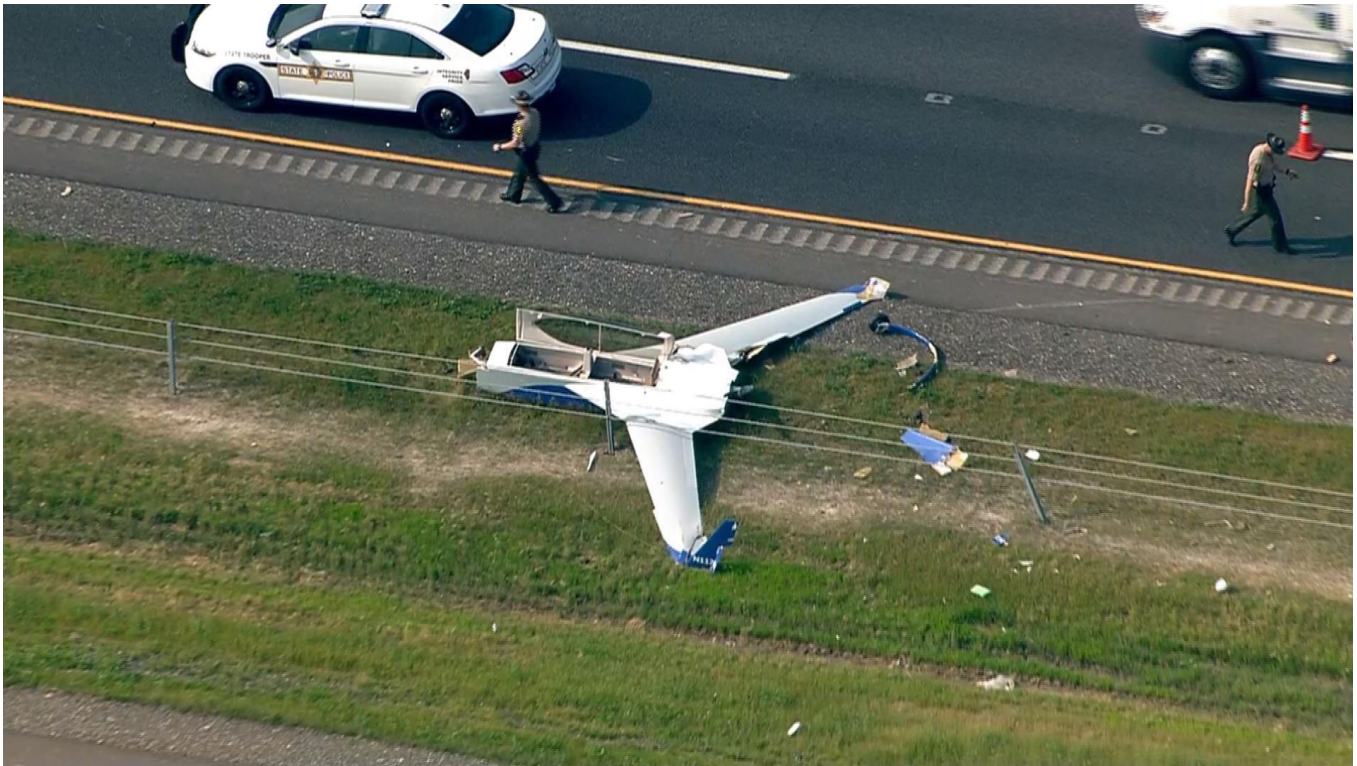
After the accident the pilot stated that he was descending toward the destination airport and contacted the ARR air traffic control (ATC) tower. The controller advised the pilot that the ARR airspace was operating under instrument flight rules (IFR) due to low visibility and haze. The pilot remained north of the ARR airspace and requested a special VFR clearance, which was denied by ATC due to an inbound IFR flight. He stated that while holding outside of ARR airspace with a reduced power setting, about 1,900 rpm, and the carburetor heat off, he reduced the mixture control about one inch of travel and the engine experienced a total loss of power and the propeller completely stopped rotating. While about 1,600 ft above ground level (agl), the pilot initiated a steep dive to increase airspeed and allow the propeller to rotate and the engine to restart. During the maneuver, he added carburetor heat but the propeller would not rotate so he pulled out of the dive about 300 ft agl and determined the interstate was the best place for a forced landing. After aligning with the west bound lane, he glided the airplane over several cars and maneuvered for an opening between vehicles where he could land the airplane. During the landing the right wing contacted a pickup truck in the far right lane, the airplane veered right, the landing gear collapsed, and the pilot was unable to maintain directional control. The airplane rotated 360° and came to rest in the grass median – see figure 1.

Figure 1 – Airplane in grass median (Courtesy of Chicago WGN9)
