National Transportation Safety Board Aviation Accident Preliminary Report

Location:	Ranger, TX	Accident Number:	CEN20LA004
Date & Time:	10/06/2019, 0835 CDT	Registration:	N36LS
Aircraft:	BEECH B36	Injuries:	4 None
Flight Conducted Under:	Part 91: General Aviation - Personal

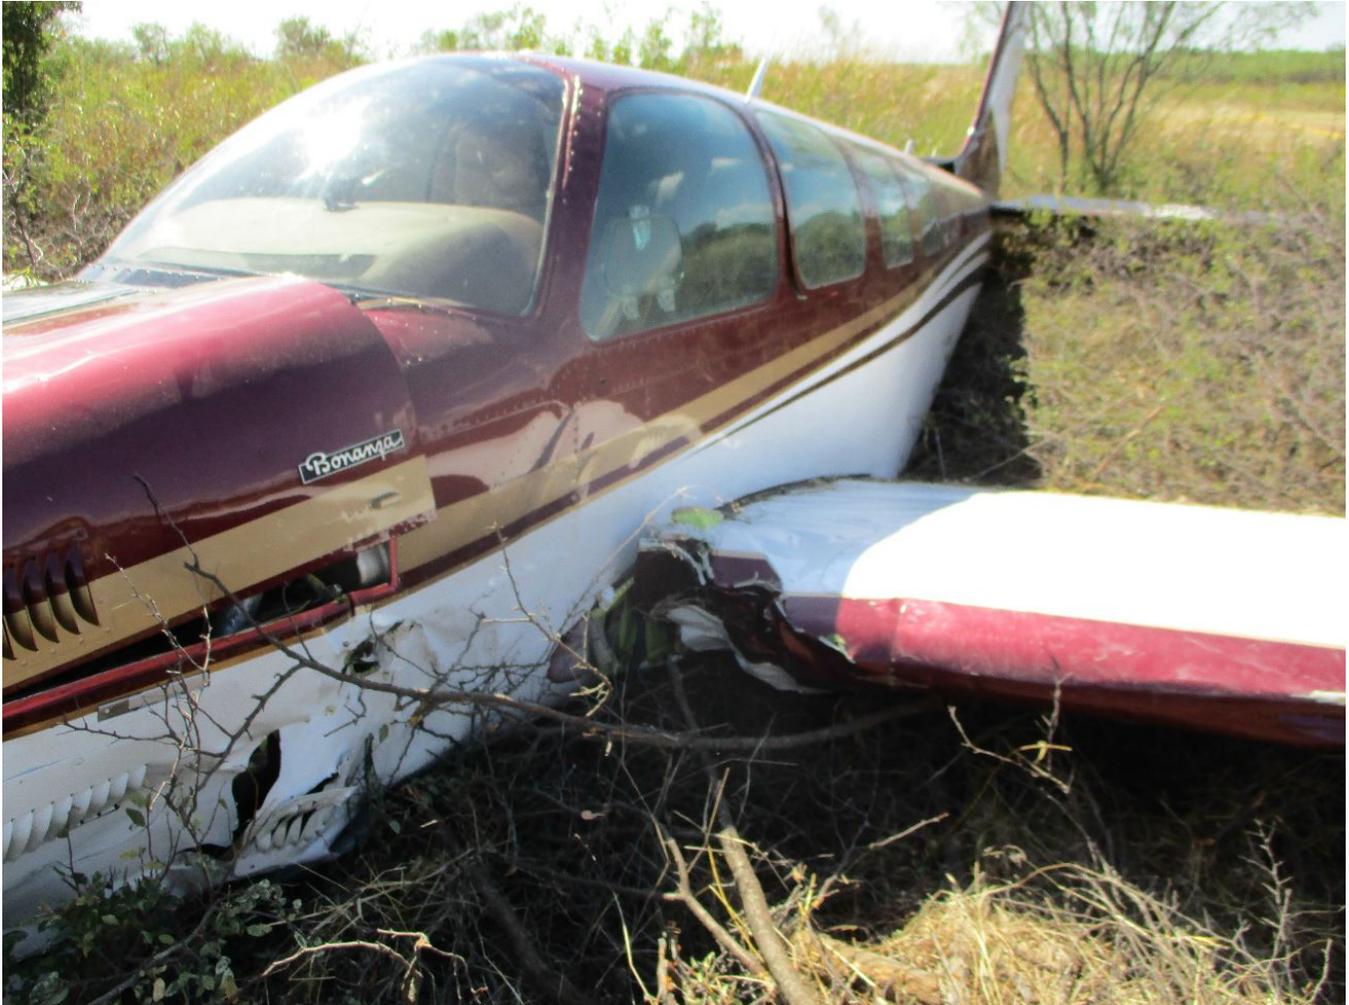
Figure 1 – A view of the front left side of accident airplane upright in a field.

During the forced landing the airplane sustained substantial damage to the fuselage and left wing. The airplane was recovered to a secure storage facility and retained for further examination.
